Great Lakes Waterways Conference

U.S. Army Corps of Engineers
Chief of Operations – Detroit District

2015 MacArthur Lock Outage

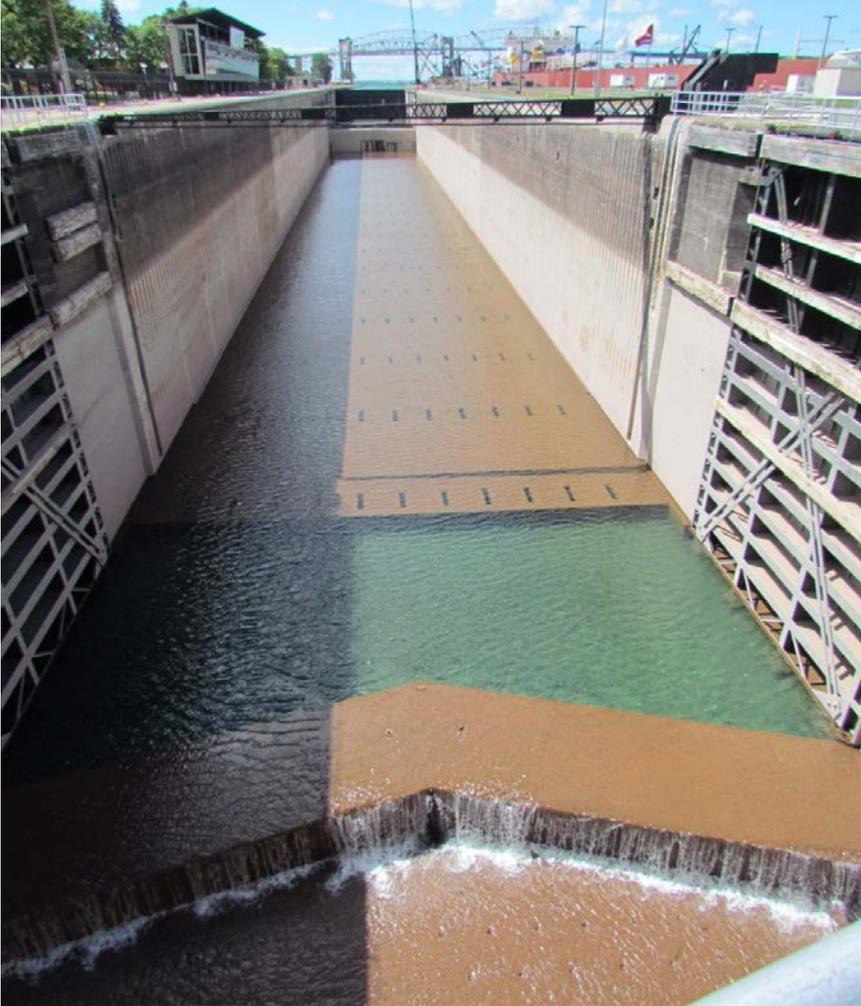
Dewatered MacArthur Lock Chamber

- Required to facilitate repairs
- Required placement of upstream dewatering bulkheads
- Typically don't dewater until winter shut down to avoid impact to navigation

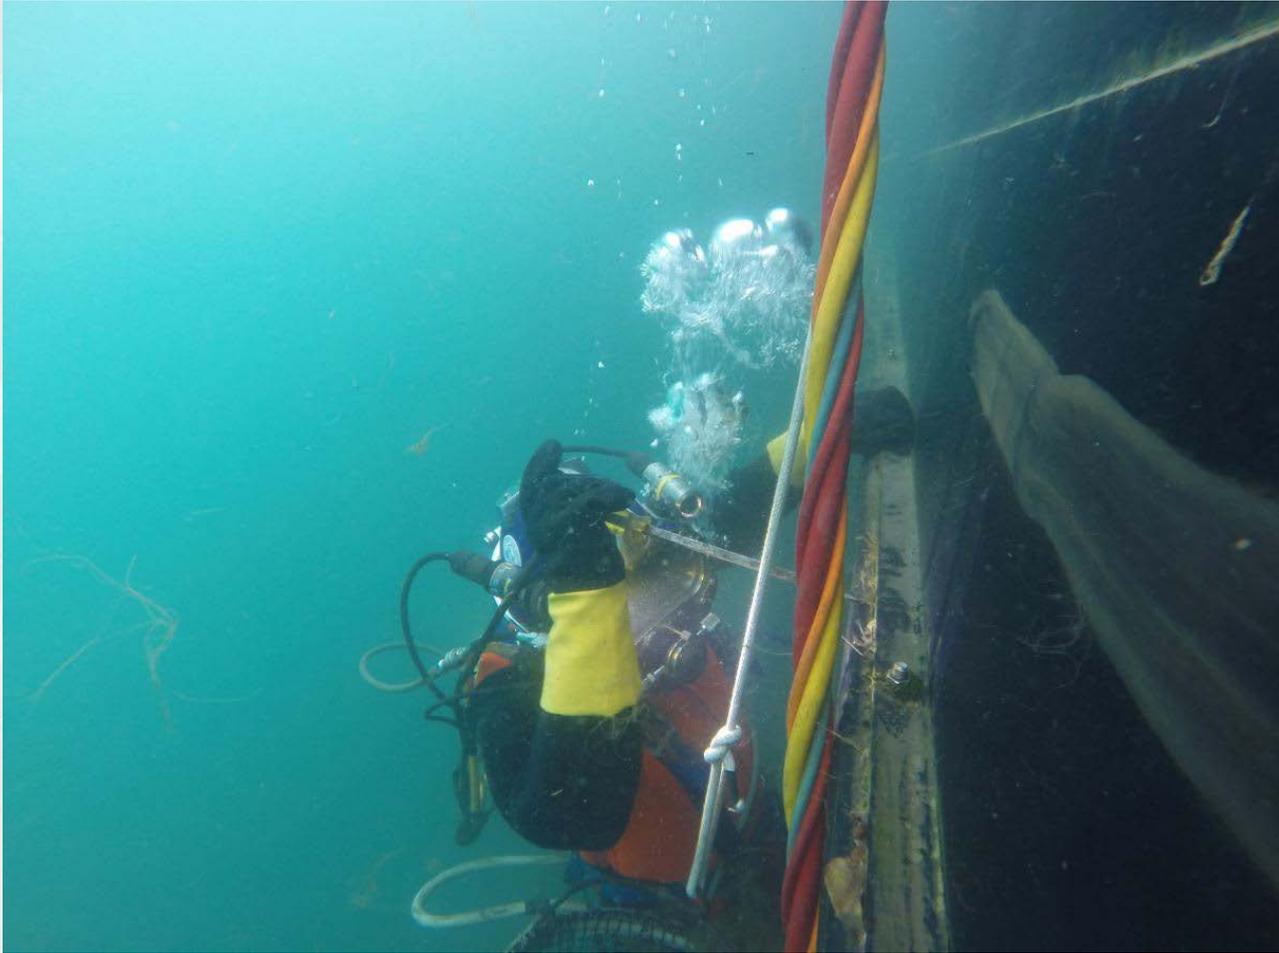
Divers Chinking Bulkheads to Reduce Seepage into Dewatered Chamber

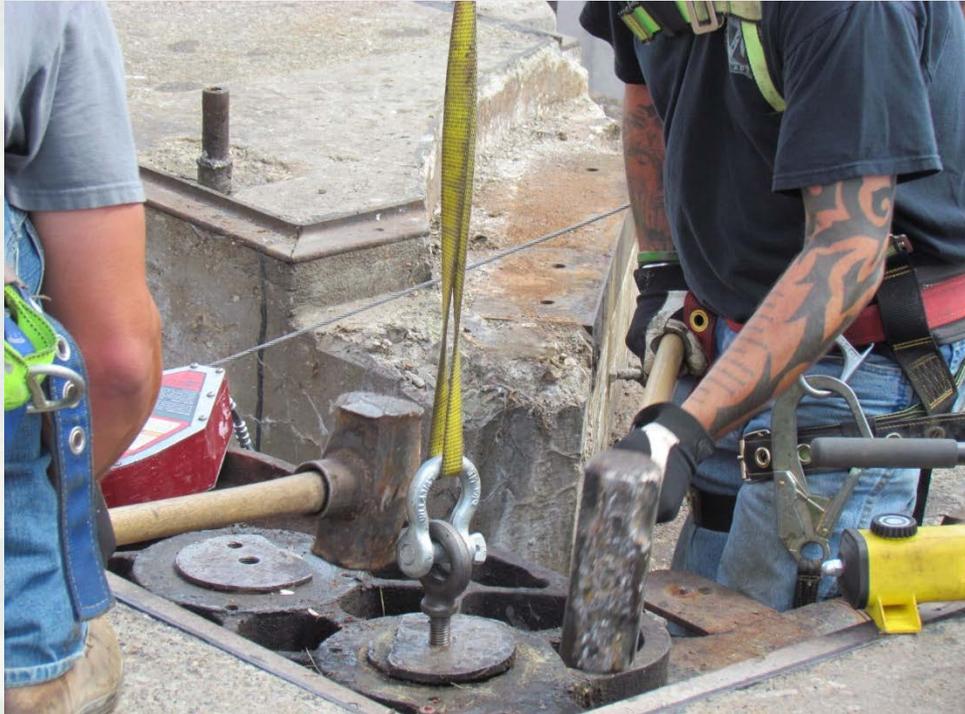
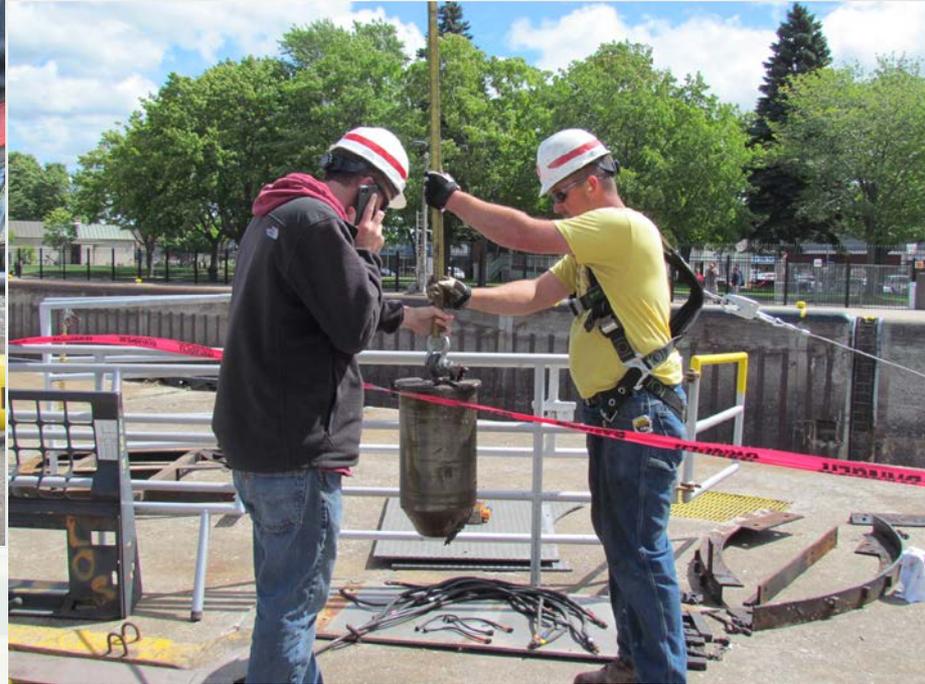
Removing Old Gate Anchorage Pins

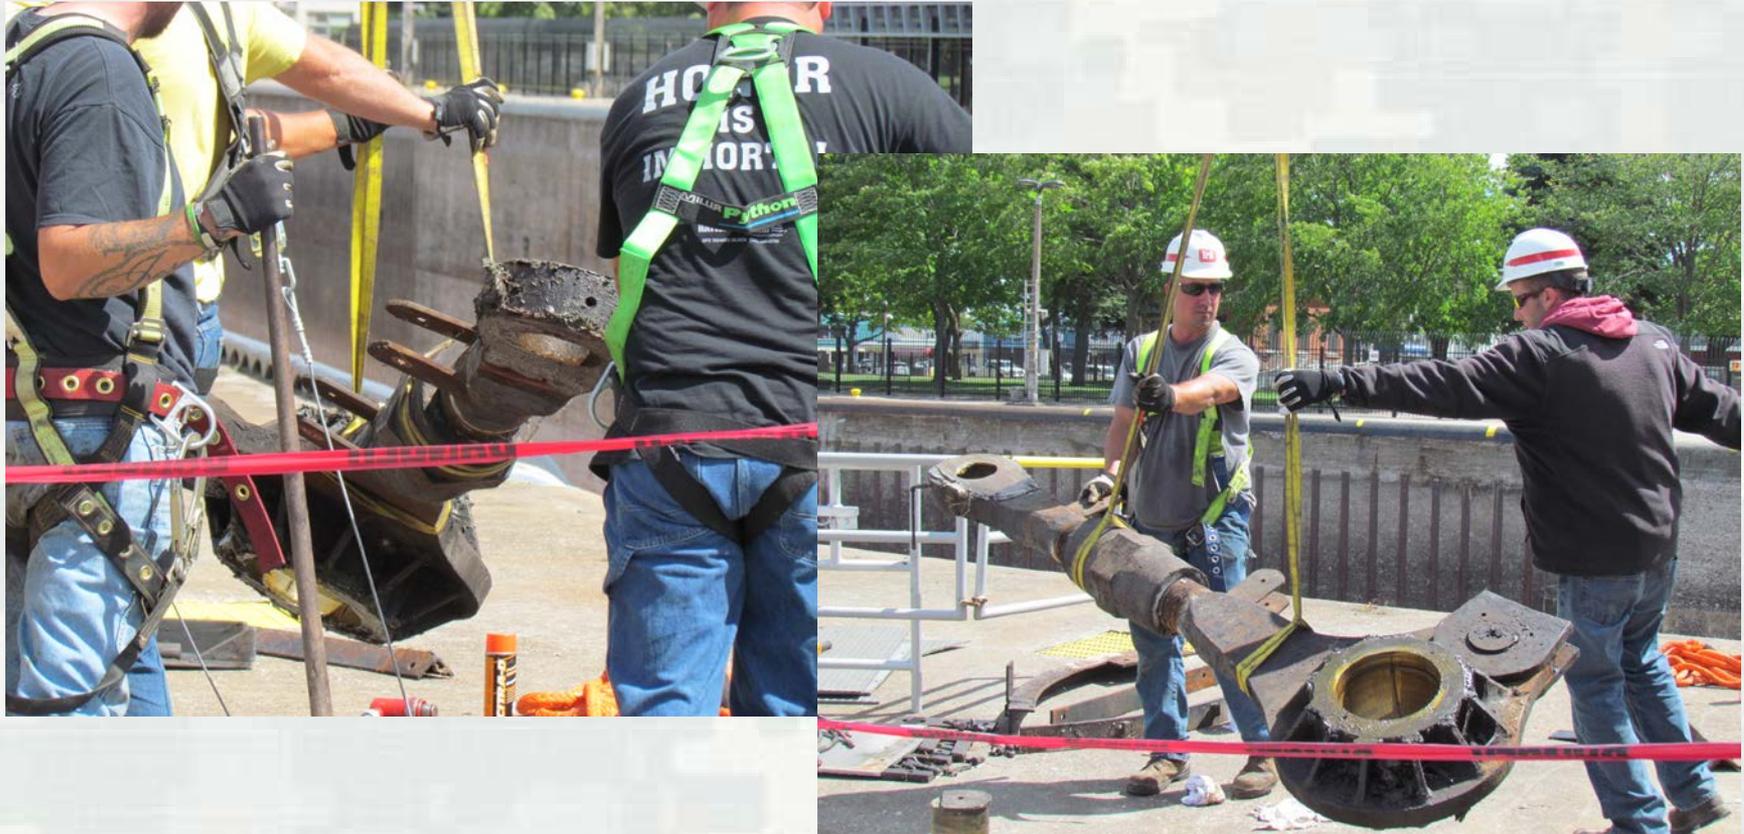
Removing Old Gate Anchorage Links

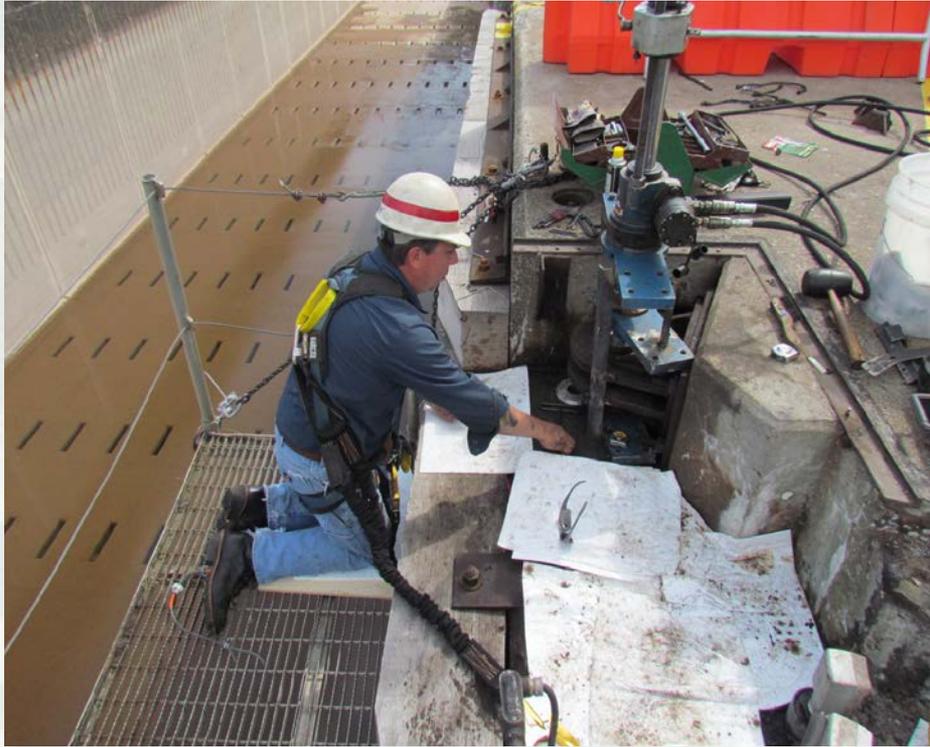
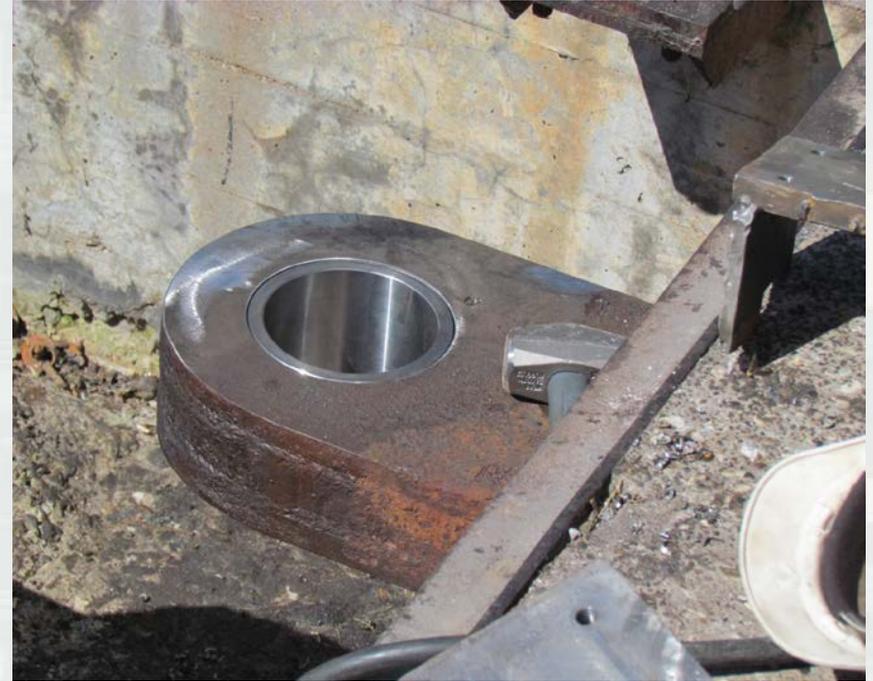
Boring Embedded Gate Anchorage & Installing New Bushings

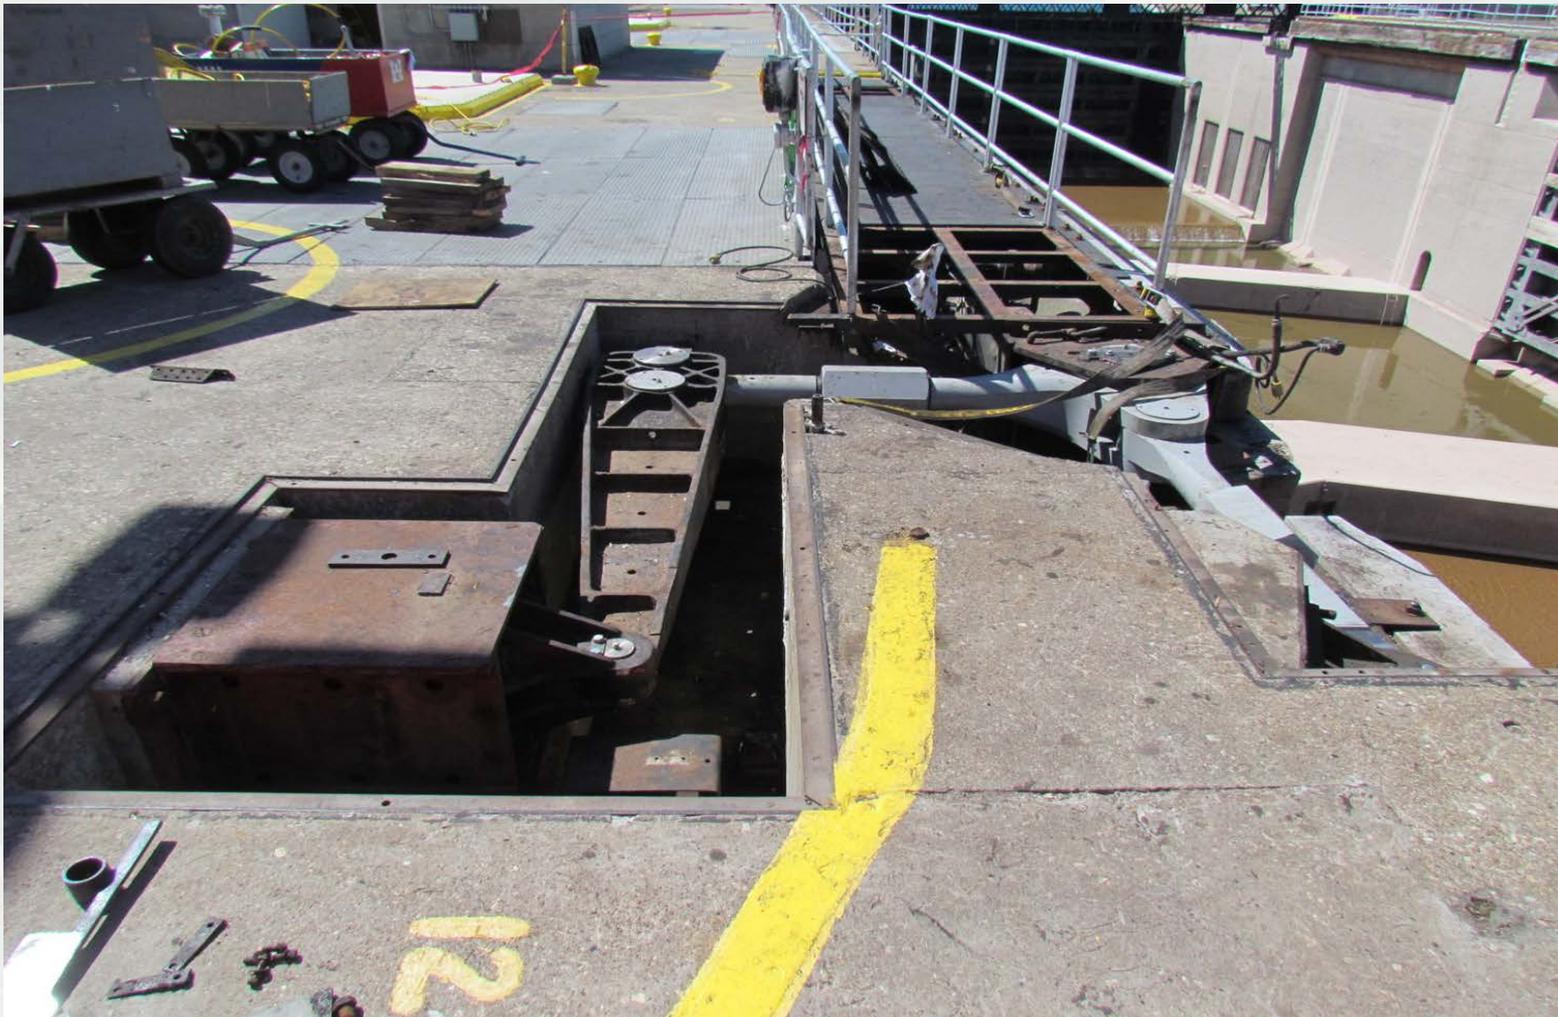
Finished Gate Anchorage Assembly

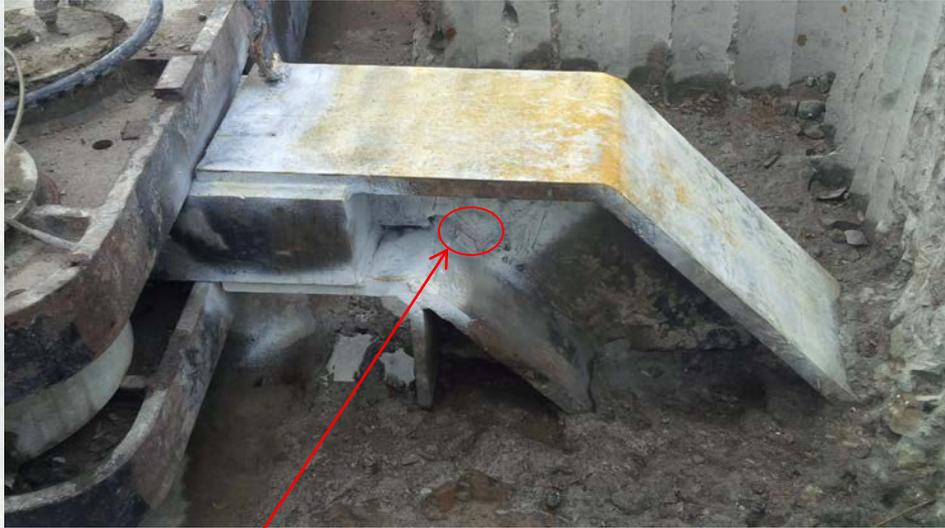
Gate 3S Weld Concerns: Visual Inspection, and ND Testing identified a 1.5" crack in the weld of the Gate 3S primary anchor.

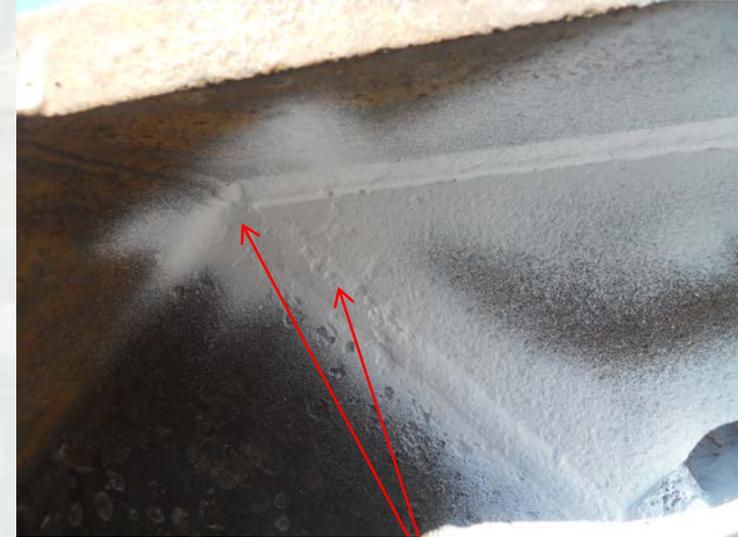
Crack In Weld

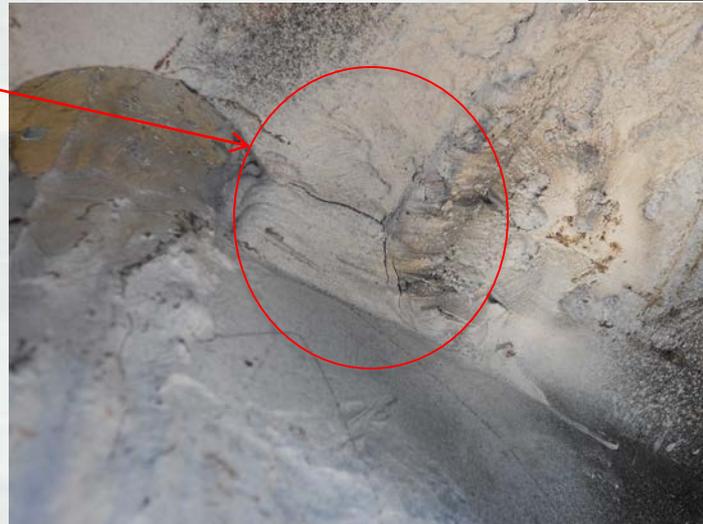
Surface Pitting

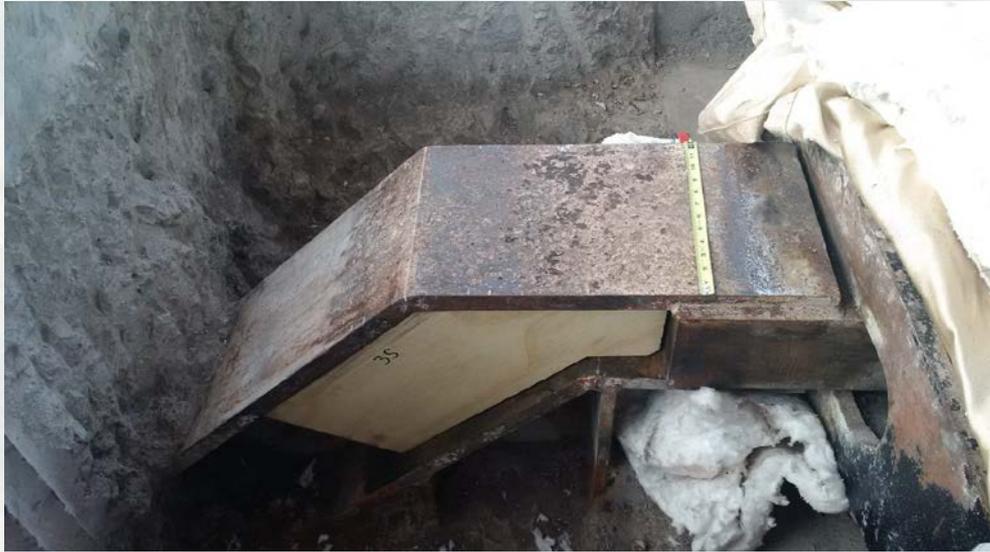
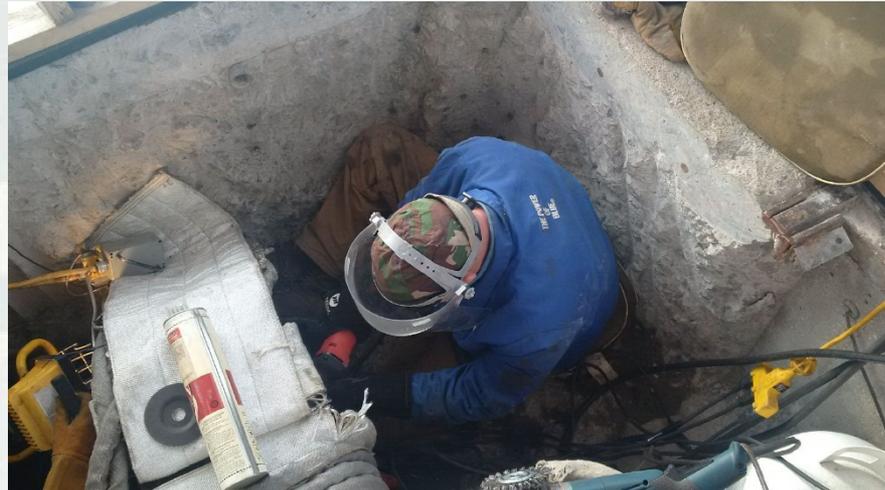
Stiffener Plate Installation

Template of stiffener plate

Soo welder installing stiffener plate

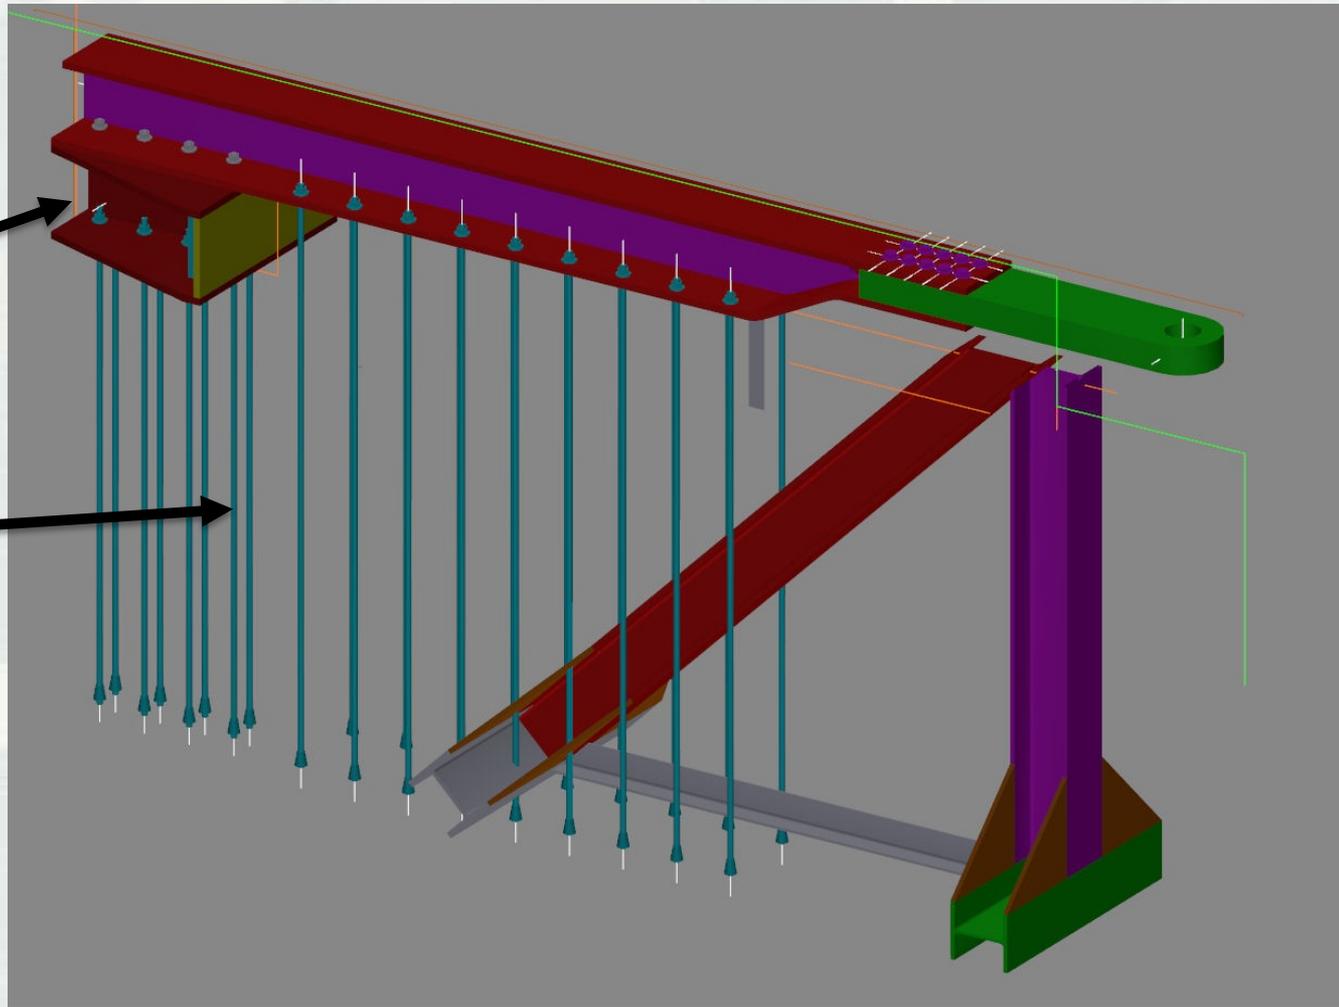
New Poe Anchorage

Shear key
provides shear
resistance

Anchors
provide
overturning
resistance

- Design Ongoing by Corps' Inland Navigation Design Center of Expertise
 - Meets current design criteria (loading, fatigue, materials)
 - Minimize impact to navigation during installation
 - Consideration of future maintenance/potential repair requirements
- Identified as Part of District's List of Critical Funding Needs for Consideration for Potential FY16 Funding Pots
- Prepared for Summer 2016 Advertisement Should Funding be Received

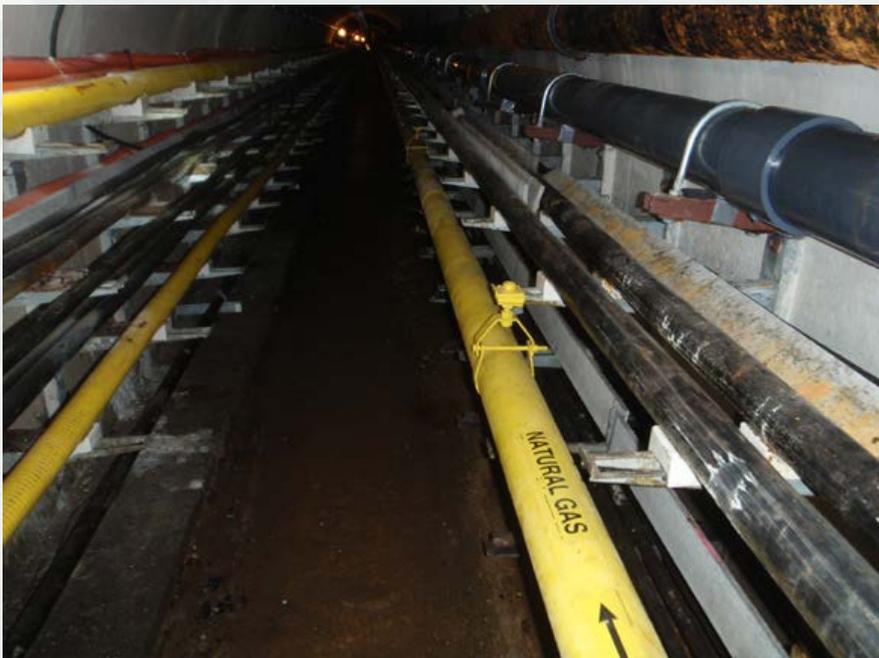
Existing highly corroded steel water line (1943) deteriorated and experiencing leakage

Waterline co-located with high power electric feeder cables within deep service tunnel

Water line located above high voltage electrical feeder lines and natural gas lines with spot corrosion

> Contract awarded to replace water line w/ work to begin Spring 2016

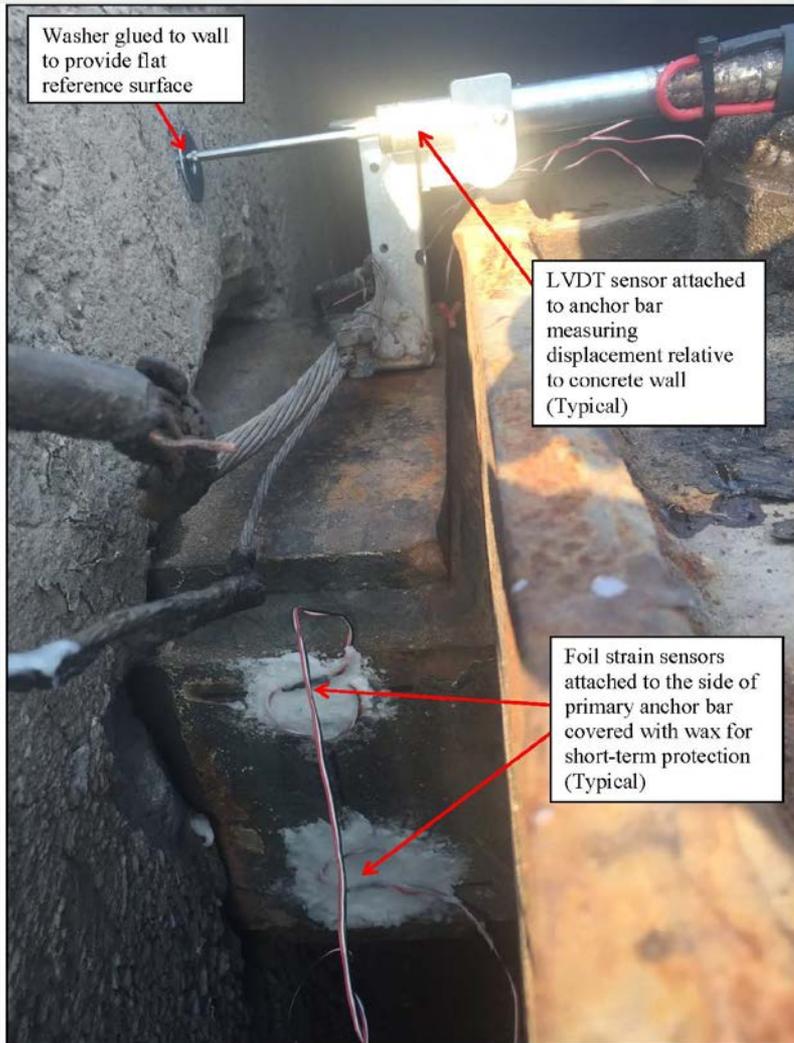
Figure 2.6 – Typical primary anchorage setup (Typical).

Strain Gauging was performed by Bridge Diagnostic Inc (BDI) to validate modeled loads. The results of the strain gauging showed actual loading to be higher than design and INDC modeled loads

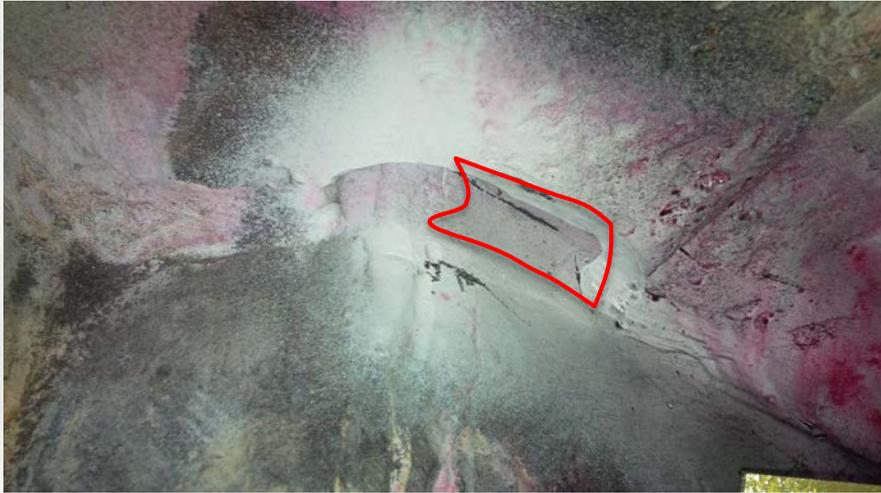
Weld repair procedure prepared by INDC & implemented by Soo crew. Grinding of the existing weld resulted in the development of shallow cracks in the weld and base metal. These were sanded out and eliminated. Crack repair preparation procedures are being altered to limit shallow crack development during grinding.

Area ground for weld repair

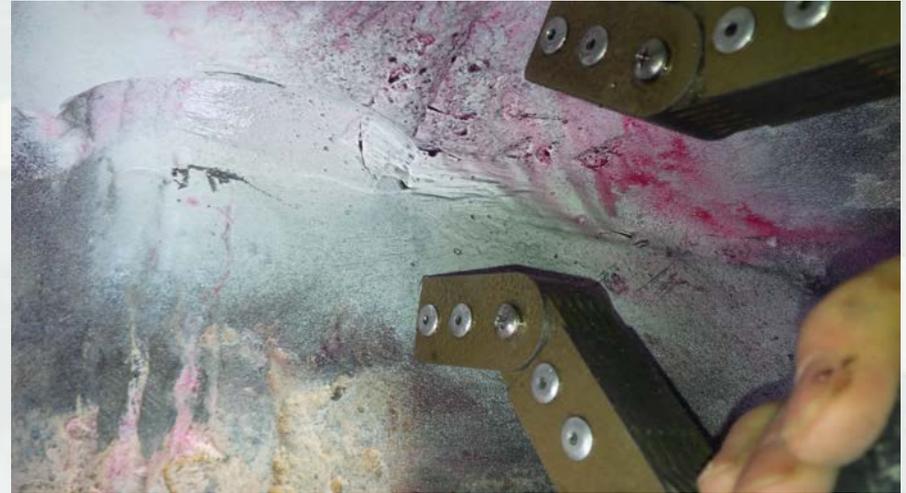
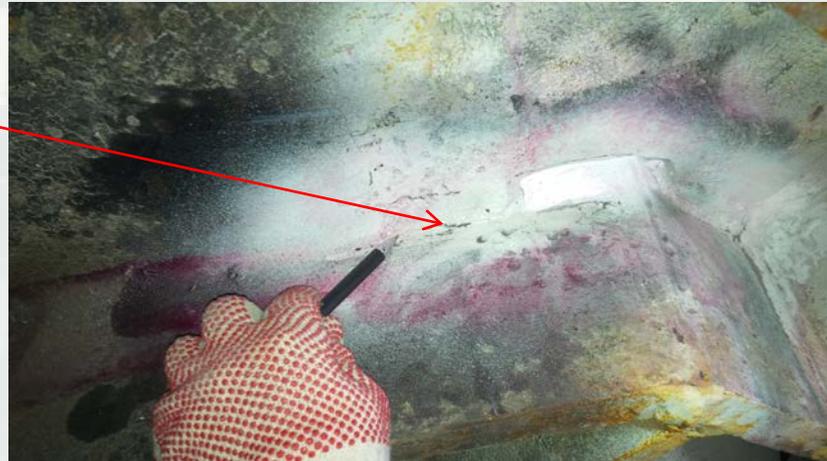
Magnetic Particle Testing

After initial grinding, visual inspection and NDT identified crack in base metal extended further than expected
