**US Army Corps  
of Engineers**®  
Detroit District

## HARBOR INFRASTRUCTURE INVENTORIES Cedar River Harbor, Michigan

**Date of Site Visit:** 13 September 2013

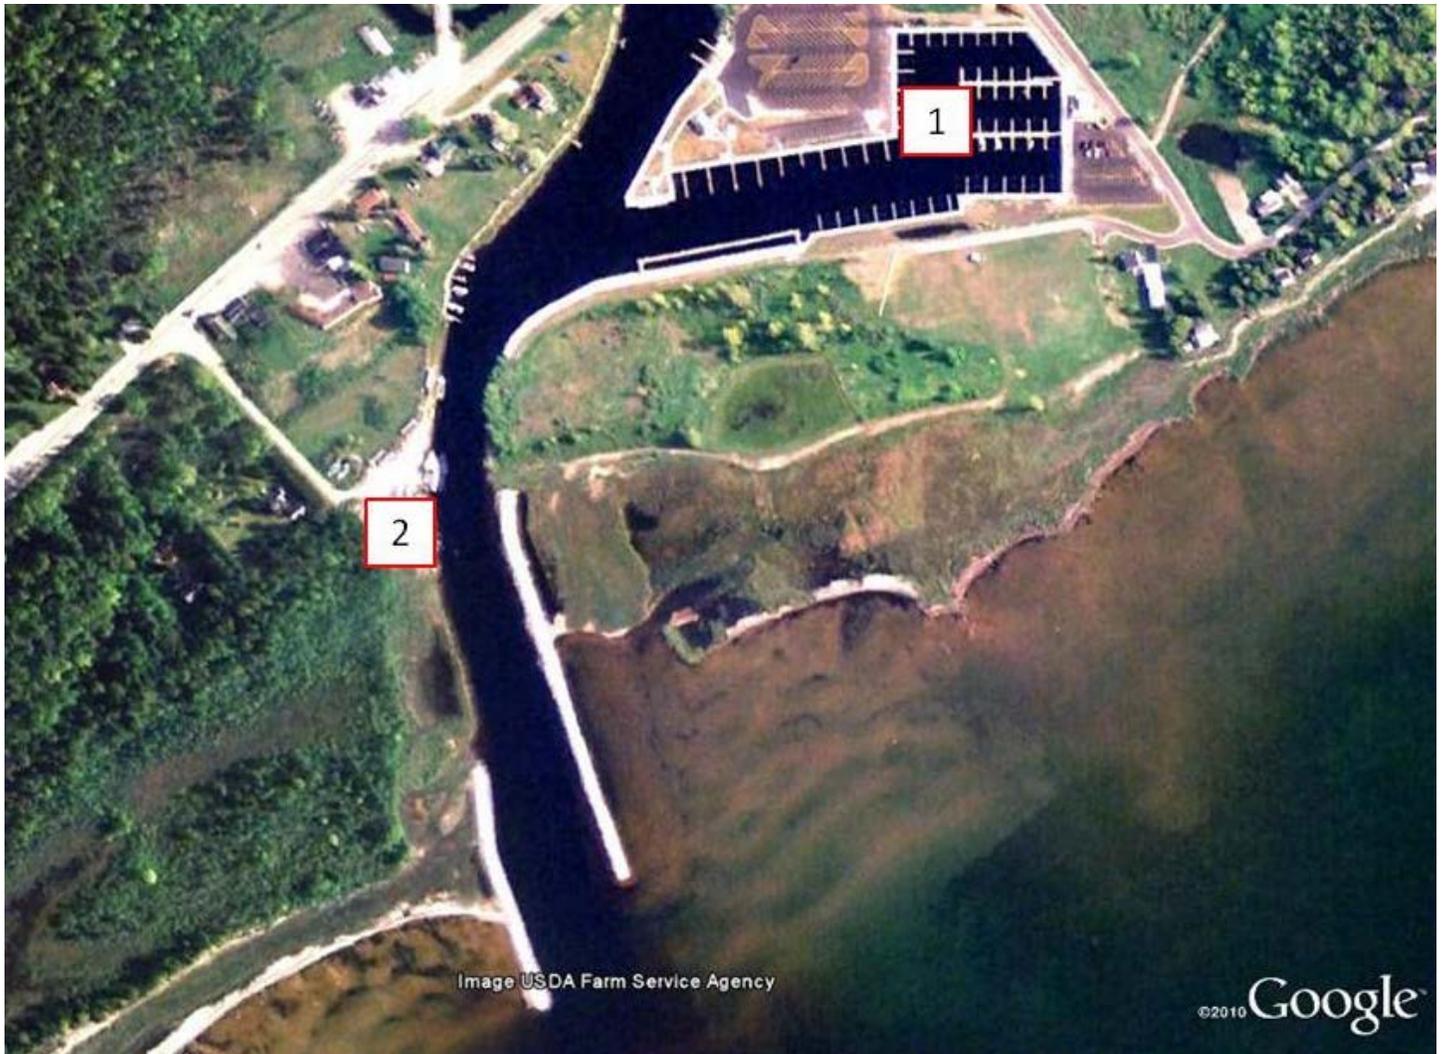
**1. Cedar River State Harbor:** The State of Michigan has a marina in the Cedar River Harbor. There are 125 slips comprised of fixed wood docks. The Michigan Department of Natural Resources and Environment also dock their boat at this marina.
