Coastal Structures Risk Communication Middle UP, Northern Wisconsin Harbors

Dave Wright
Chief of Operations
Detroit District

Oct 29, 2013

US Army Corps of Engineers
BUILDING STRONG

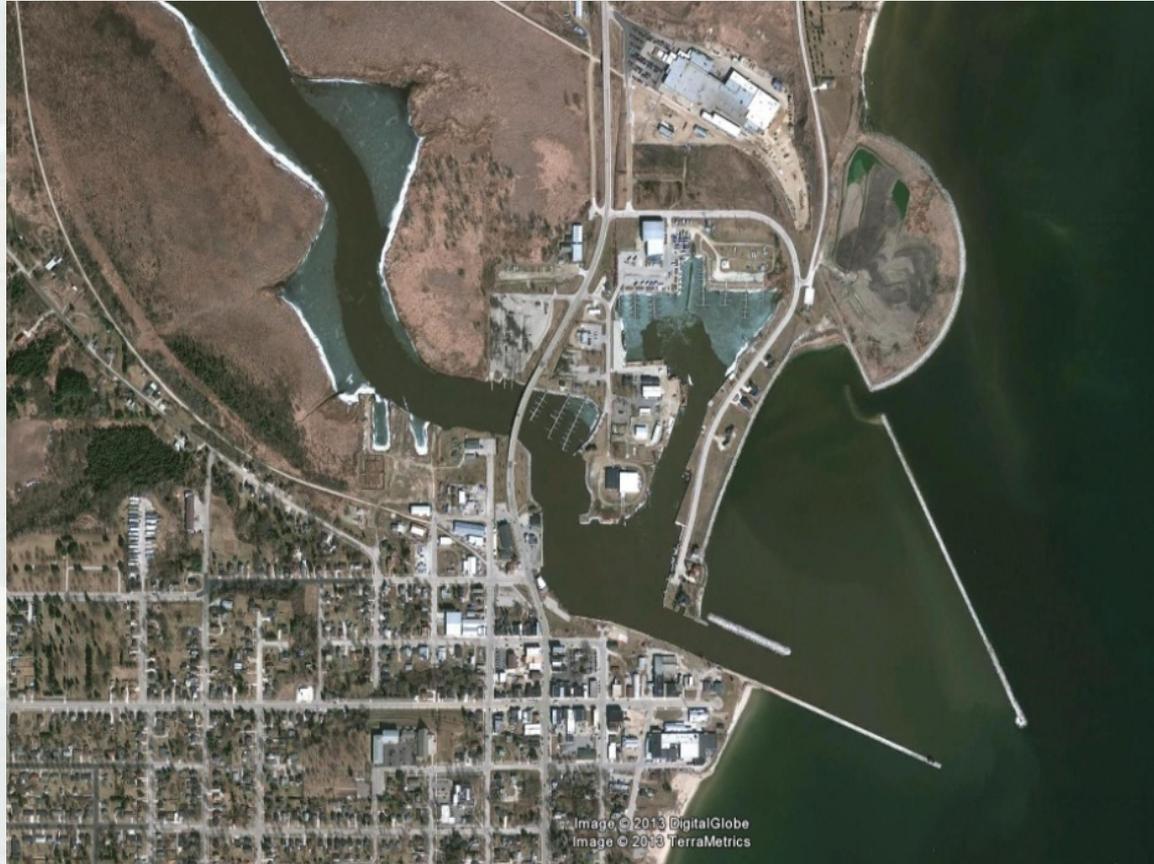
Kewaunee Harbor: B – Low Risk of Failure

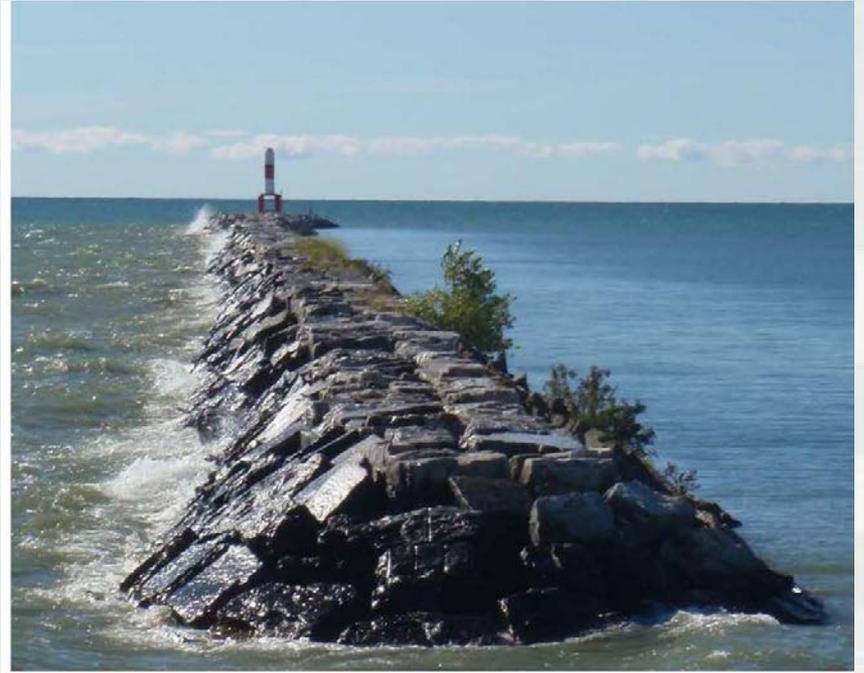
North Breakwater.

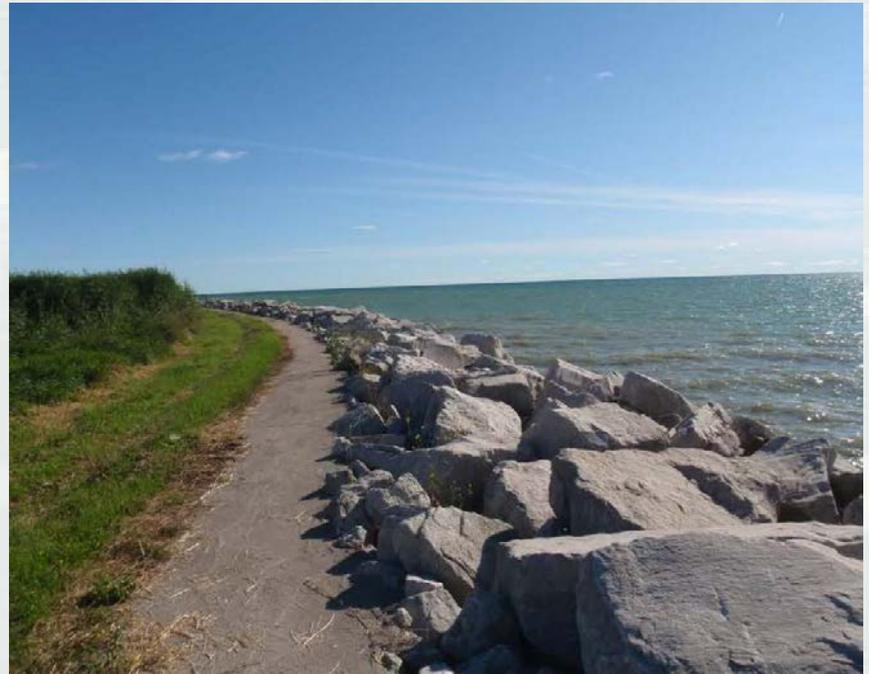
South Breakwater.

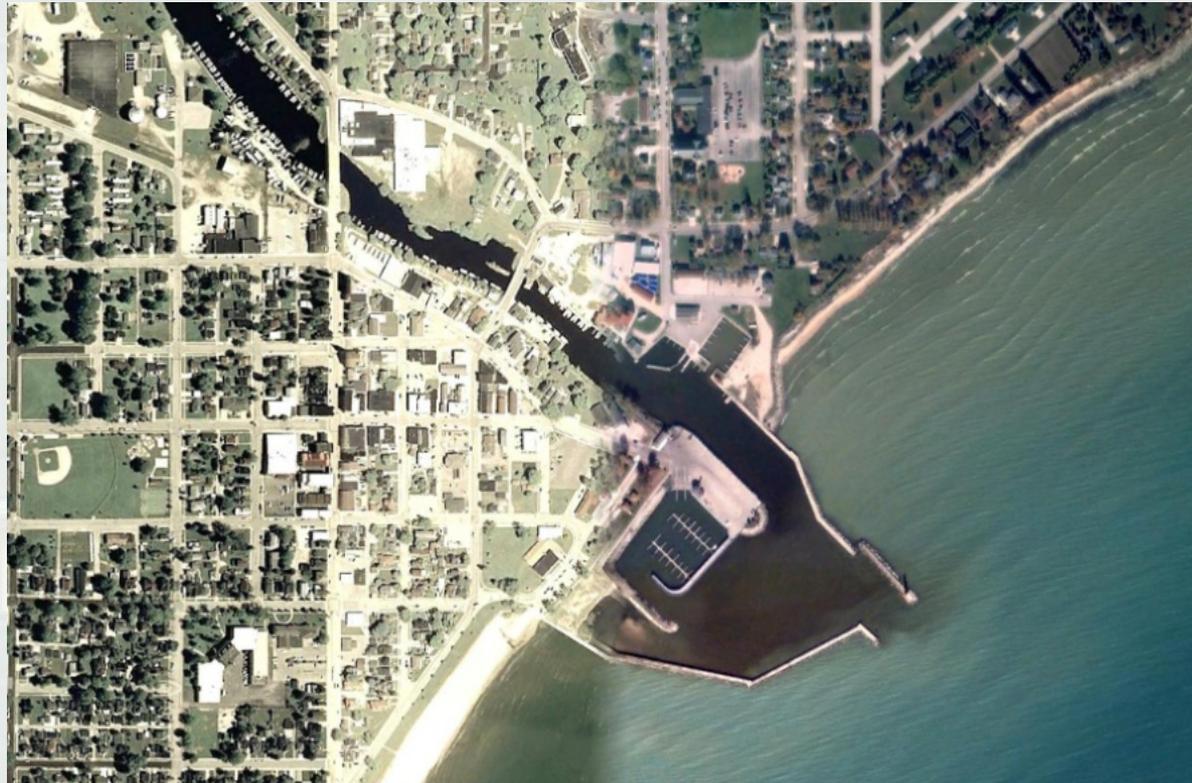
Algoma Harbor: C – Medium Risk of Failure

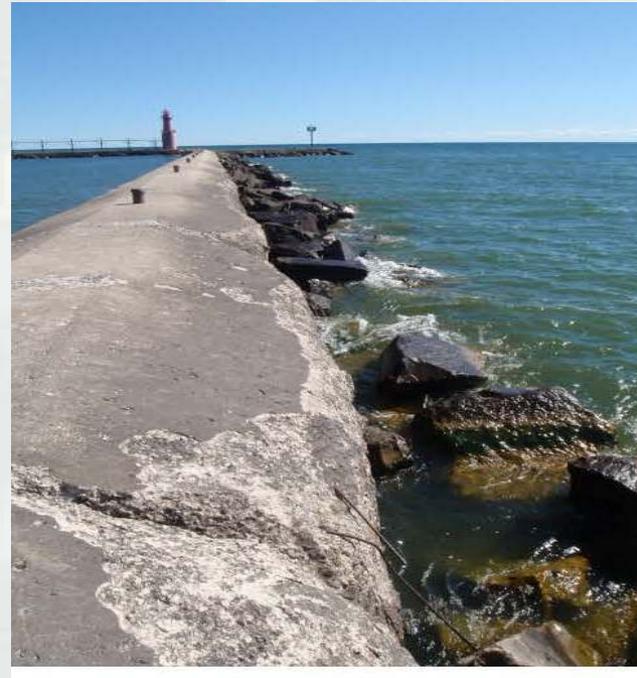
South Breakwater, Section F.

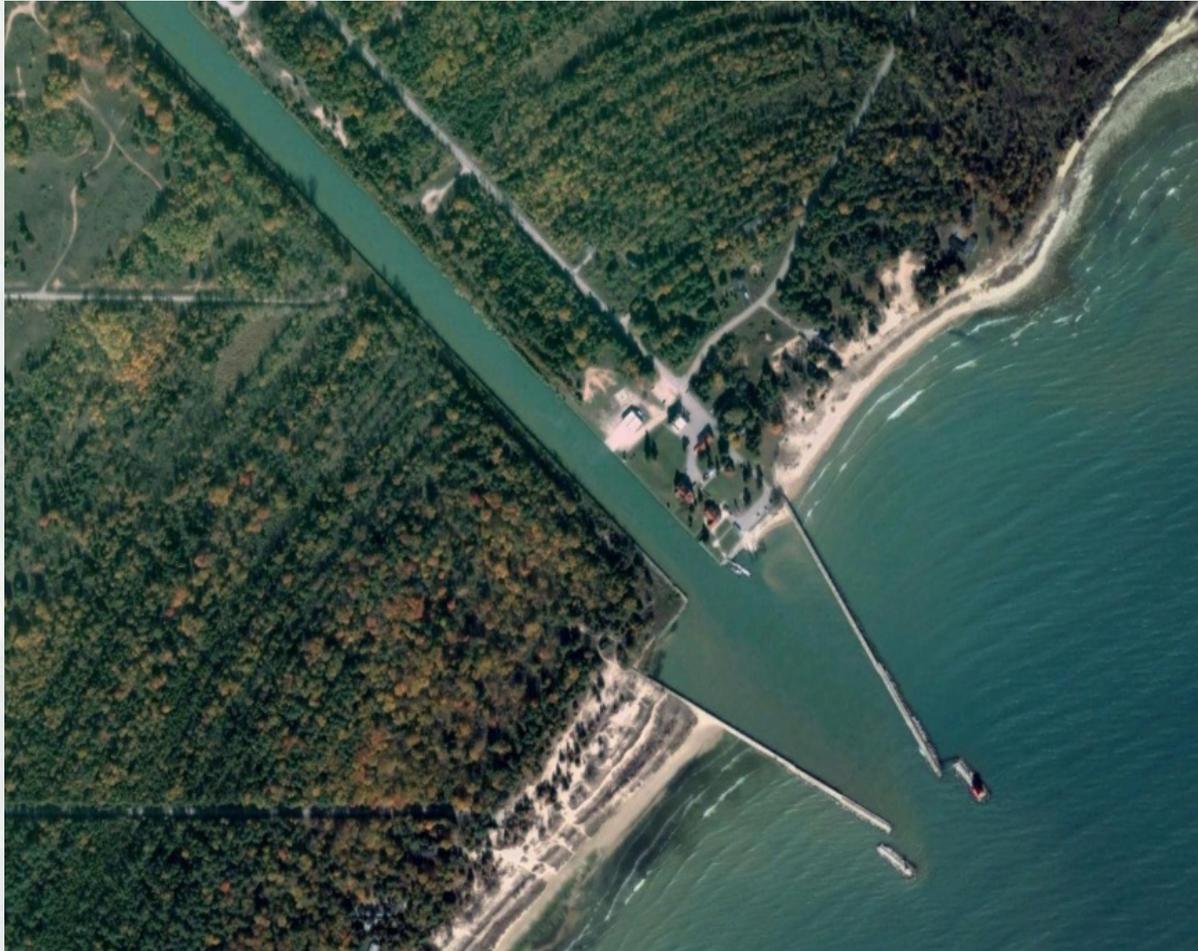
Sturgeon Bay Harbor: B – Low Risk of Failure

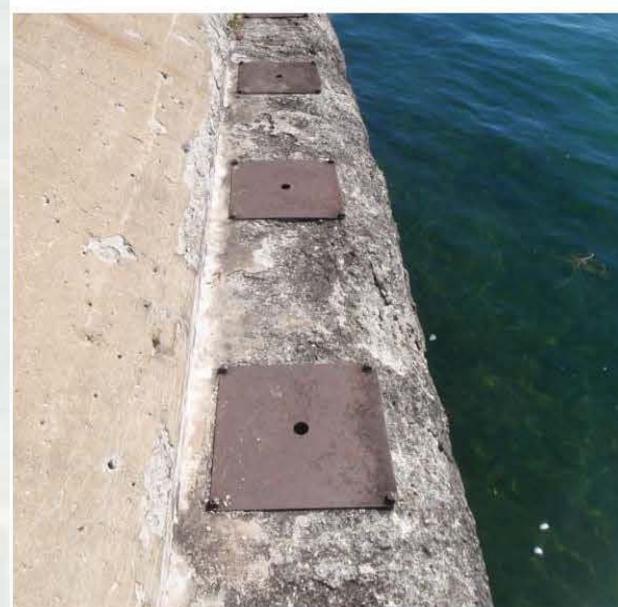
Moderate Deterioration of Harbor Side foot locks.

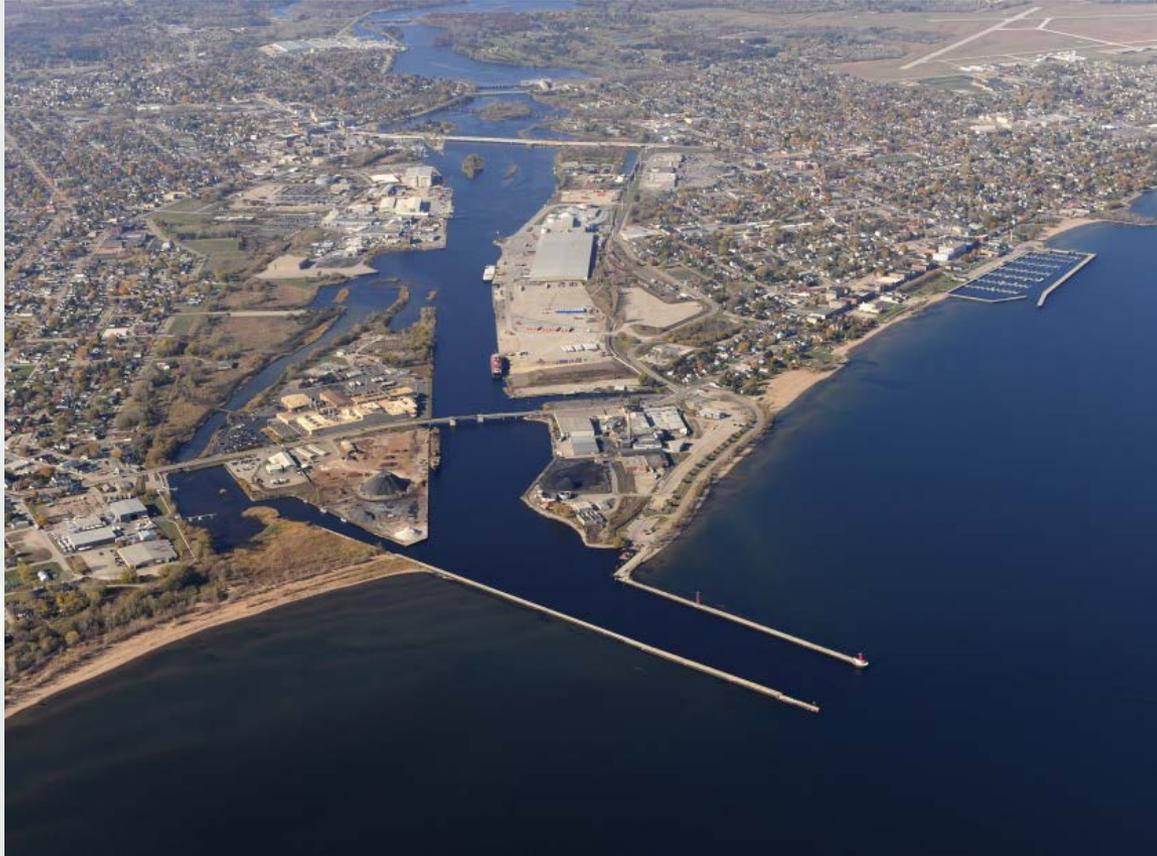
Menominee Harbor:
C – Medium Risk of Failure

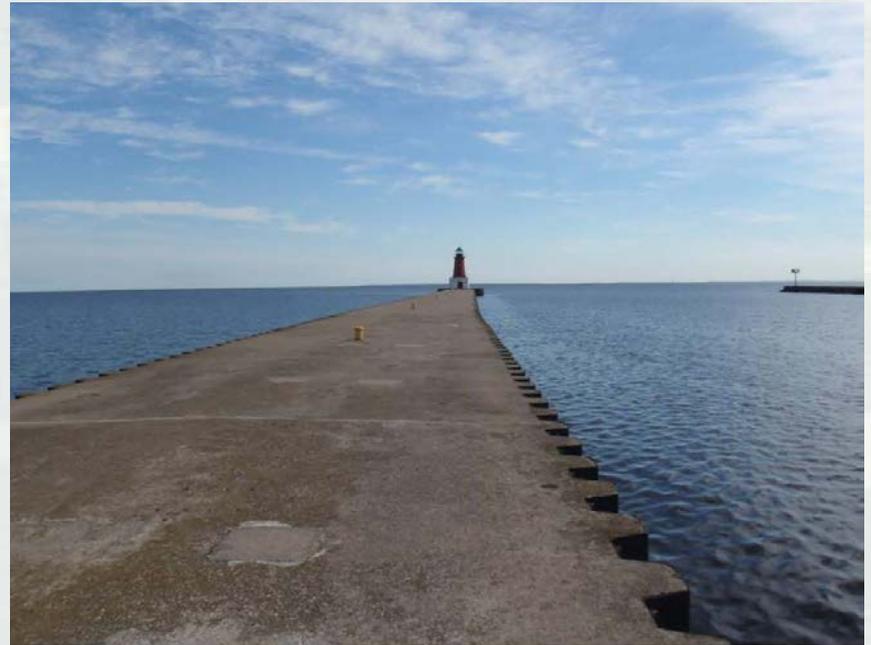
Overview of North Breakwater.

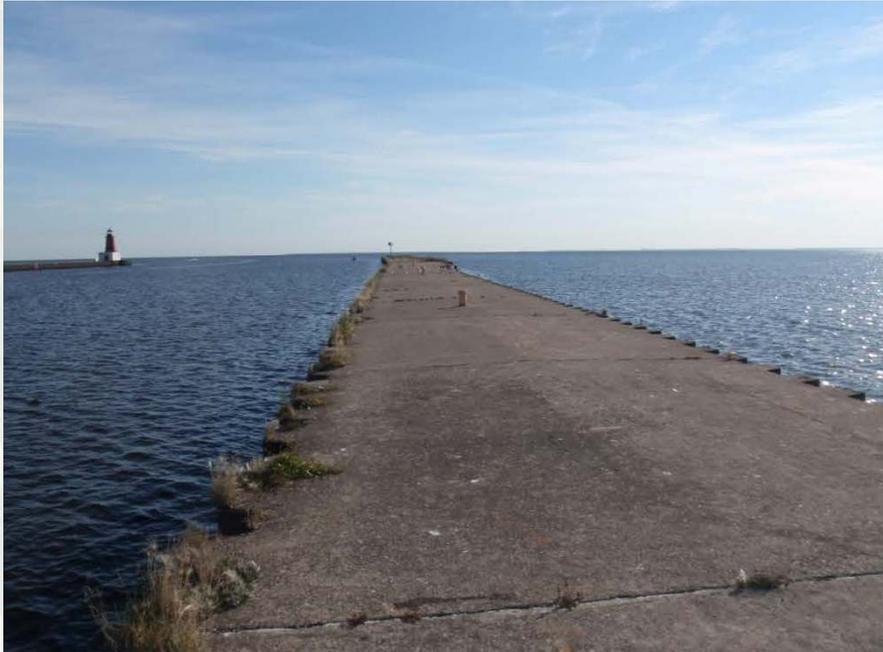
North Breakwater, Section C.

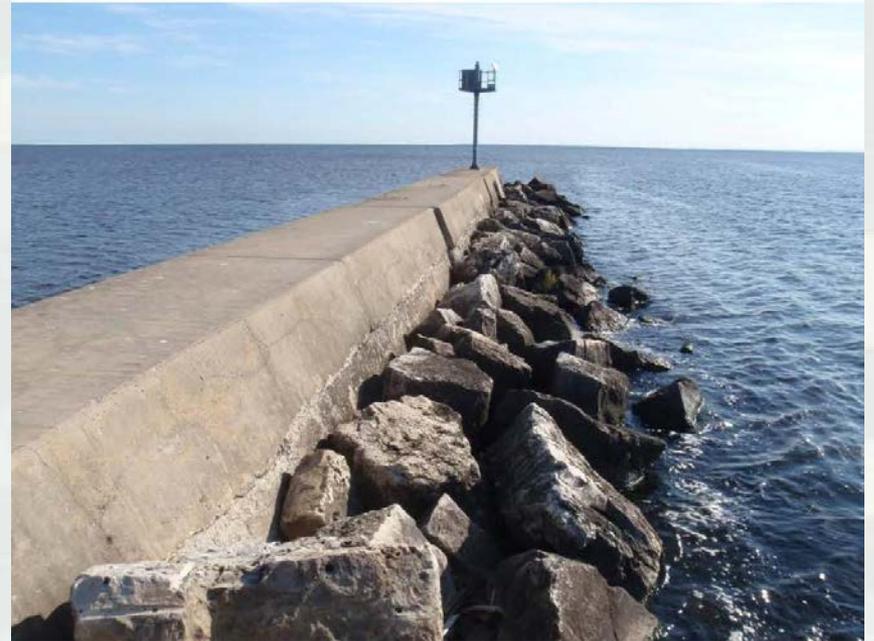
Overview of South Breakwater.

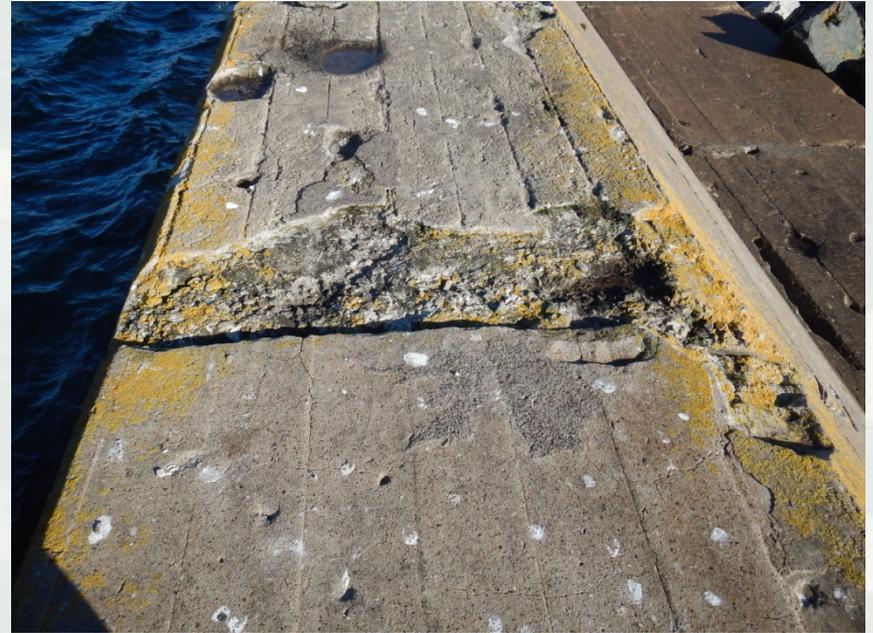
Concrete Spalling.

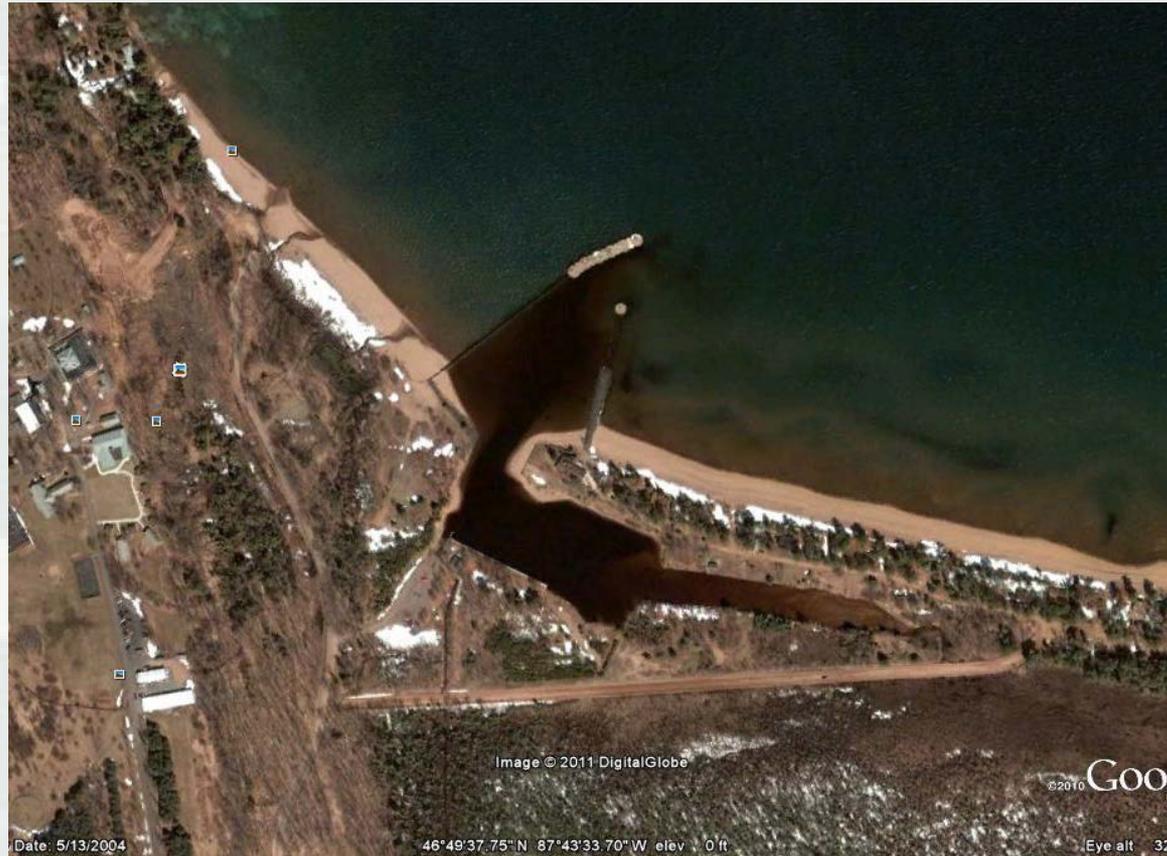
Big Bay Harbor: C – Medium Risk of Failure
