# Coastal Structures Risk Communication Mid-Northern Michigan Harbors

Dave Wright  
Chief of Operations  
Detroit District

May 17, 2013

# Harbors of “Mid-Northern” Michigan

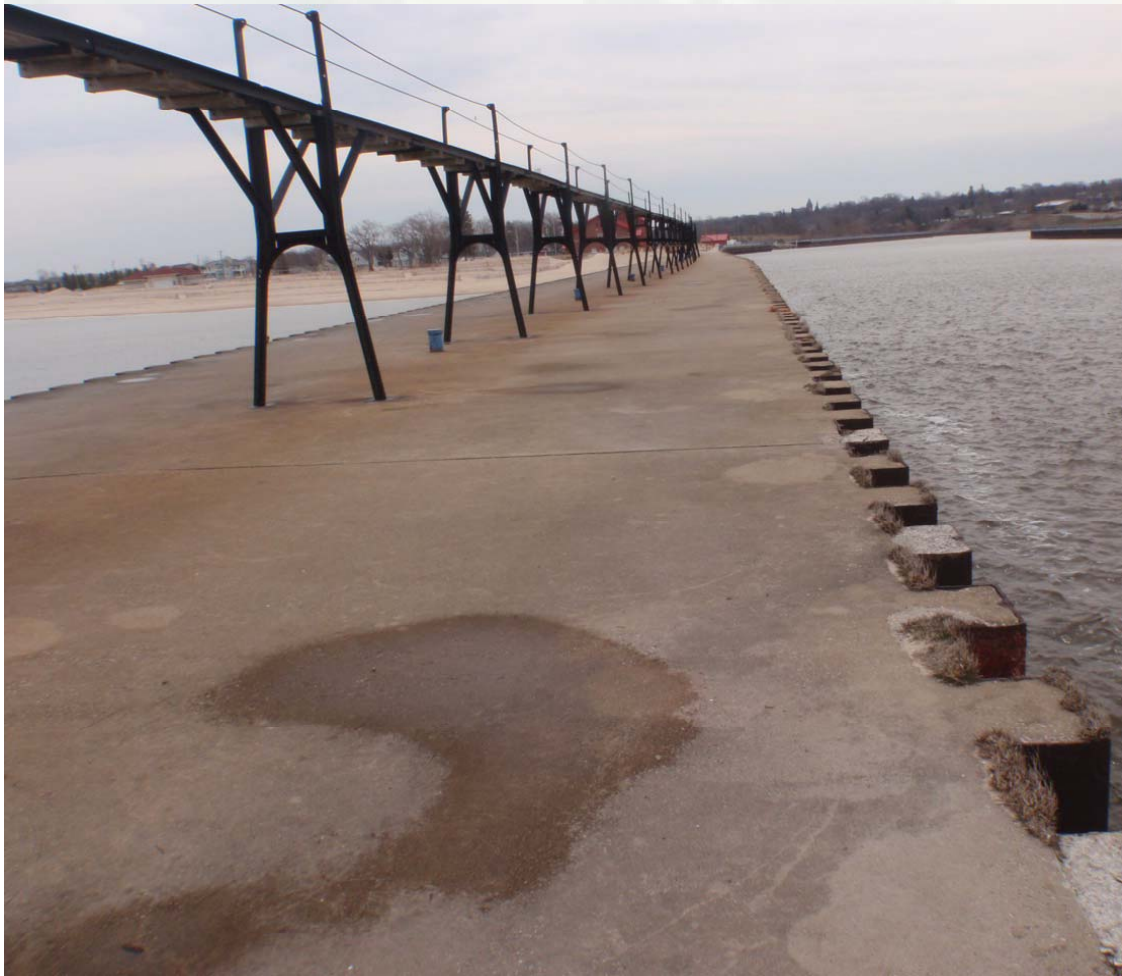
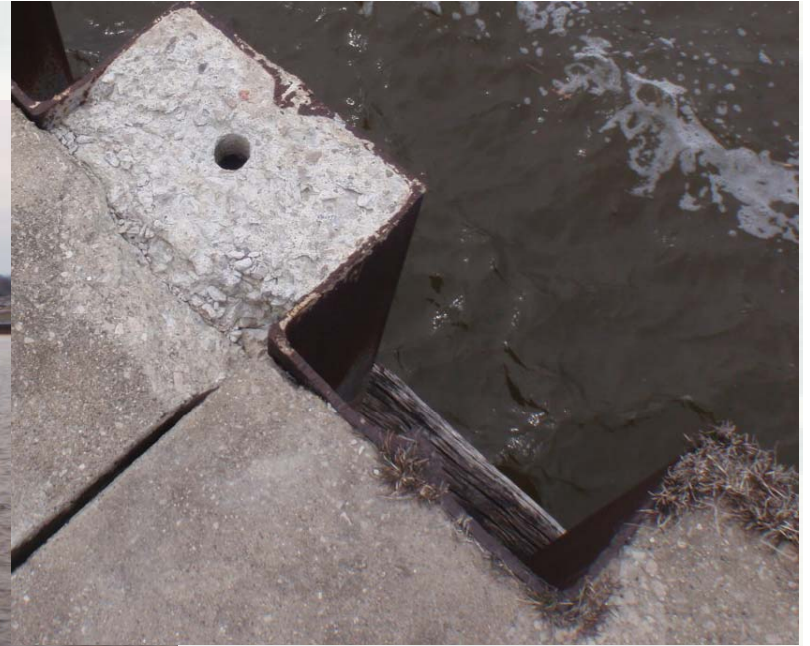
## Manistee Harbor – North Breakwater & Pier

Cracks, Fractures & spalling are most evident at the SSP pans and ladders. Caulk and backer rod is completely gone at most expansion joints.

Some repairs have been made in past 15 years.

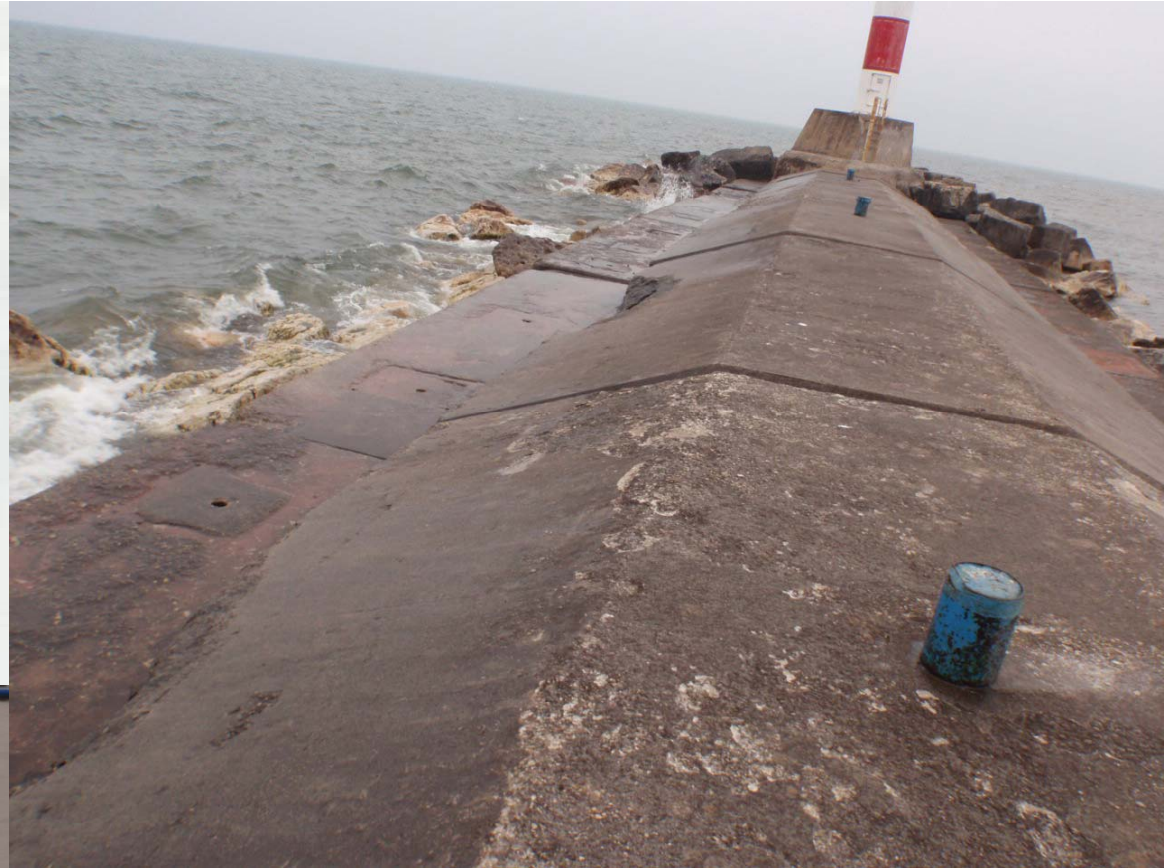
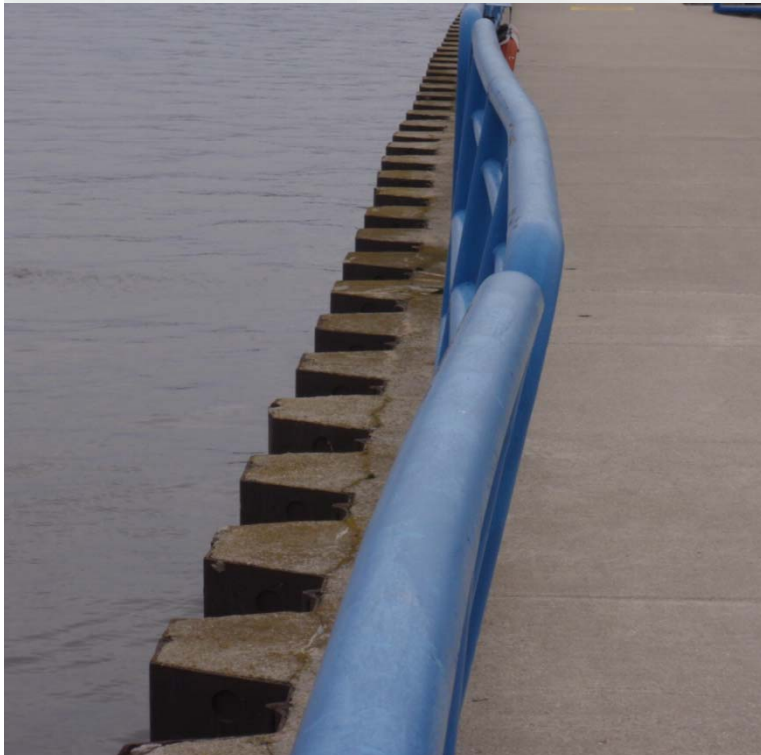
## Manistee Harbor – S. Breakwater

Heavy Spalling, chipping and cracking is increasing at and side slopes on concrete cap. Loss of crib stone is sign of timber crib damage. The crib is exposed with low water levels.

Boat strike. S.S.P. damage, sections of the railing bent

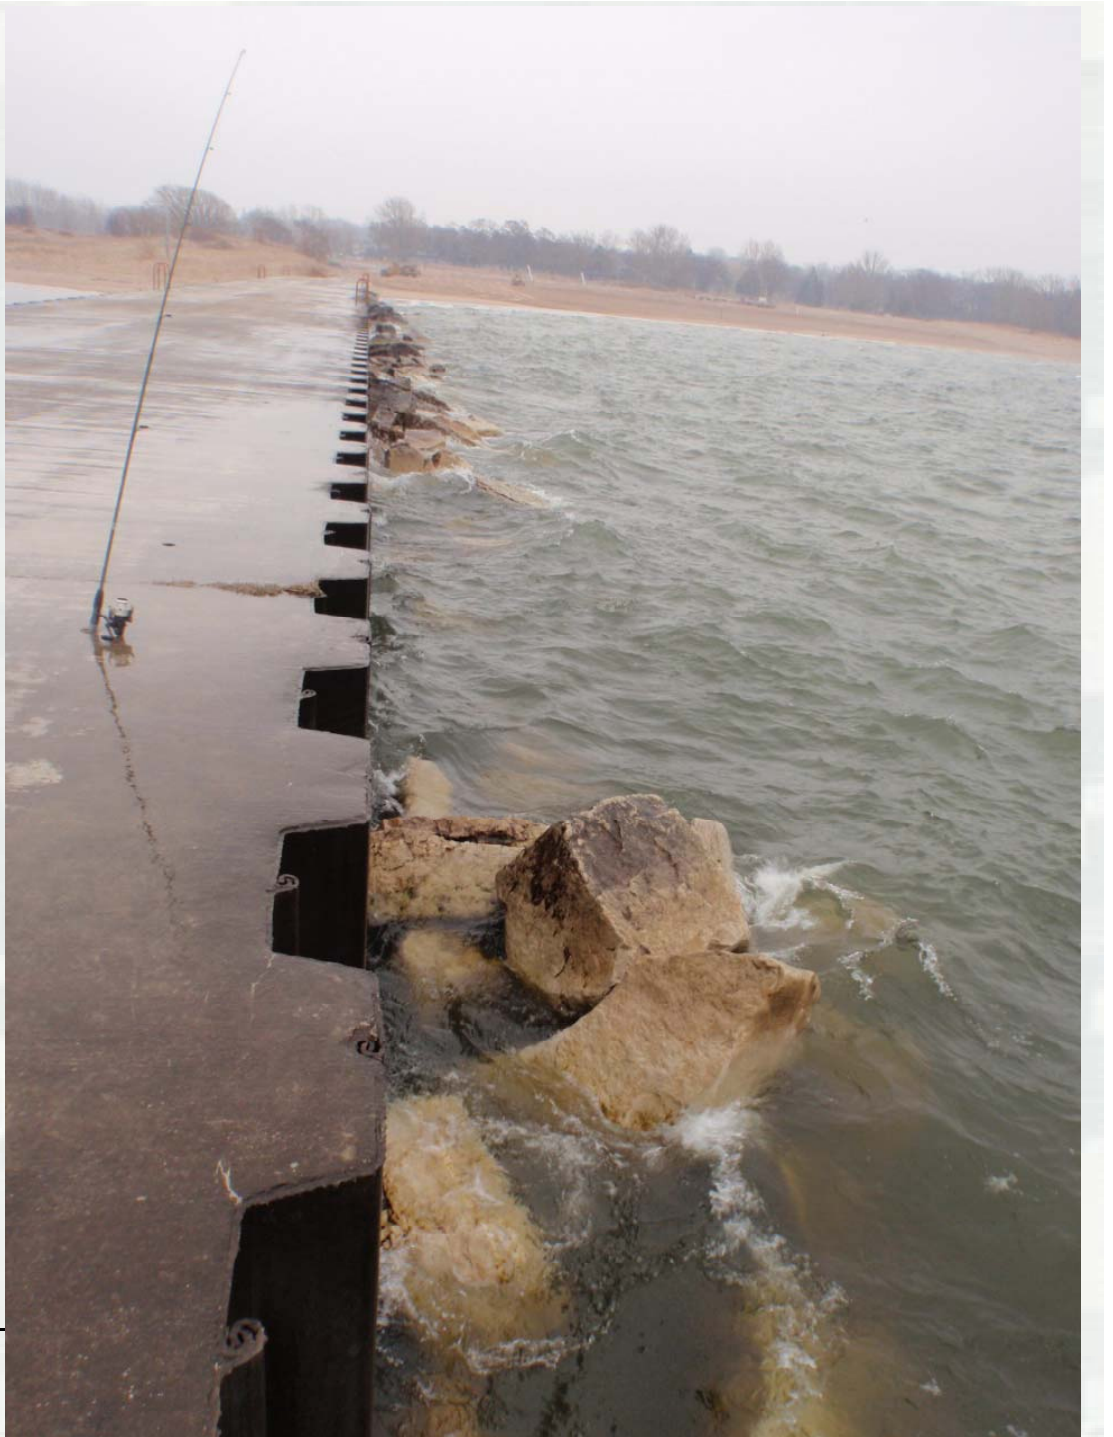
## Manistee Harbor – S. Breakwater

Riprap stone on lake side is displaced and settled.

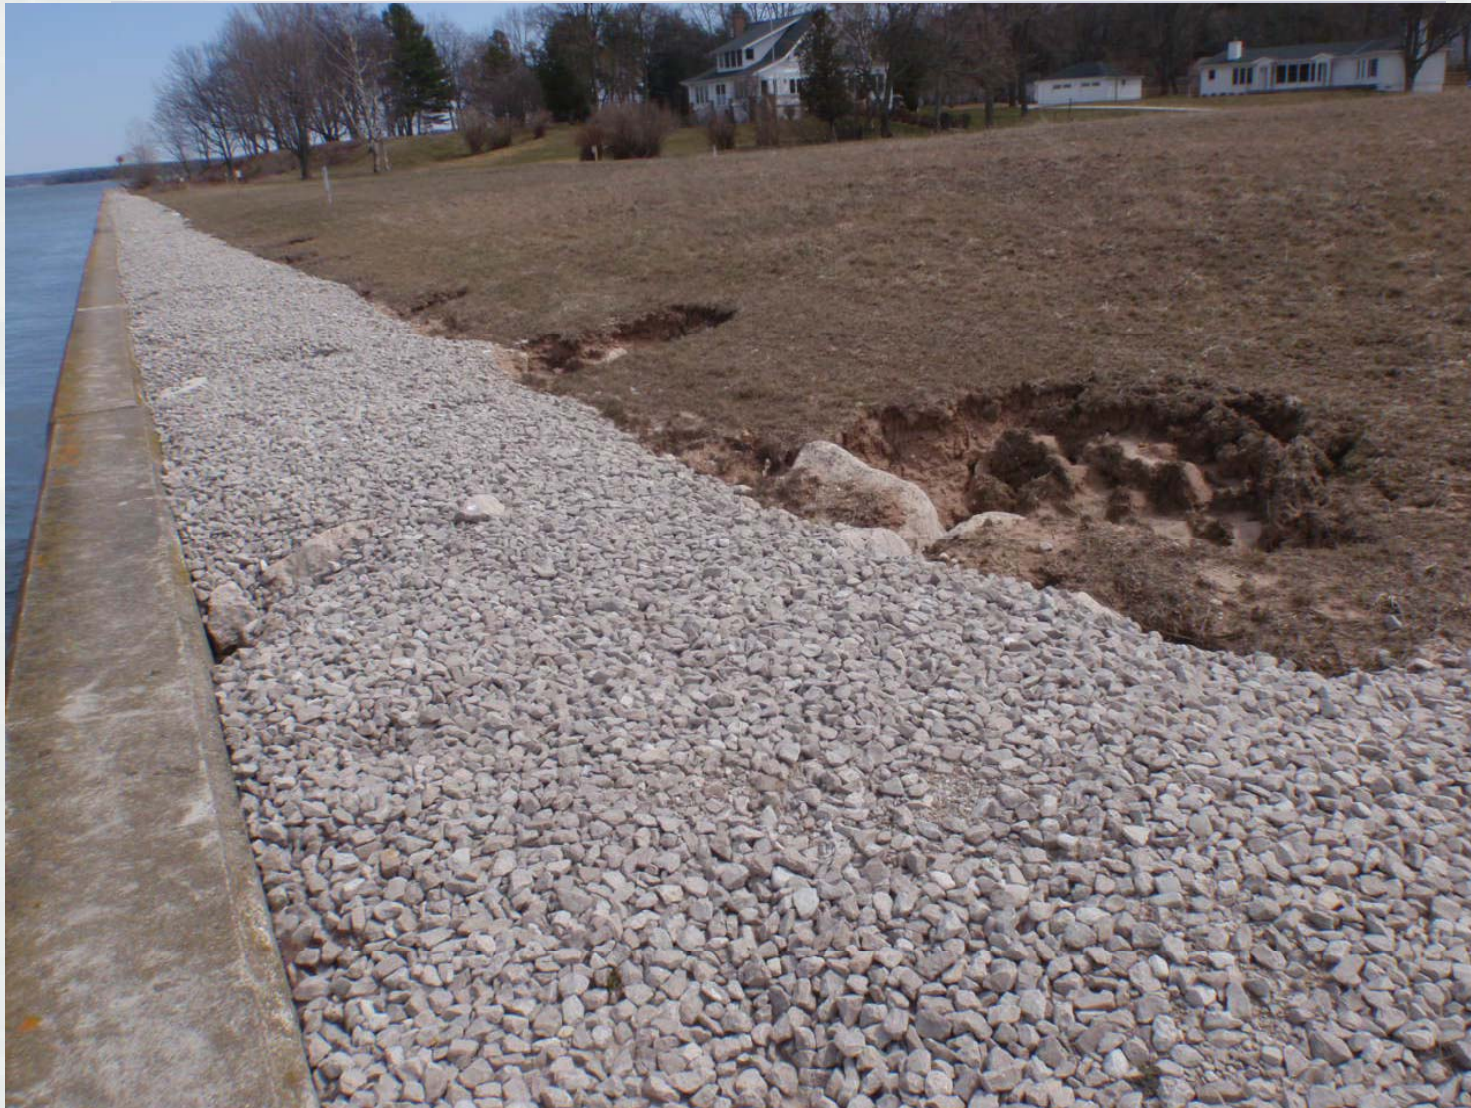
## Portage Lake Harbor – Southside revetment

Backfill stone has been replenished, but there are still many signs of undermining of substructure

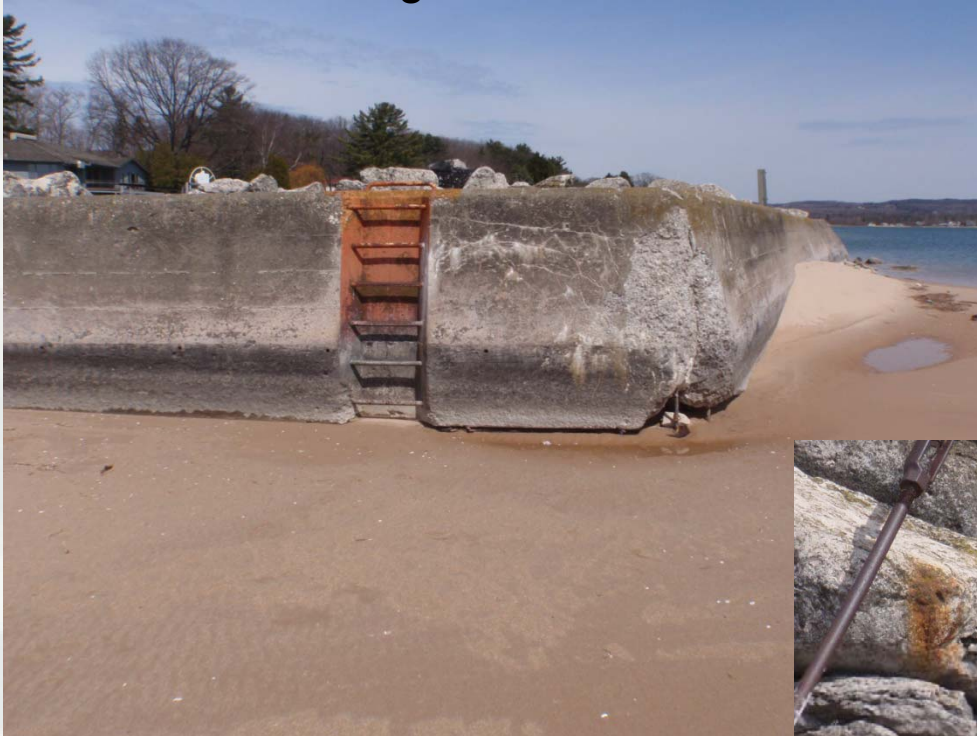
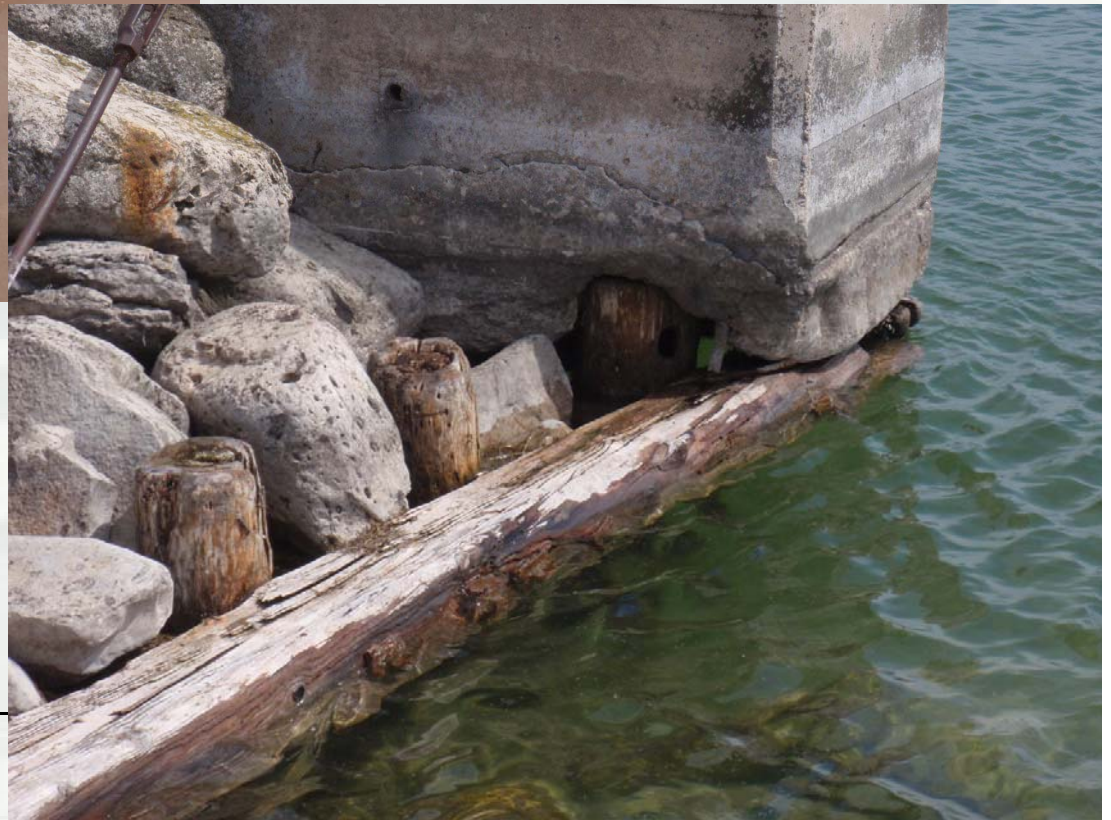
**Portage Lake Harbor** – Low water has exposed the timber crib, Backfill material migrating under the revetment and with the tilting wall indicates at least some of the timber cribbing has failed or is at near failure condition.

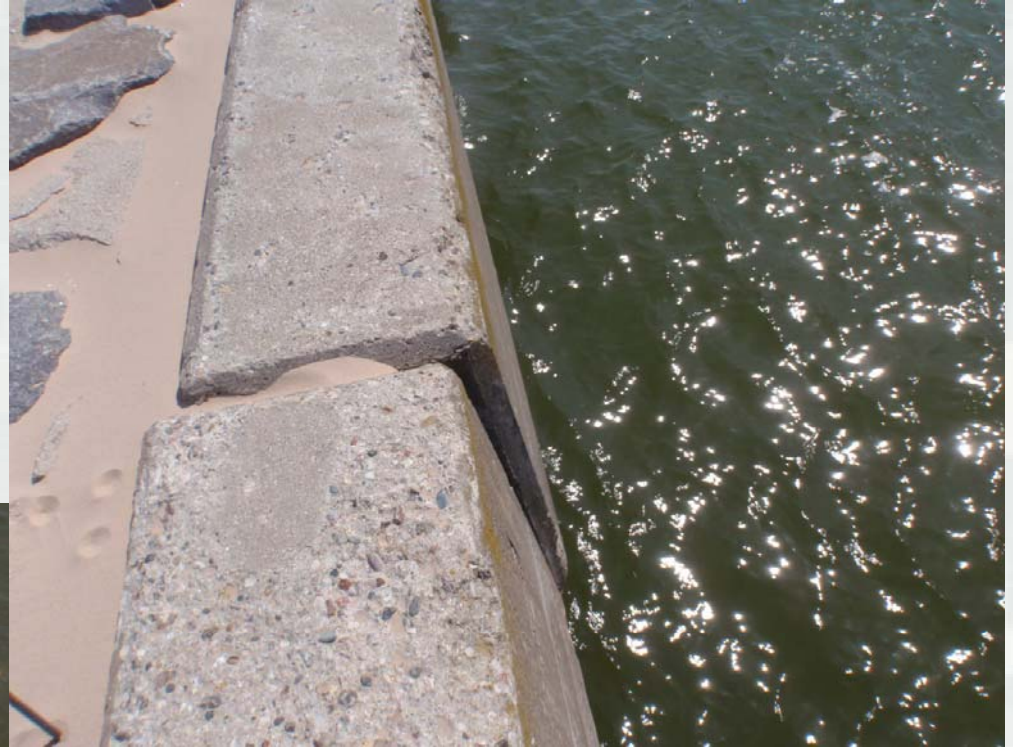
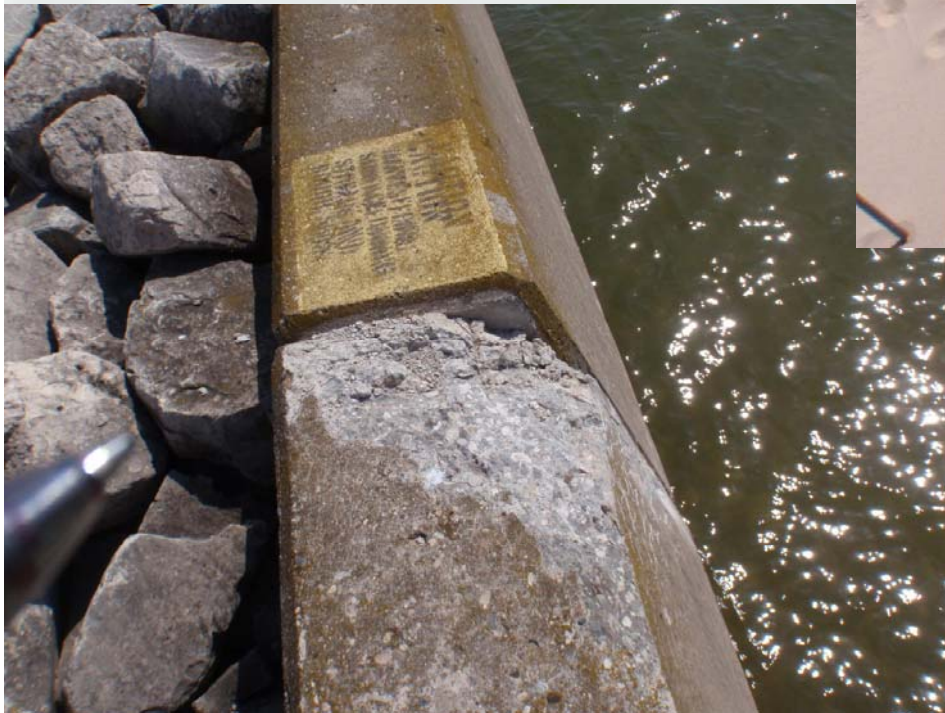
## Portage Lake Harbor –

The entire wall is tilting to the north. There is block misalignment and settlement in areas.

← The concrete cap has spalling that is increasing

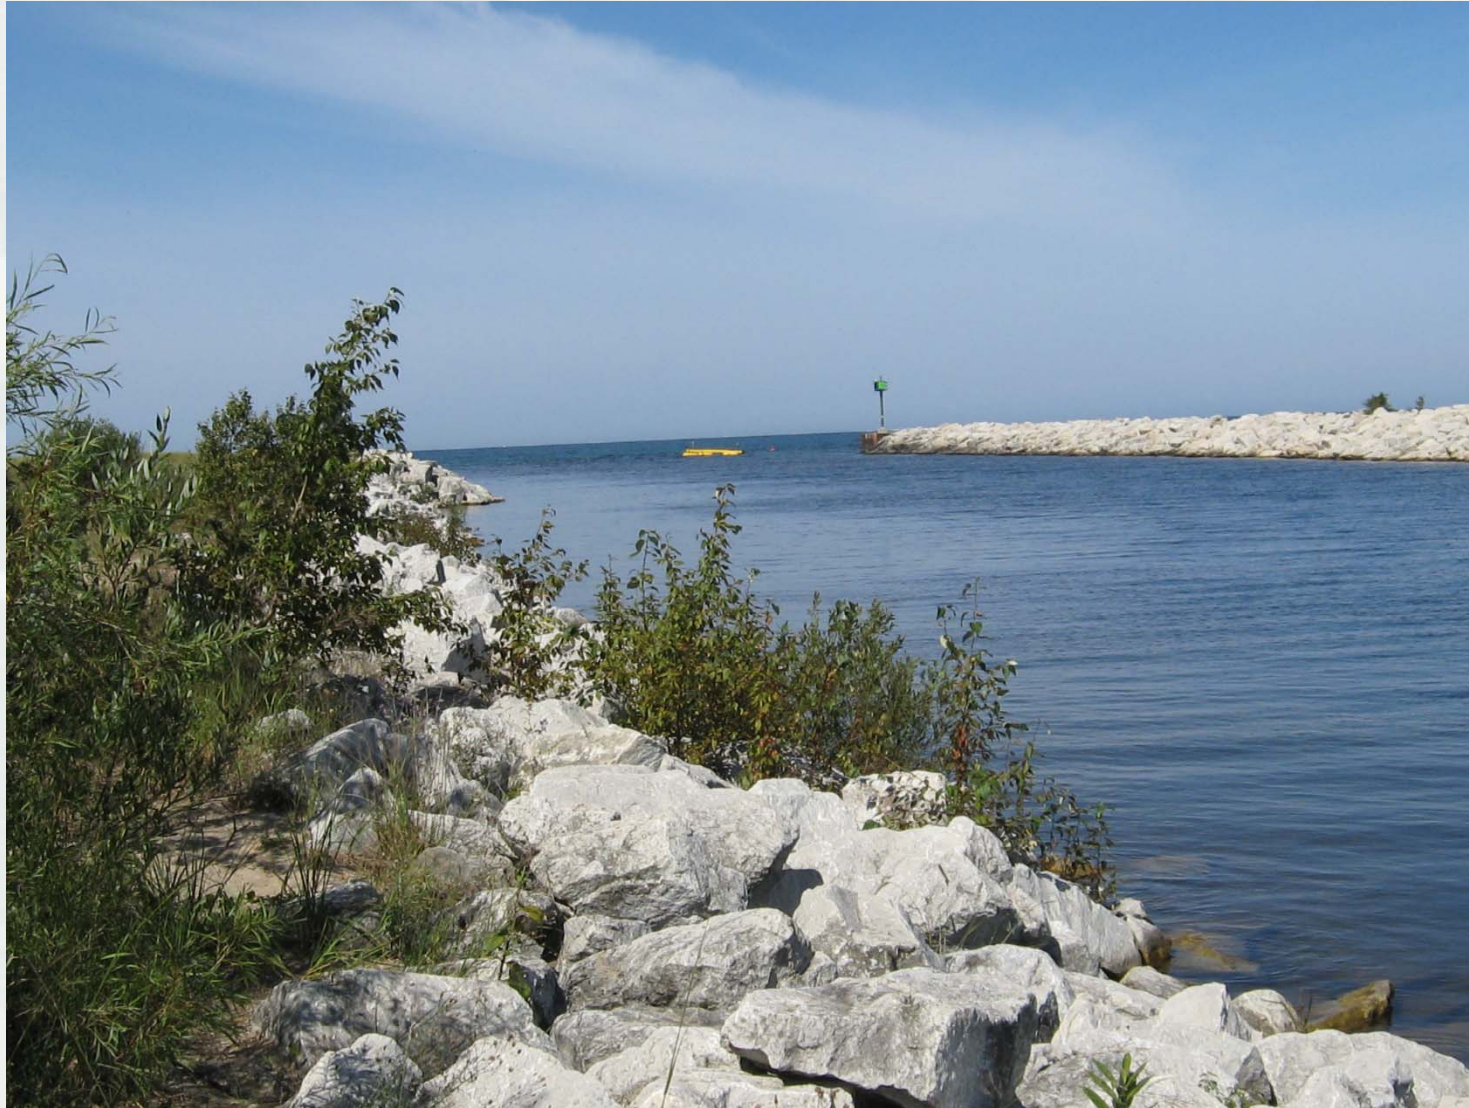
## Arcadia Harbor --

Vegetation growing along portions of the structure

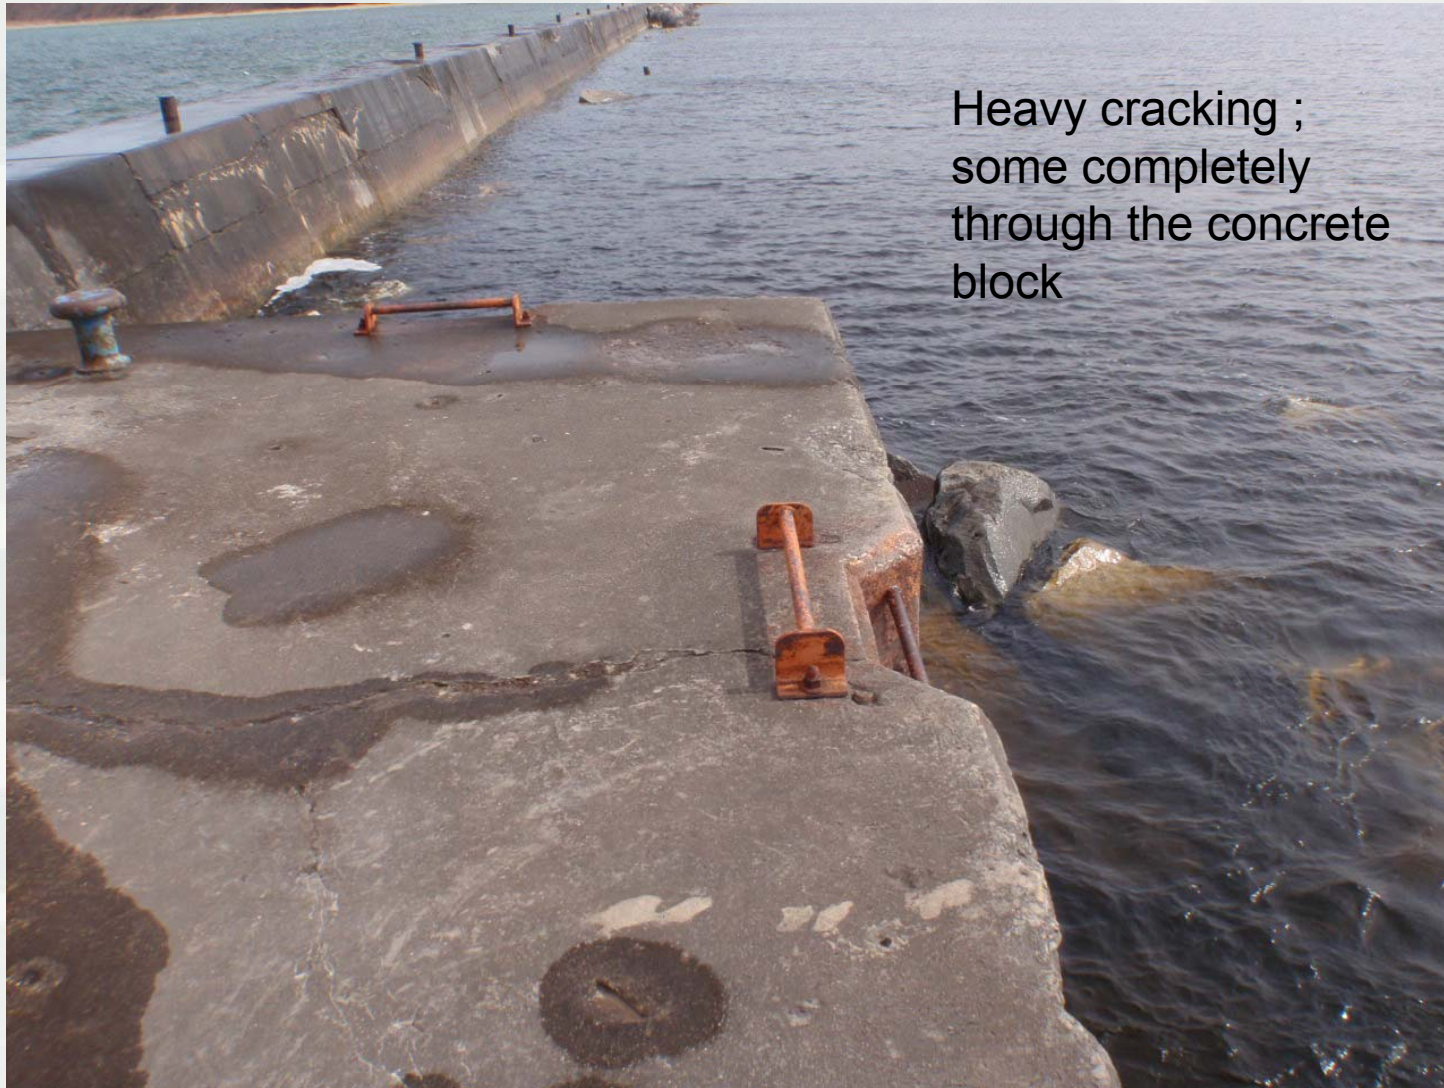
## Frankfort Harbor – North Breakwater

Heavy cracking ;  
some completely  
through the concrete  
block

Ladders need  
paint; ladders  
have all rungs, a  
few bent rungs at  
water level from  
ice.

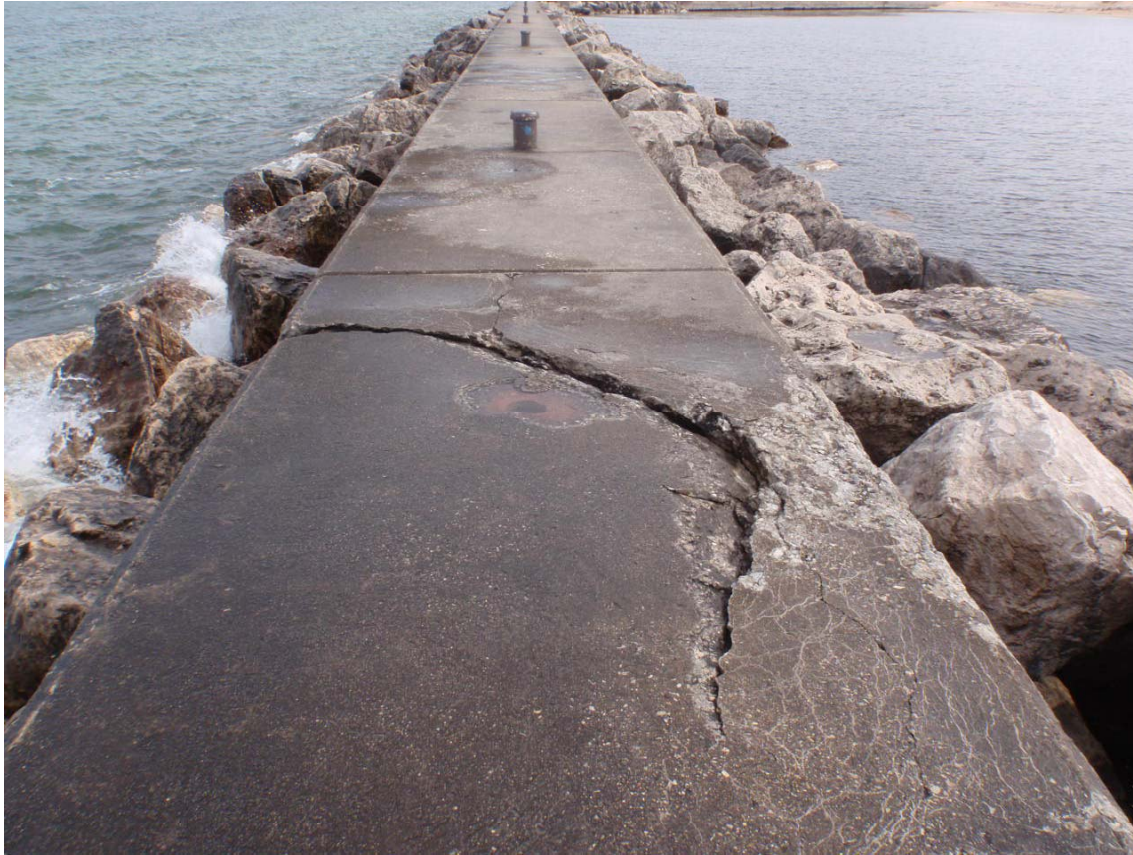
## Frankfort Harbor – North Breakwater

Heavy cracking. Severe chipping at block edge, rounded corners with re-rod exposed, numerous areas of spalling.

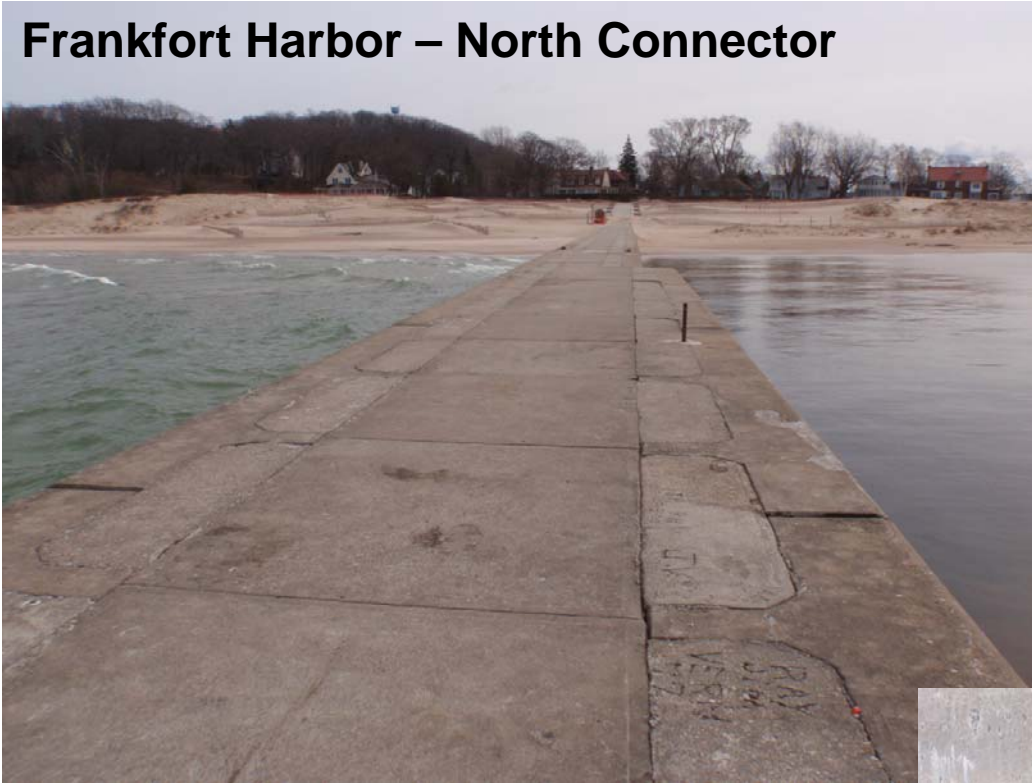
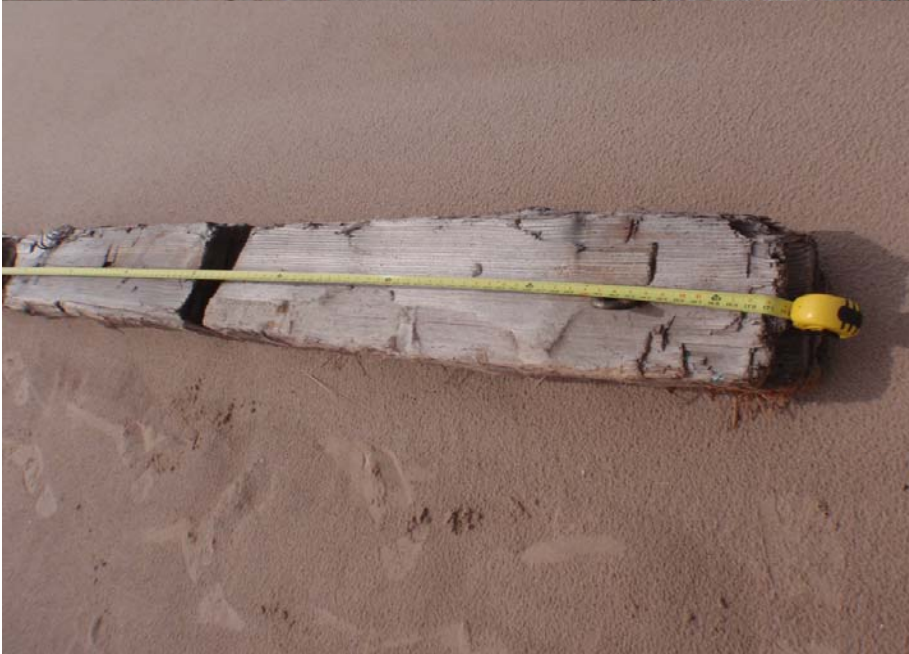
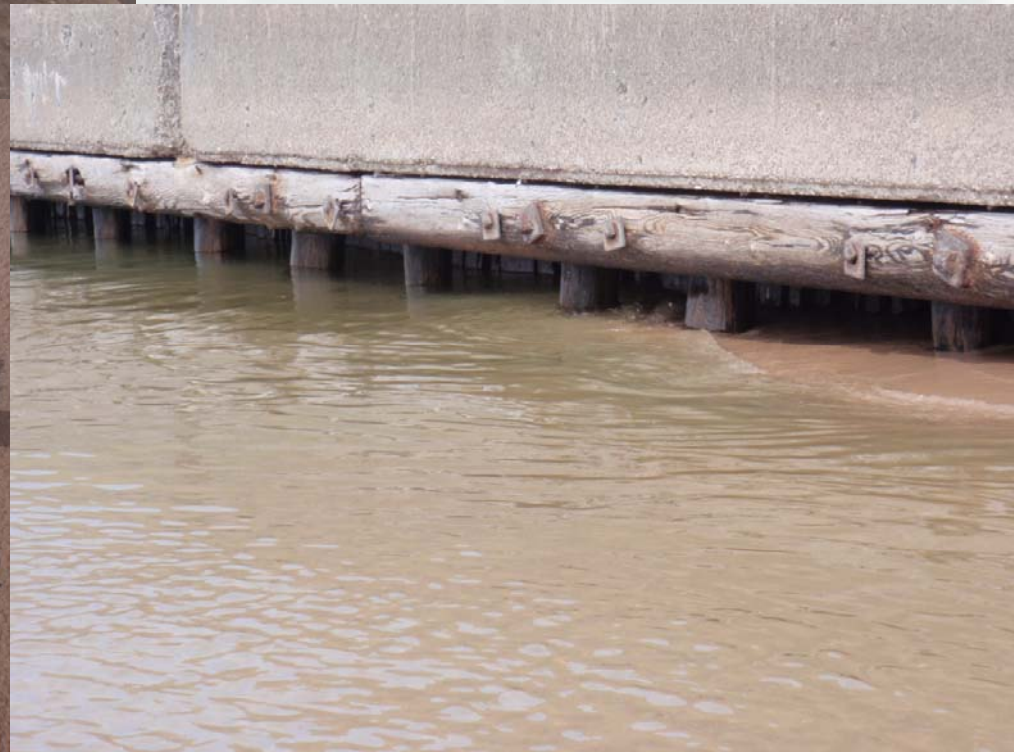
## Frankfort Harbor – North Connector

- Some timber crib headers are missing at basin side. Tie rods are broken and are visible hanging out of the crib.
- No riprap on either side of the structure.
- Settlement visible in the grouted cells (that was repaired in 2000)

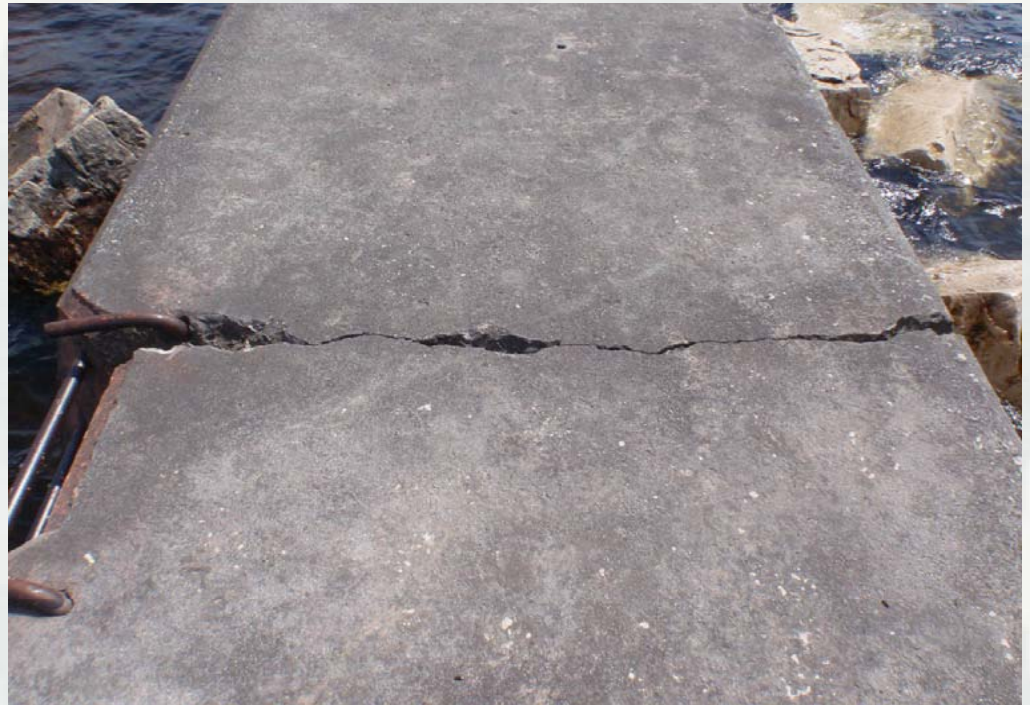
## Frankfort Harbor – South Breakwater

Caulk failure at expansion joints in the concrete blocks is causing chipping. Water surges through block seams with minor wave action.

The seam joints need to be cleaned and resealed as grass and large weeds are growing through them.

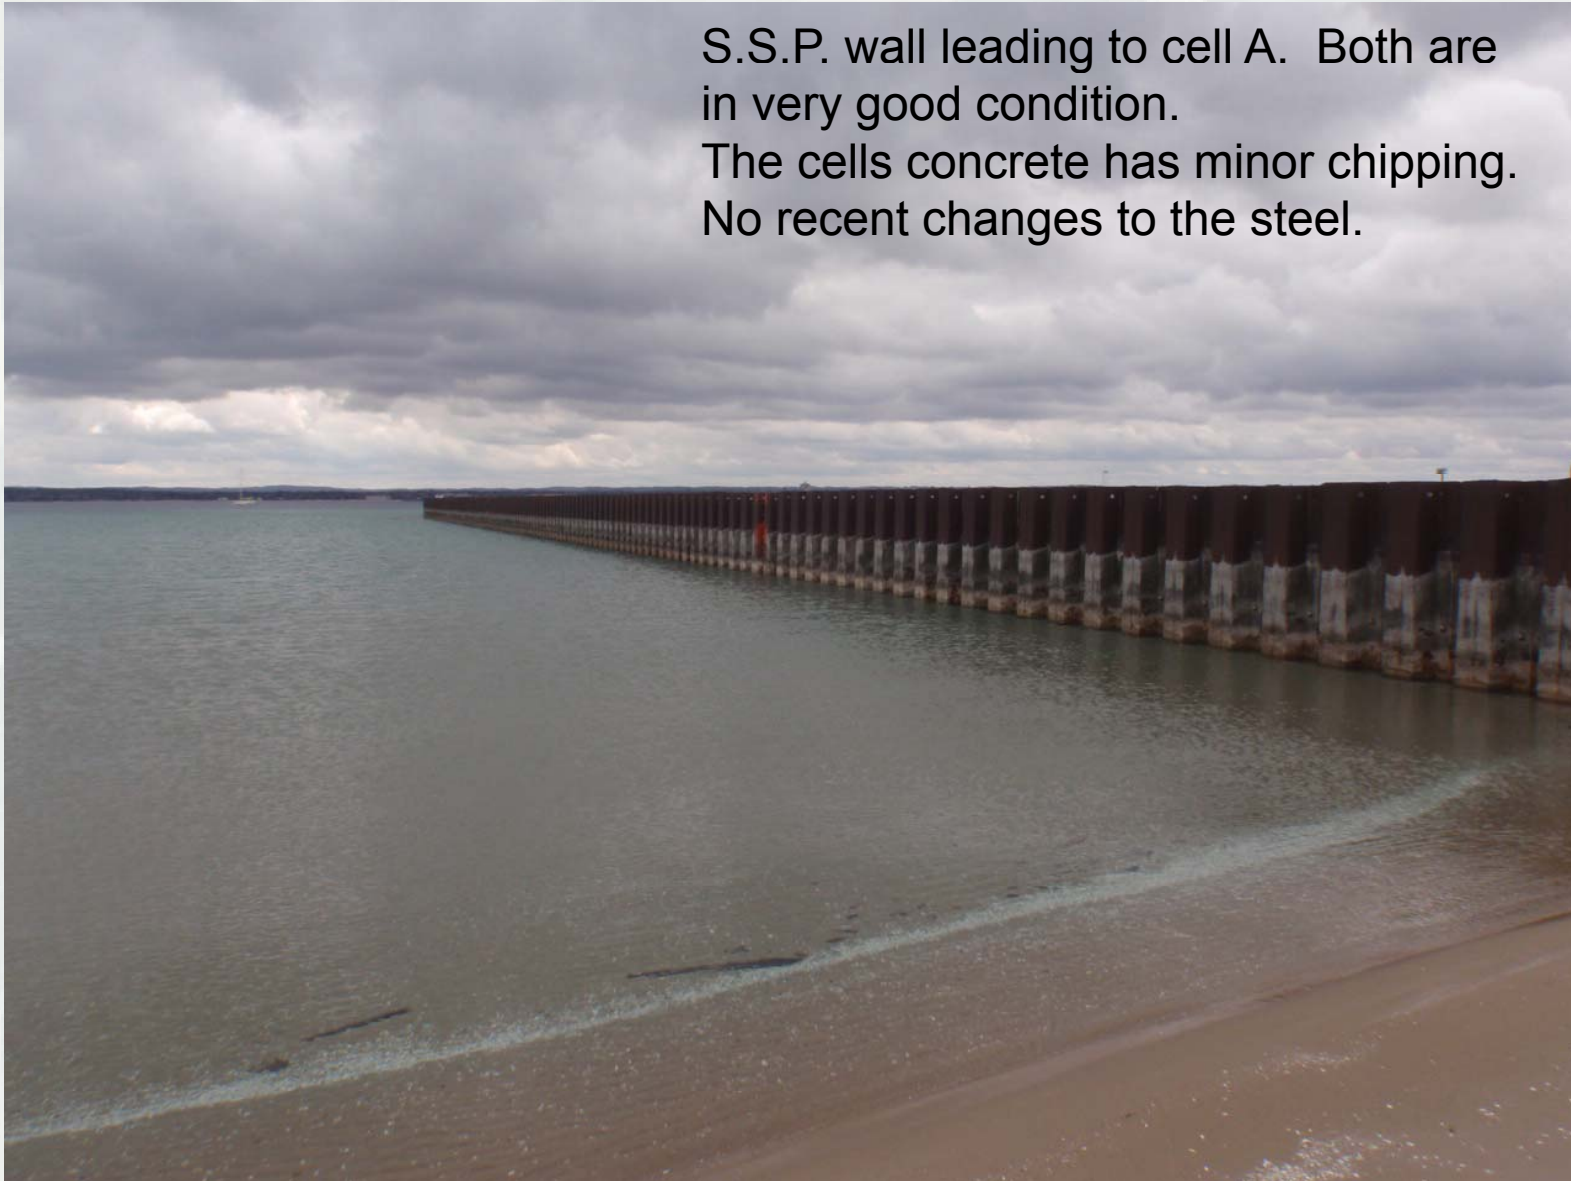
## Greilickville Harbor:

S.S.P. wall leading to cell A. Both are in very good condition. The cells concrete has minor chipping. No recent changes to the steel.

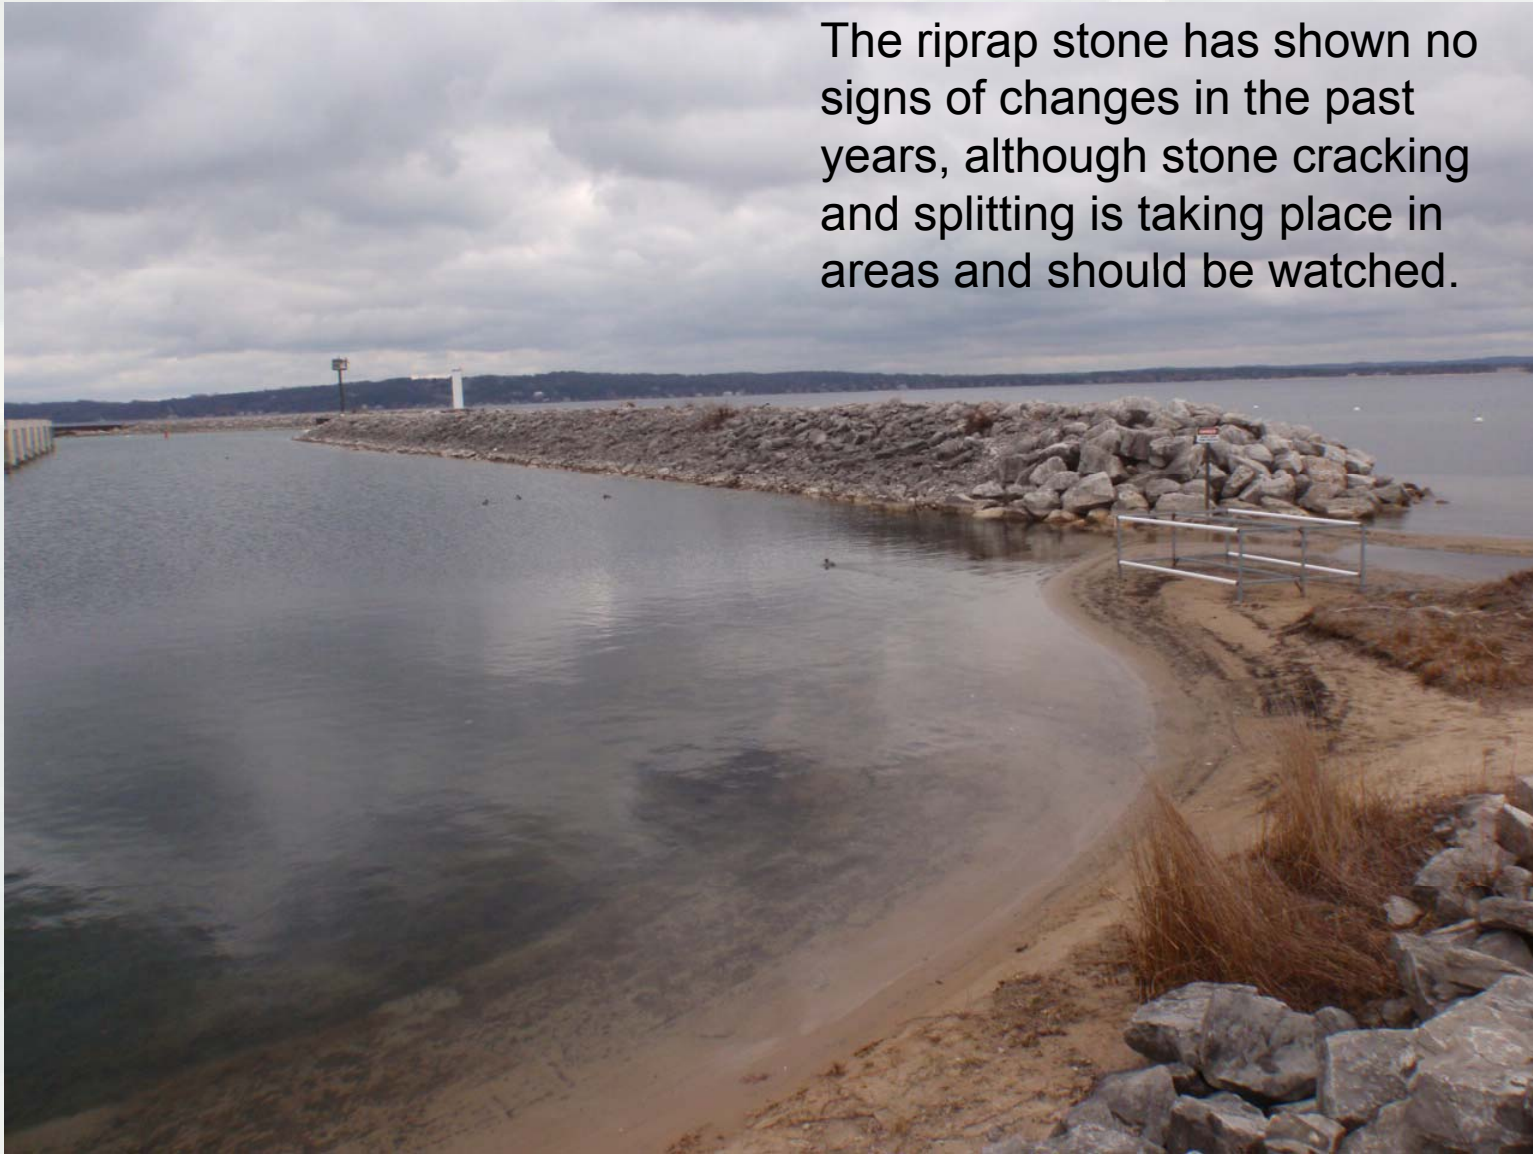
## Greilickville Harbor:

The riprap stone has shown no signs of changes in the past years, although stone cracking and splitting is taking place in areas and should be watched.

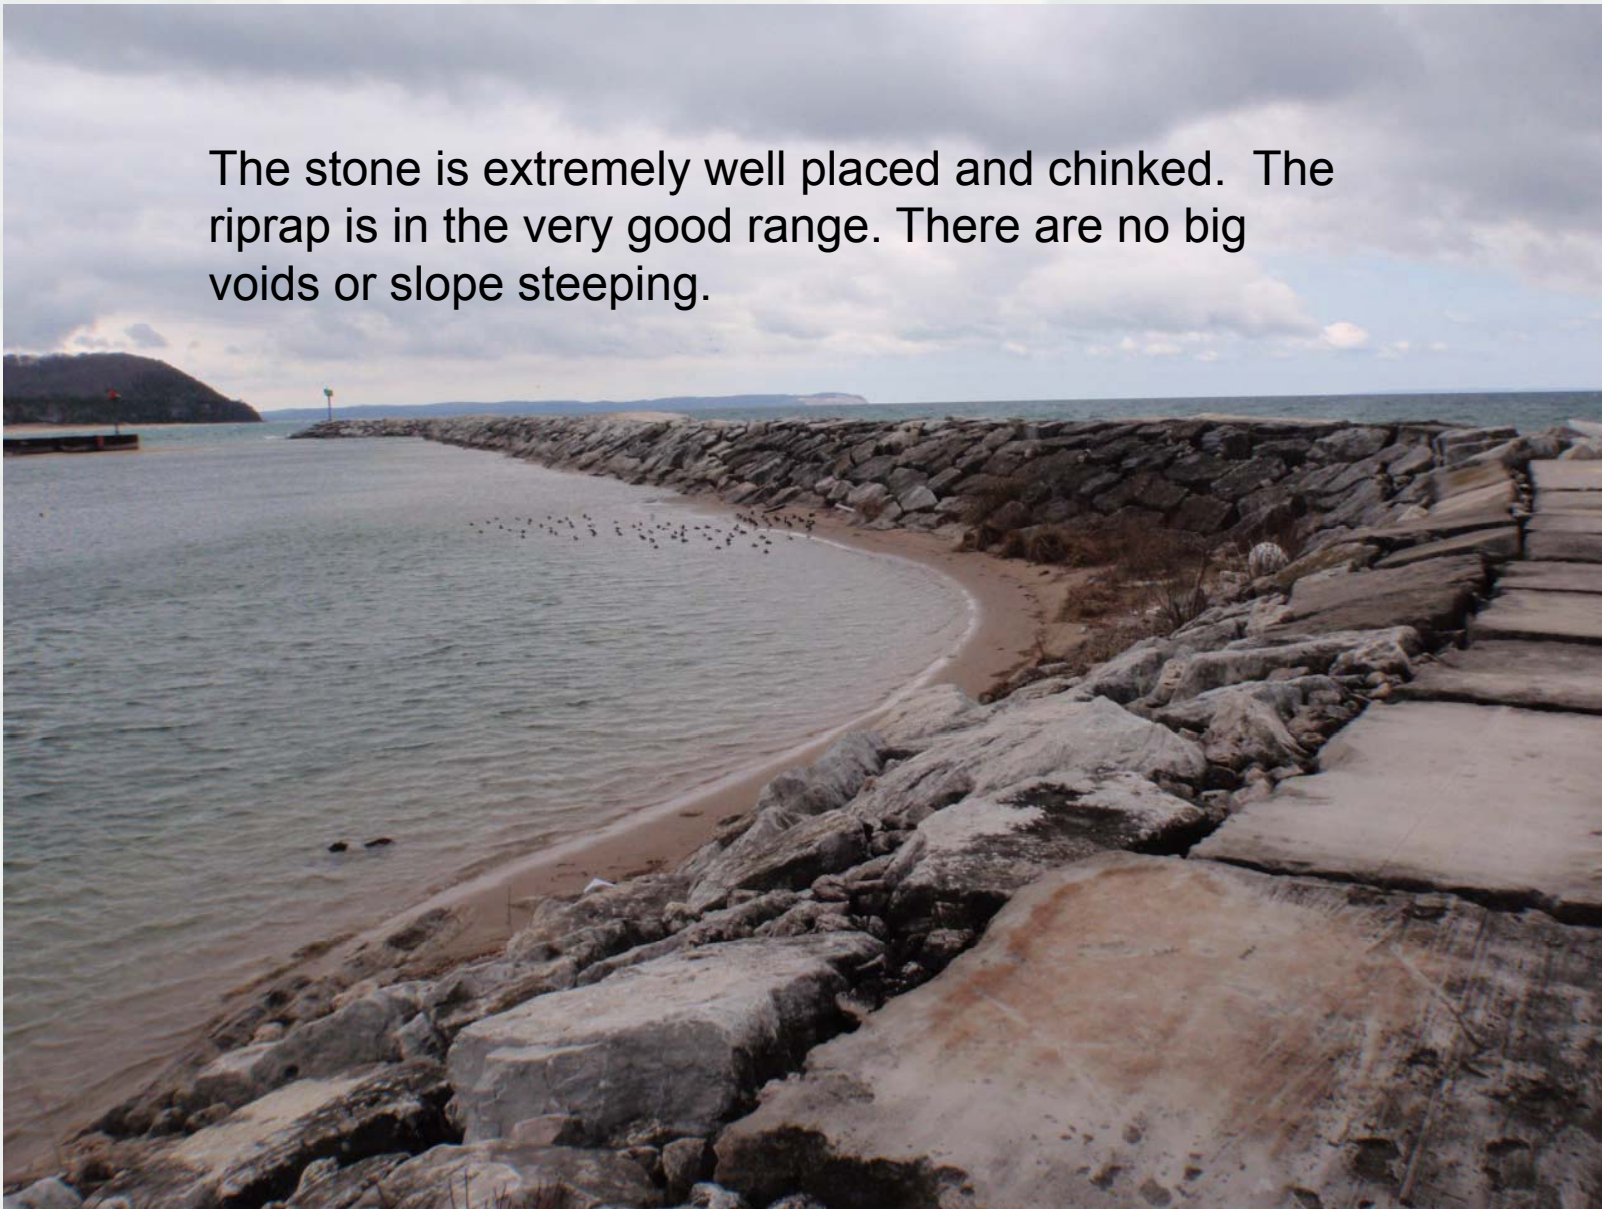
## Leland Harbor – North Rubblemound breakwater

The stone is extremely well placed and chinked. The riprap is in the very good range. There are no big voids or slope steeping.
