# Coastal Structures Risk Communication Mid-Northern Michigan Harbors

Dave Wright  
Chief of Operations  
Detroit District

May 17, 2013

# Harbors of “Mid-Northern” Michigan

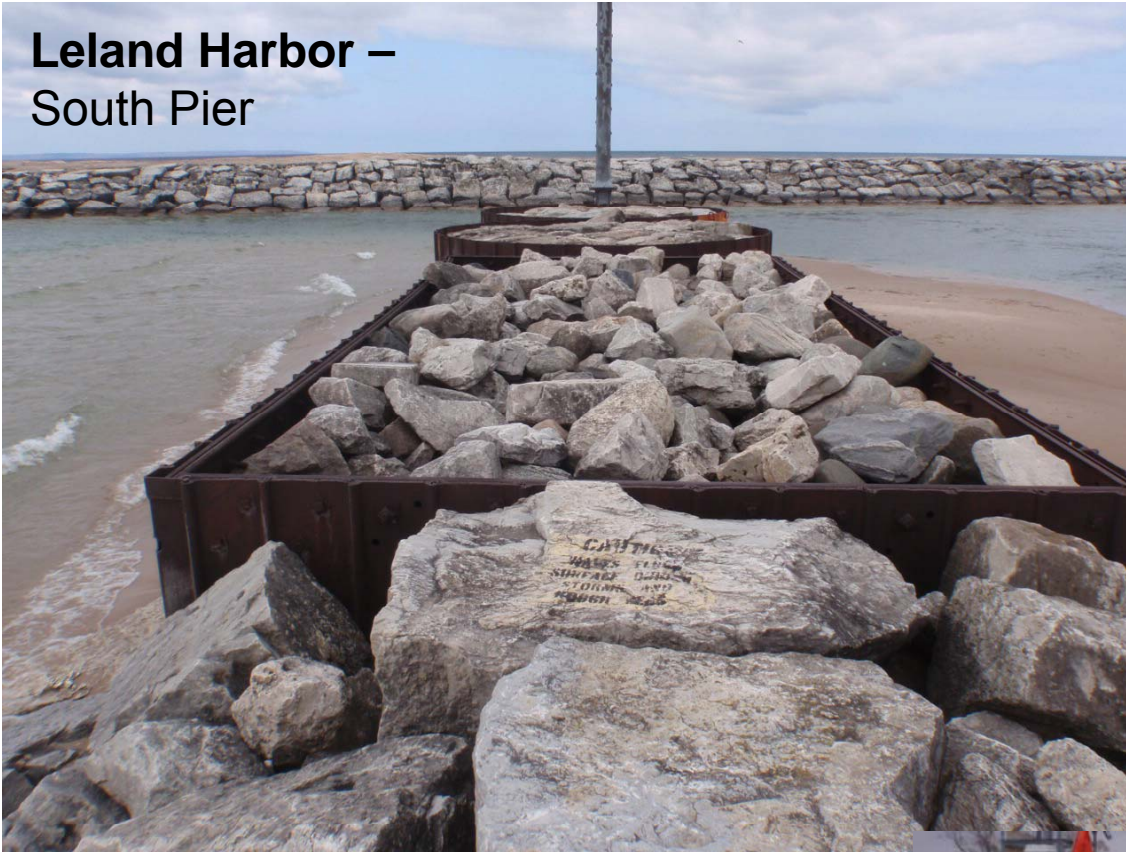
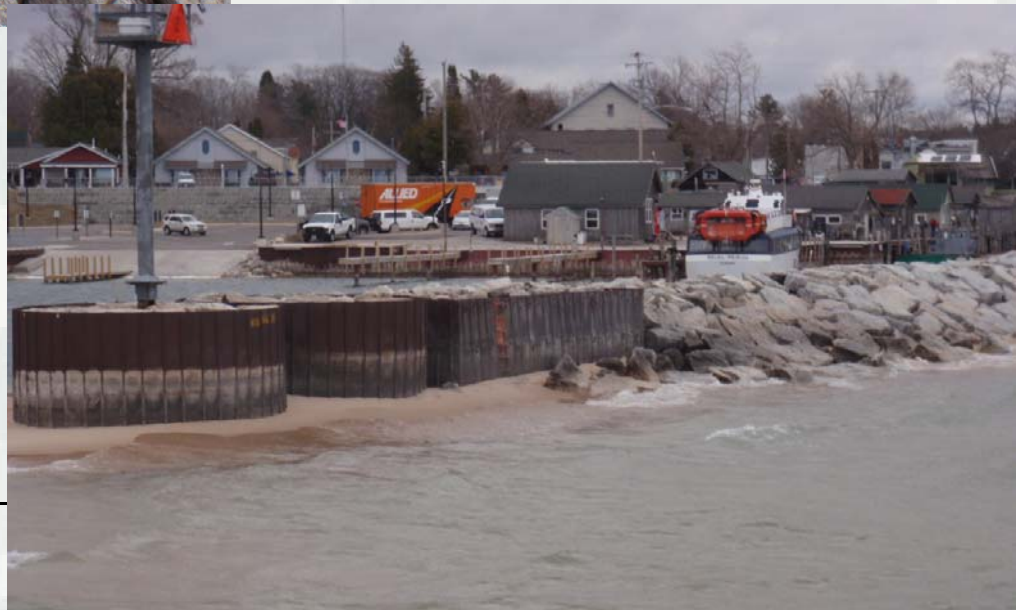
## Leland Harbor – South Pier

The three cells have exposed stone inside that shows slight settling since the 2007 inspection.

The stone is a bit loose, it could be replenished and use chinking.

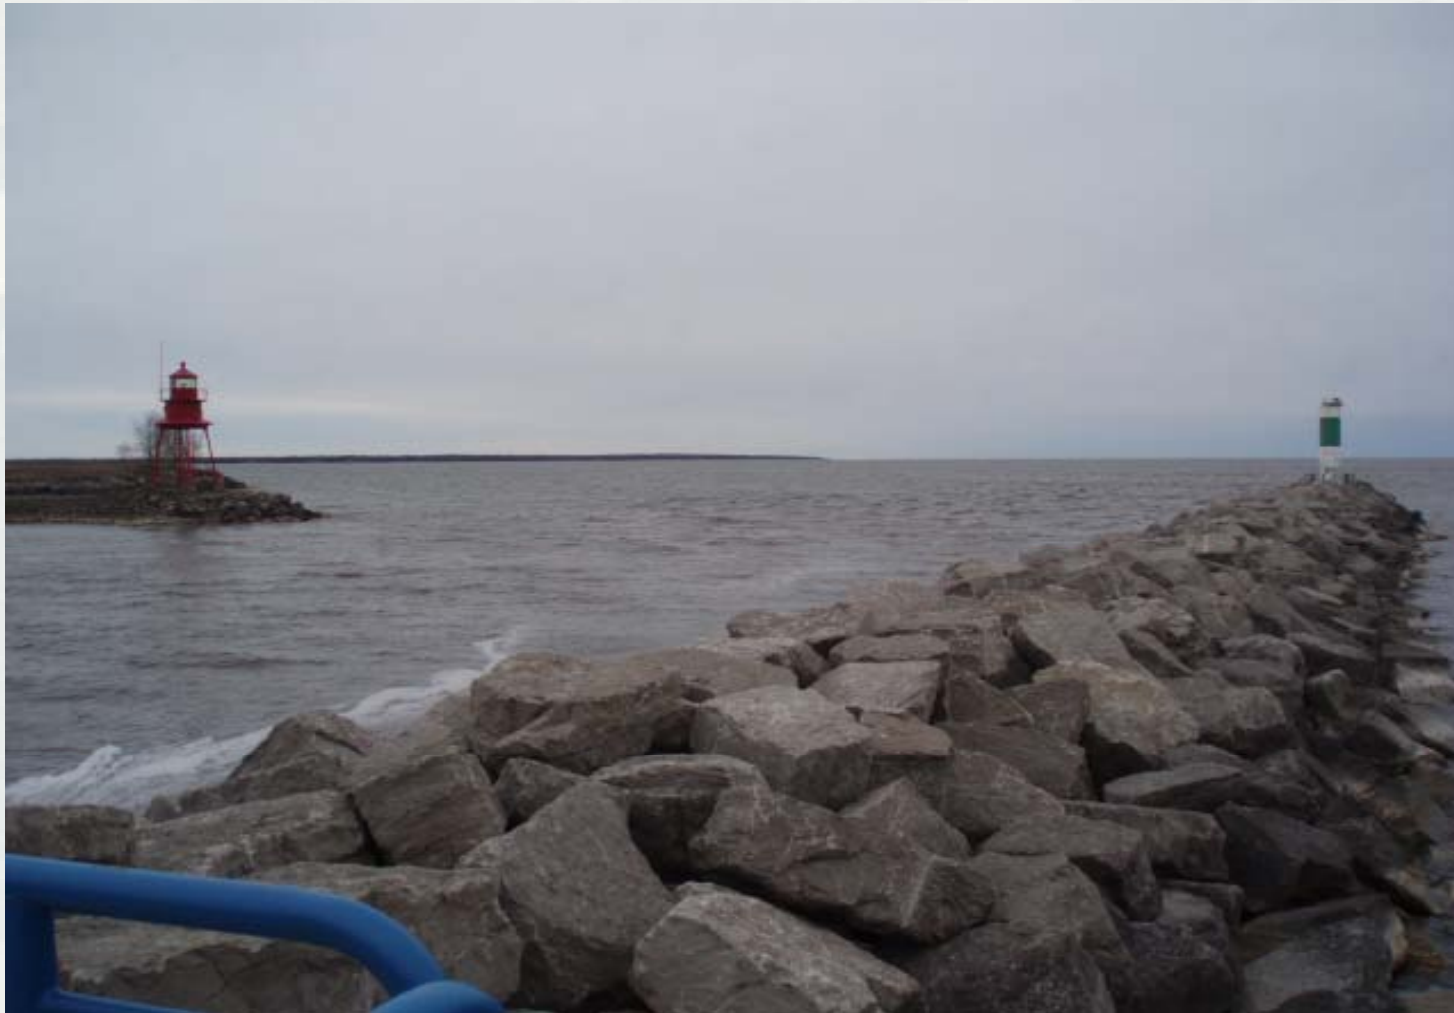
## Alpena Harbor

Rubblemound breakwaters – minimal stone loss and movement

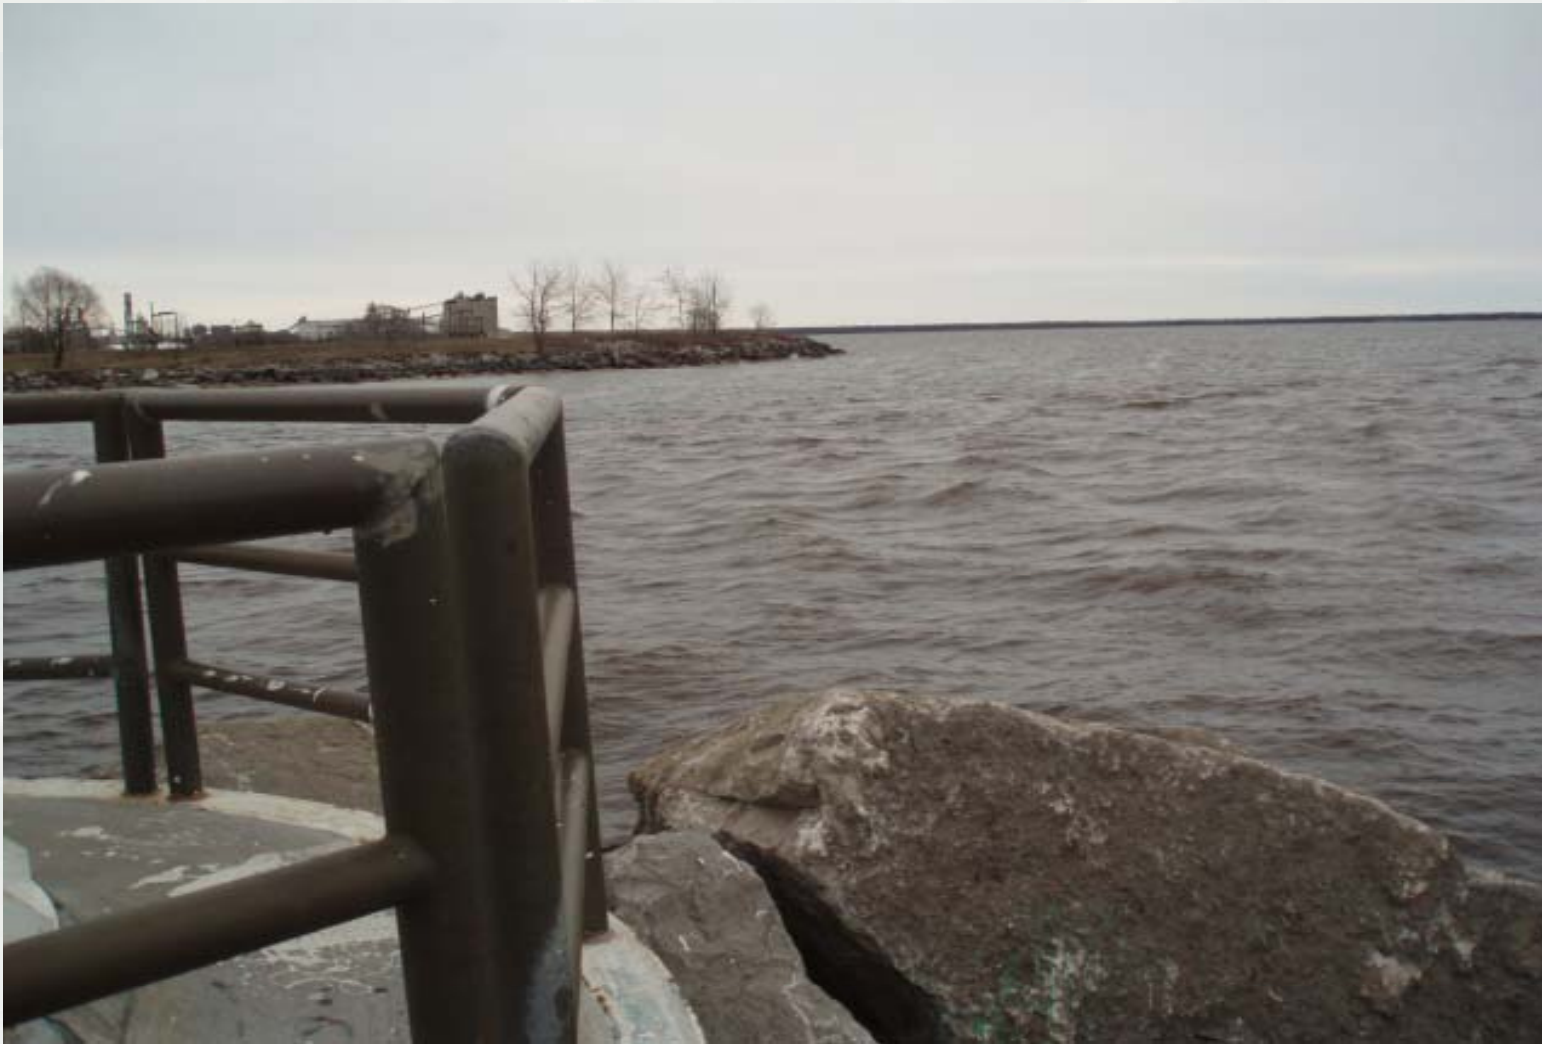
## Alpena Harbor

Rubblemound breakwaters – paint and signage are needed

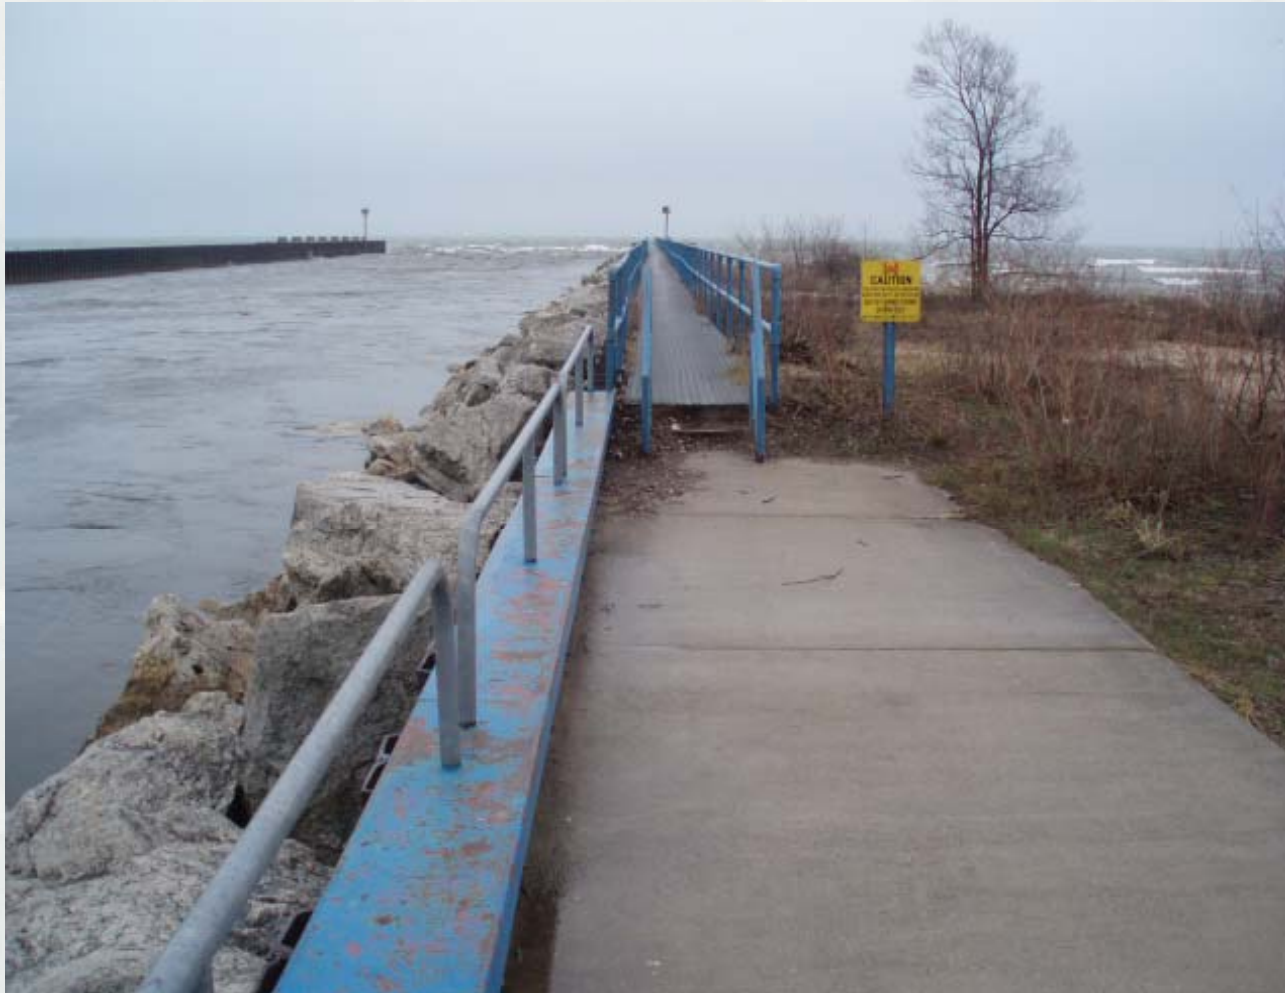
## **Au Sable Harbor –**

Paint surface of cover on top of Steel Sheet Pile wall is badly worn

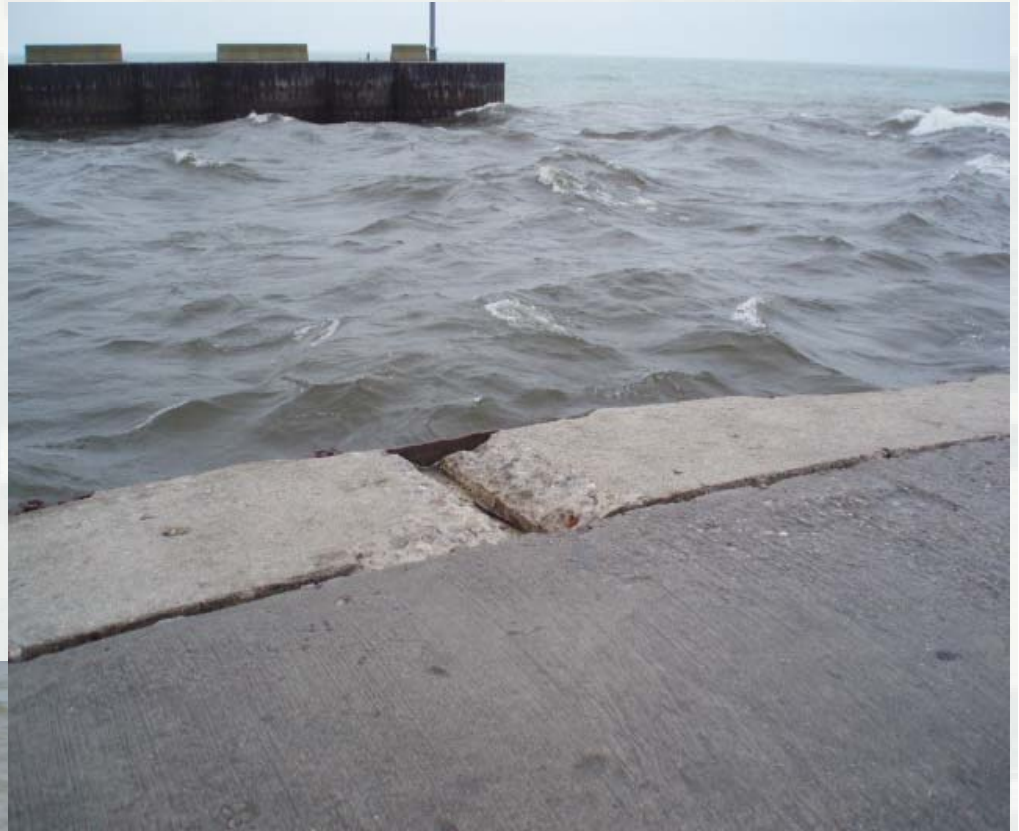
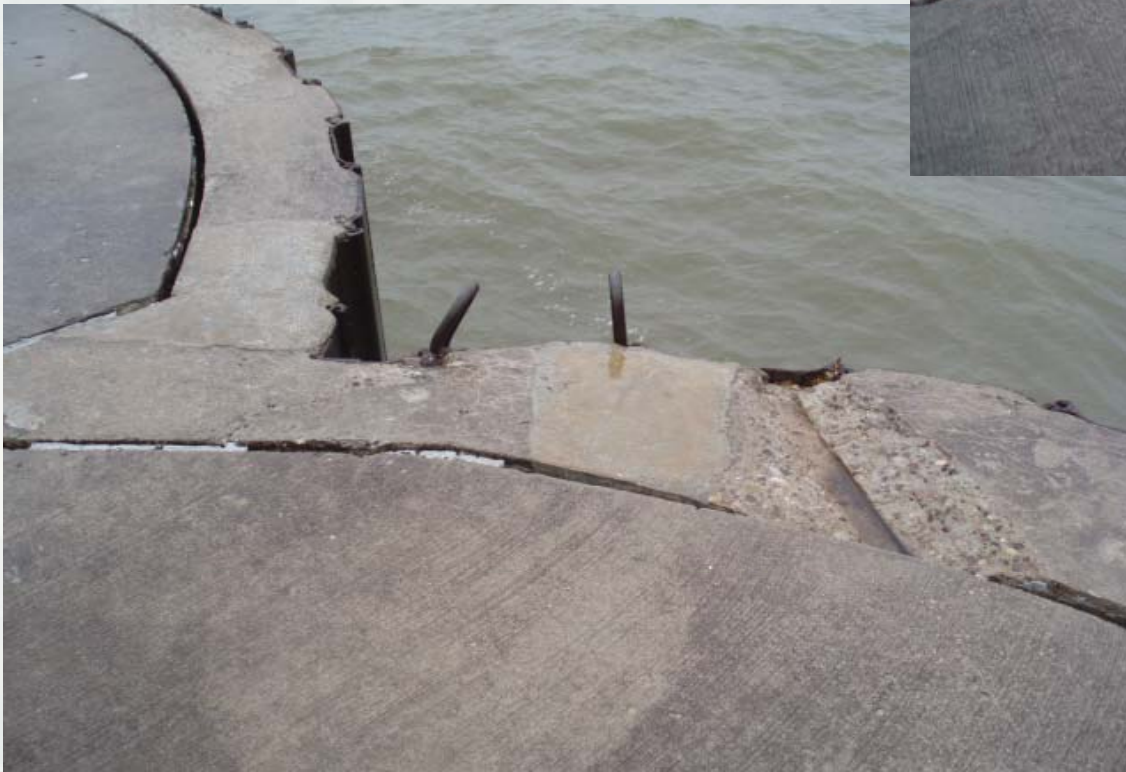
## **Au Sable Harbor –**

Spalled concrete patches where re-bar steel was placed near surface, and bent ladder rails

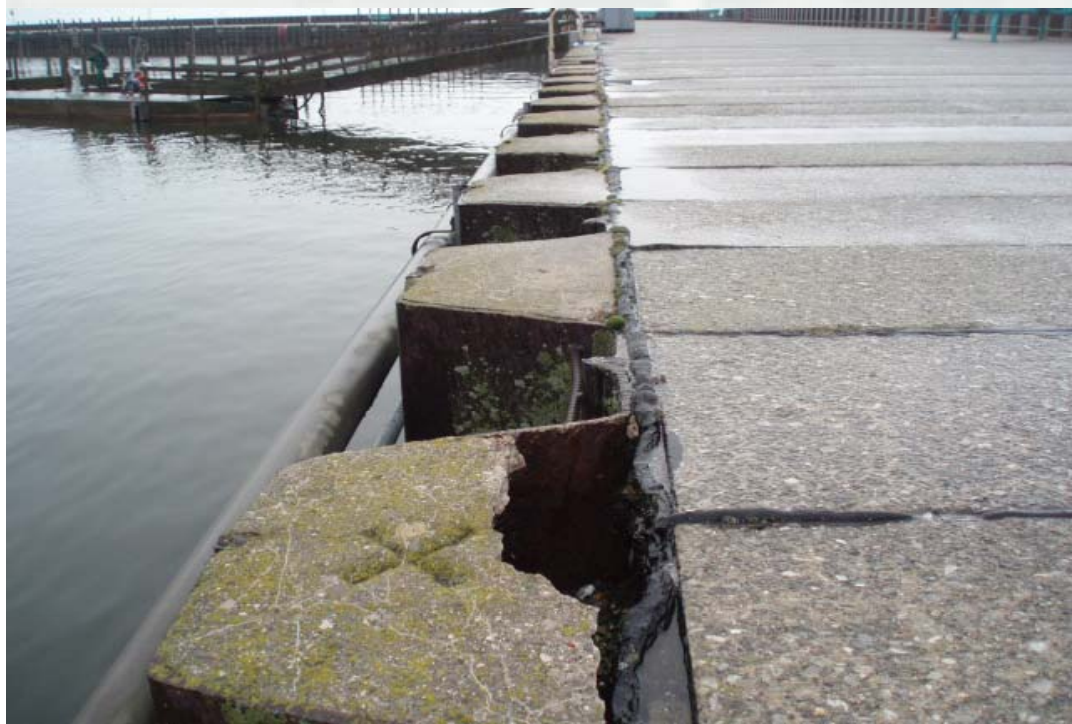
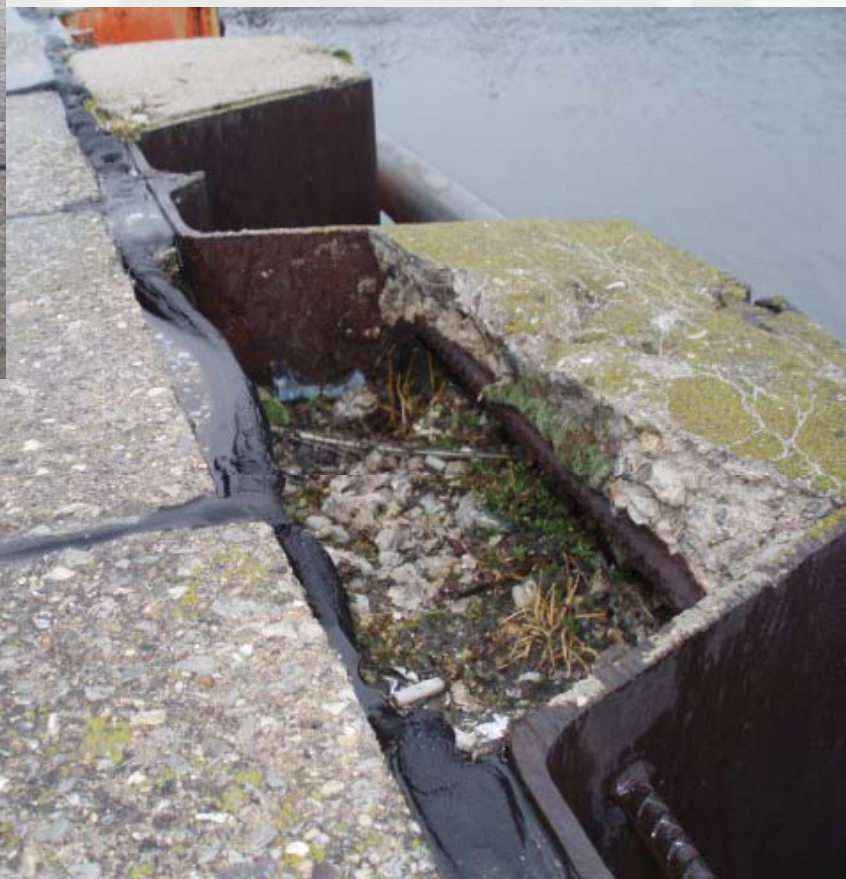
## **Tawas Bay Harbor:**

Section B: Broken concrete openings along walkway (similar conditions on all sections)

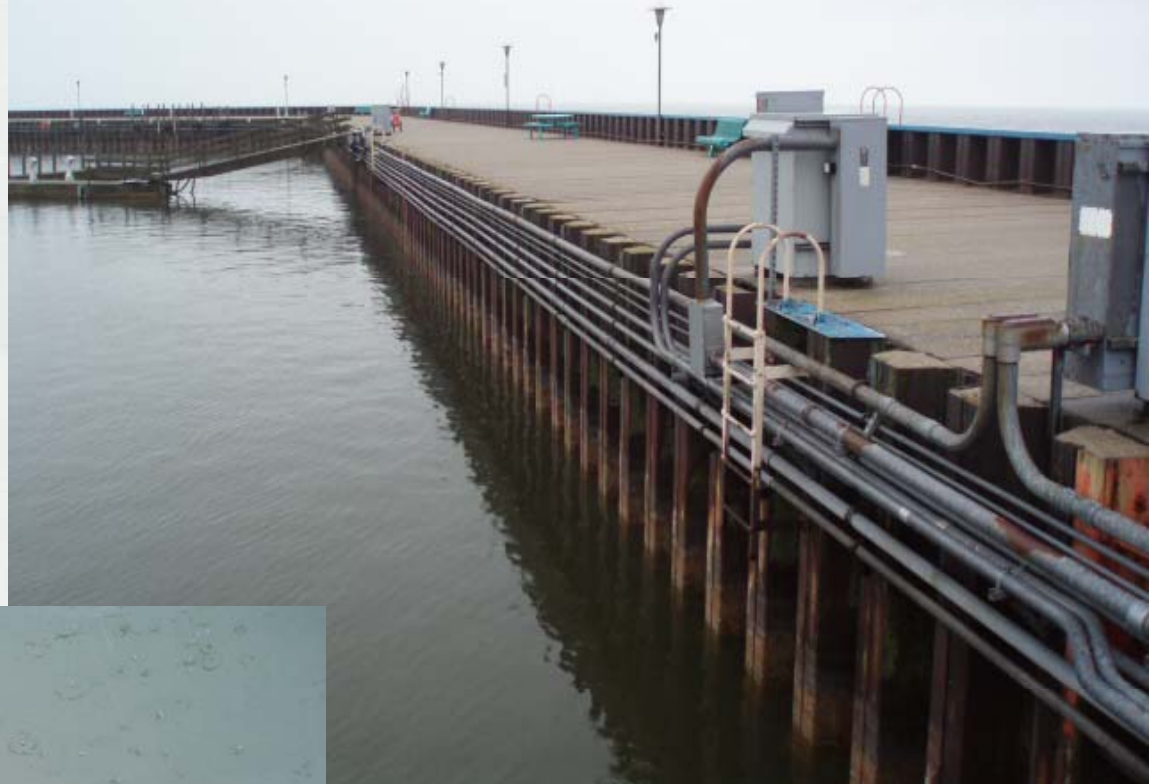
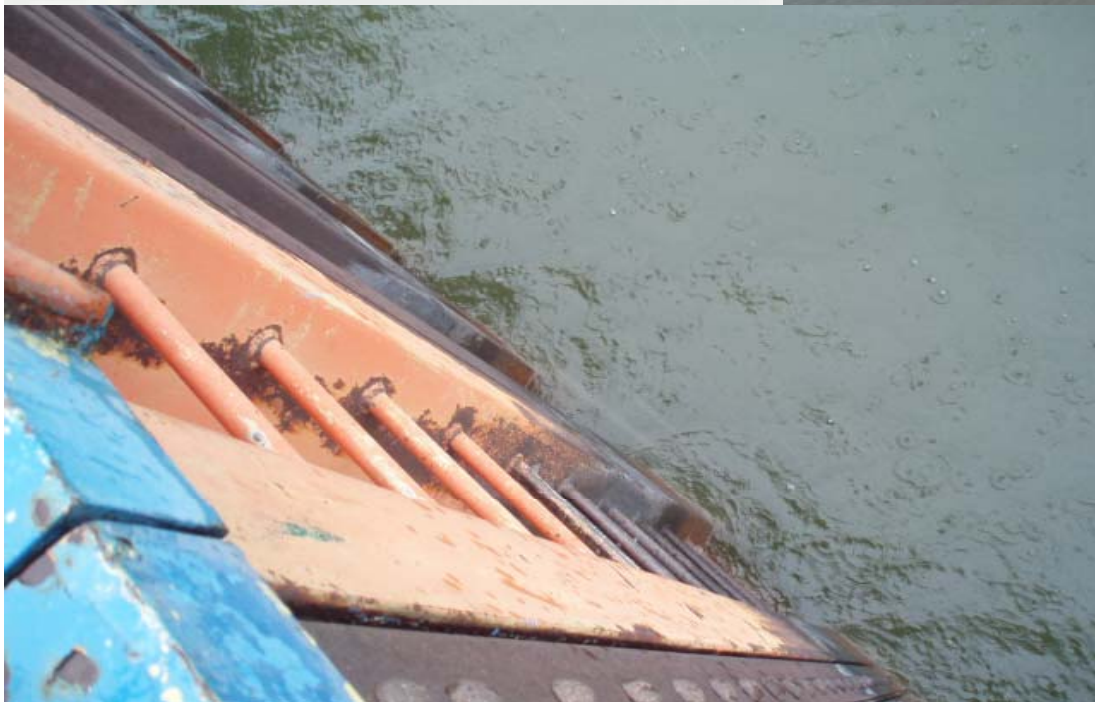
**Tawas Bay Harbor:**

Steel Sheet Pile SSP wall in good condition

Ladders in good condition; painting needed in some areas.

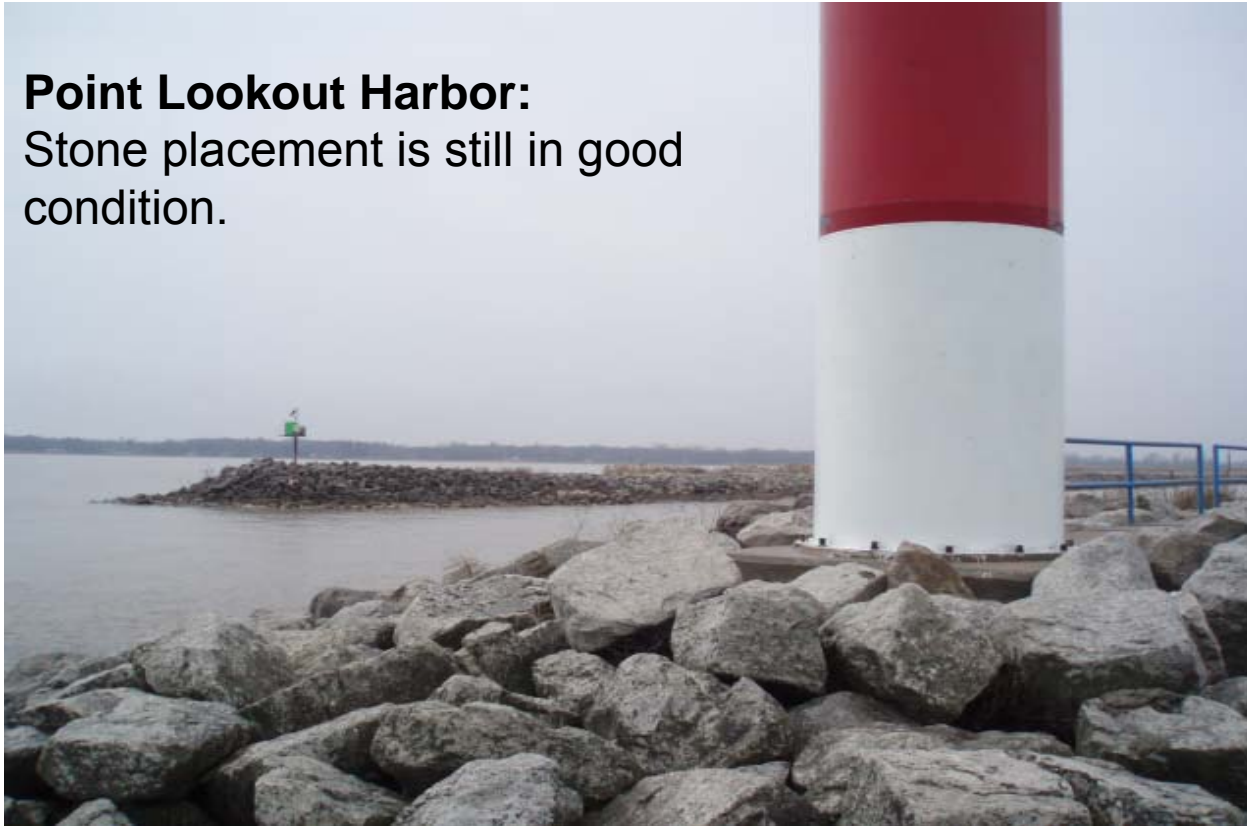
**Point Lookout Harbor:**  
Stone placement is still in good condition.

Safety Rail is in need of paint

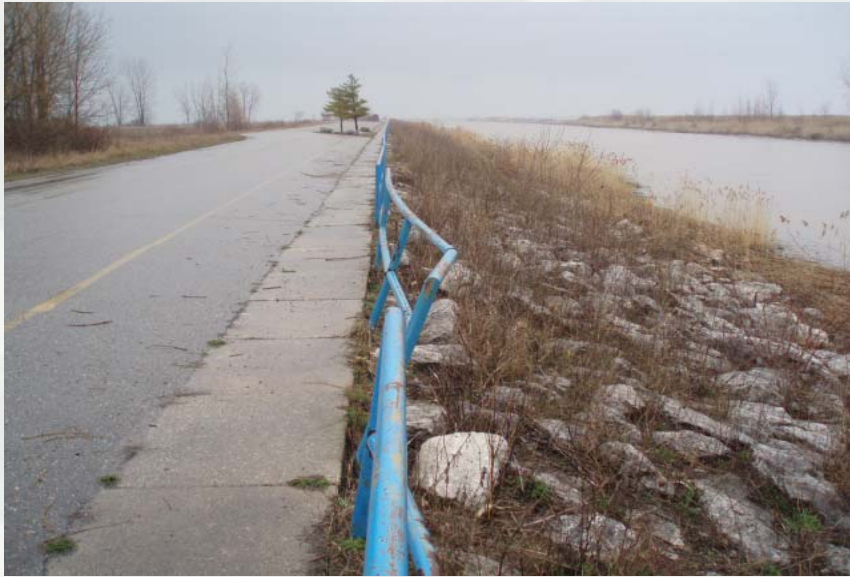
Stone placement is still in good condition.

Damaged safety rail, and Poor Alignment of hand rail. Over-grown vegetation present on breakwater

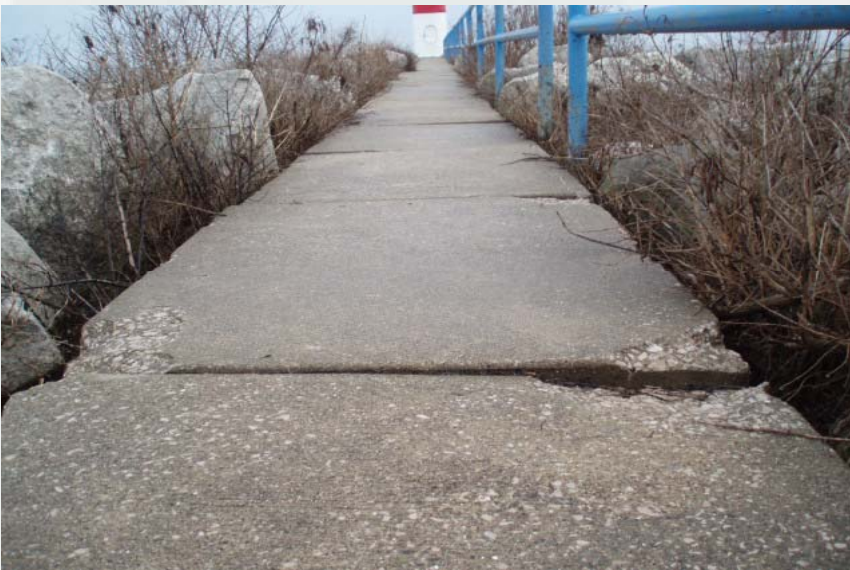
Concrete walkway has spalling and uneven surfaces; due to freeze, thaw and settlement movement beneath slabs
