# Coastal Structures Risk Communication Southern Lake Michigan Harbors

Dave Wright  
Chief of Operations  
Detroit District

July 18, 2012

# Harbors of Southwest Michigan & Northern Indiana & Illinois

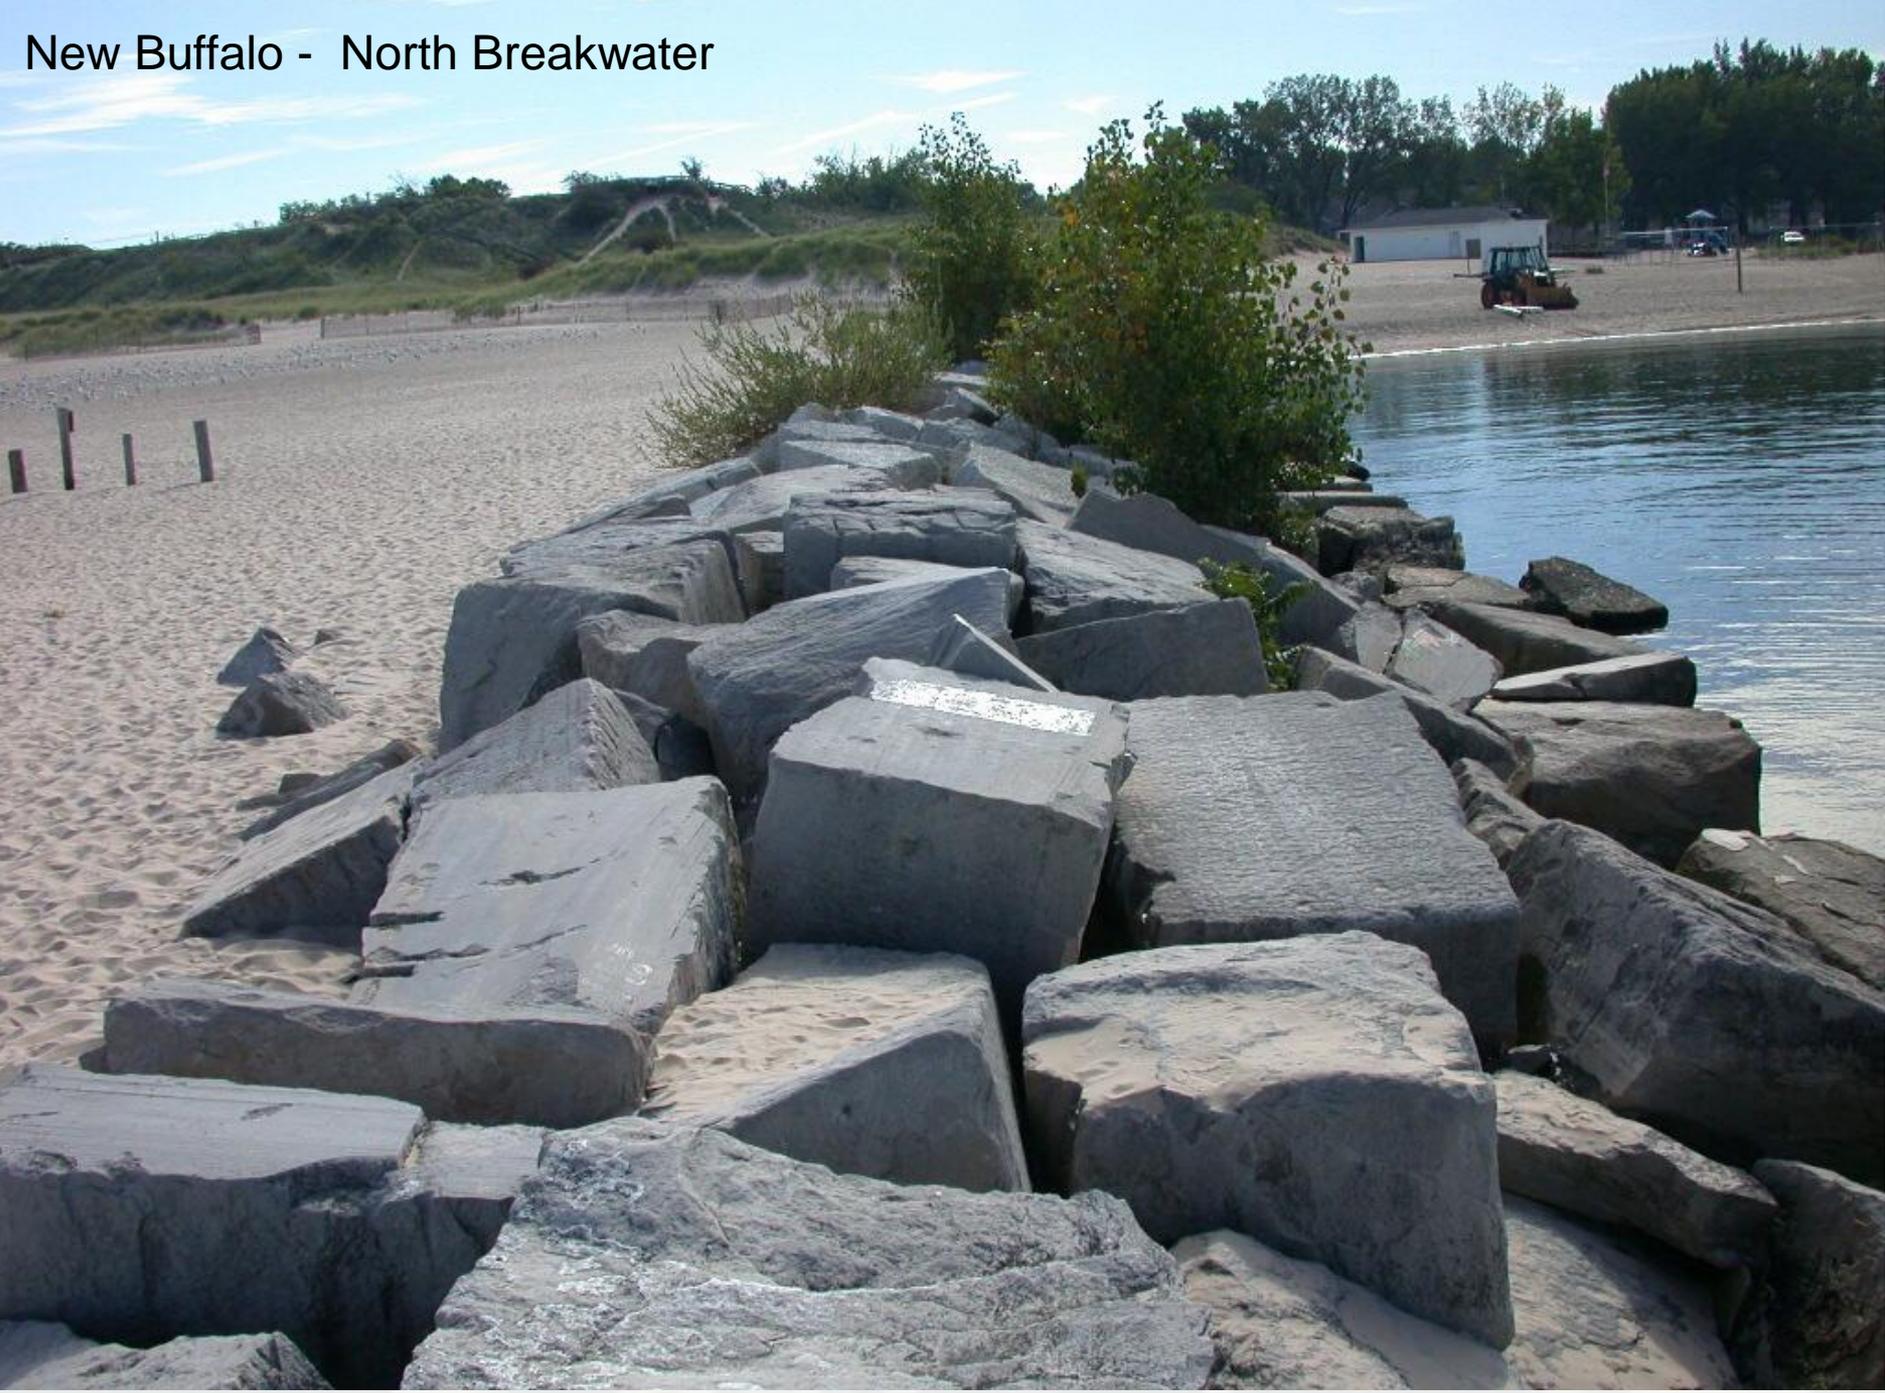
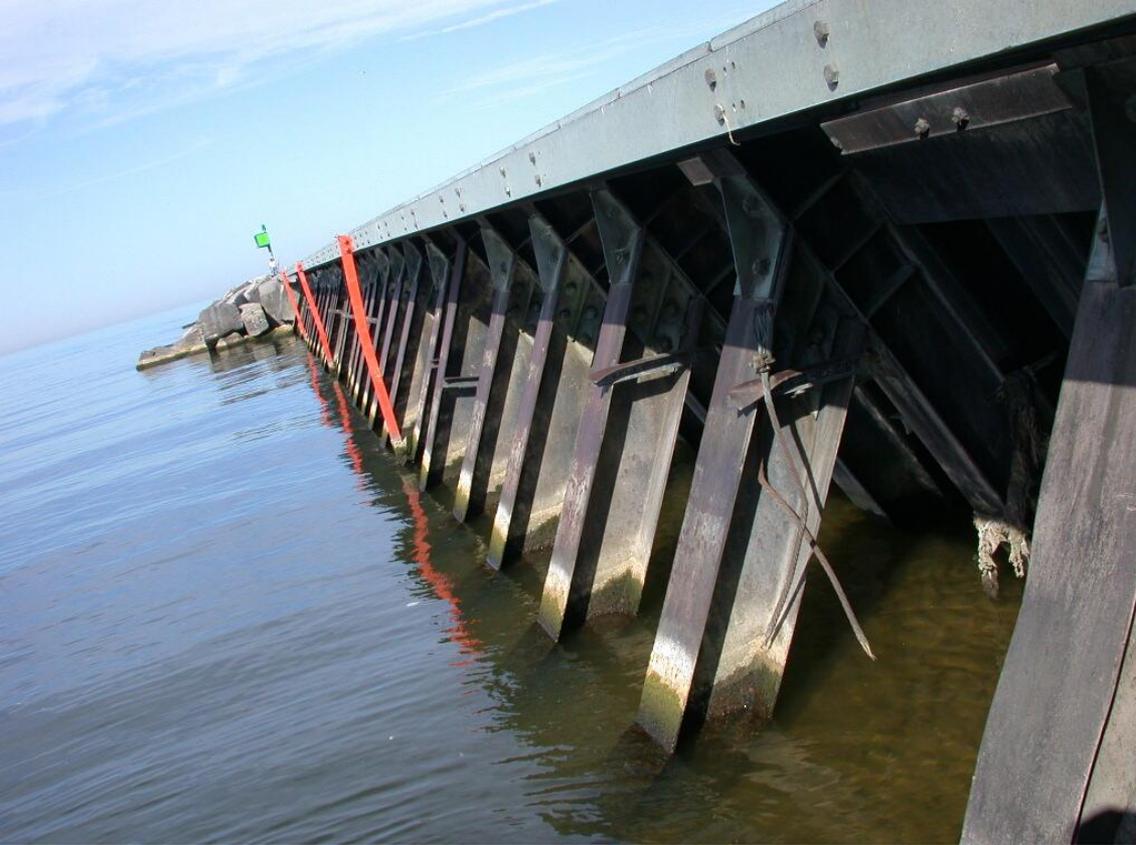
New Buffalo - North Breakwater

Un-even Grating

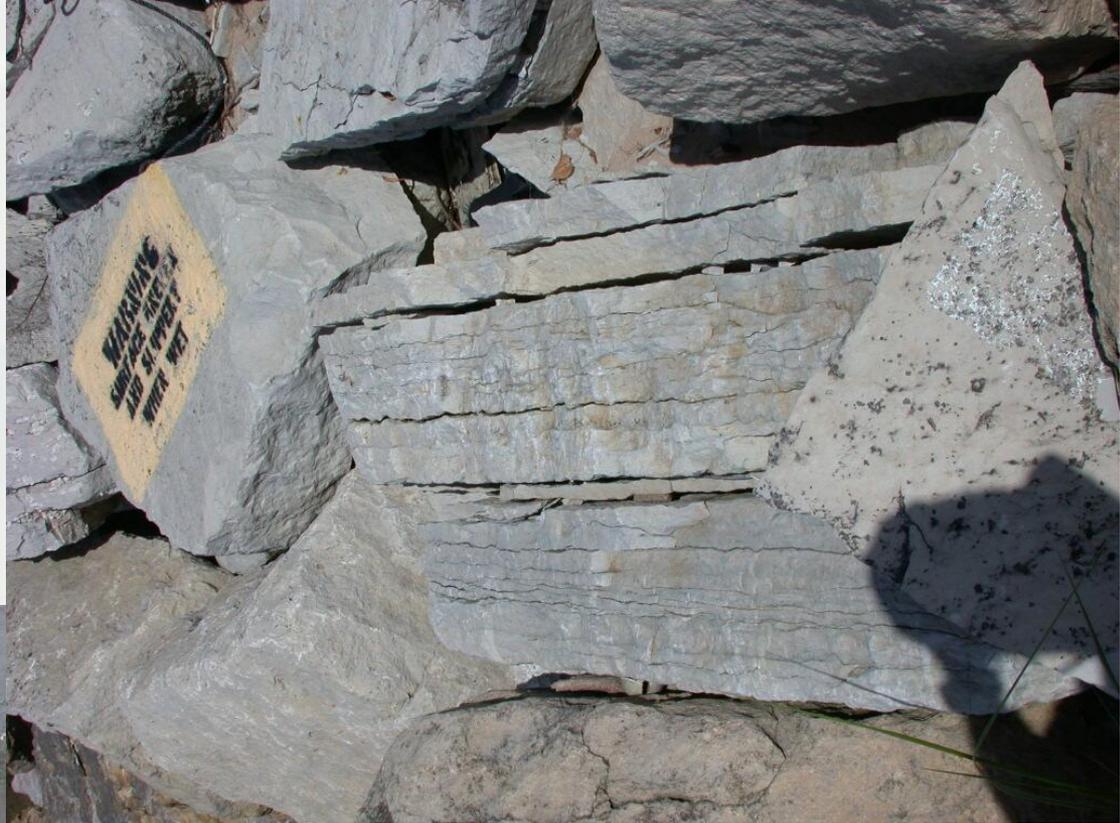
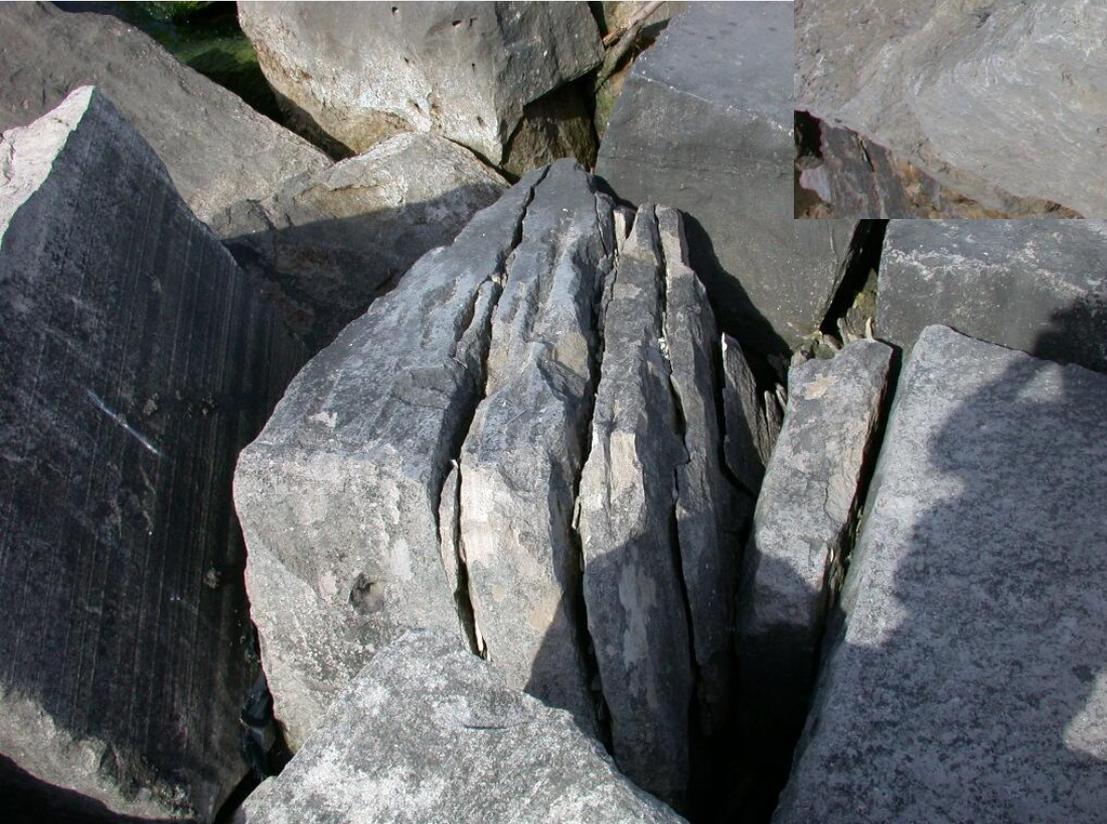
# New Buffalo - South Breakwater Stone Deteriorating

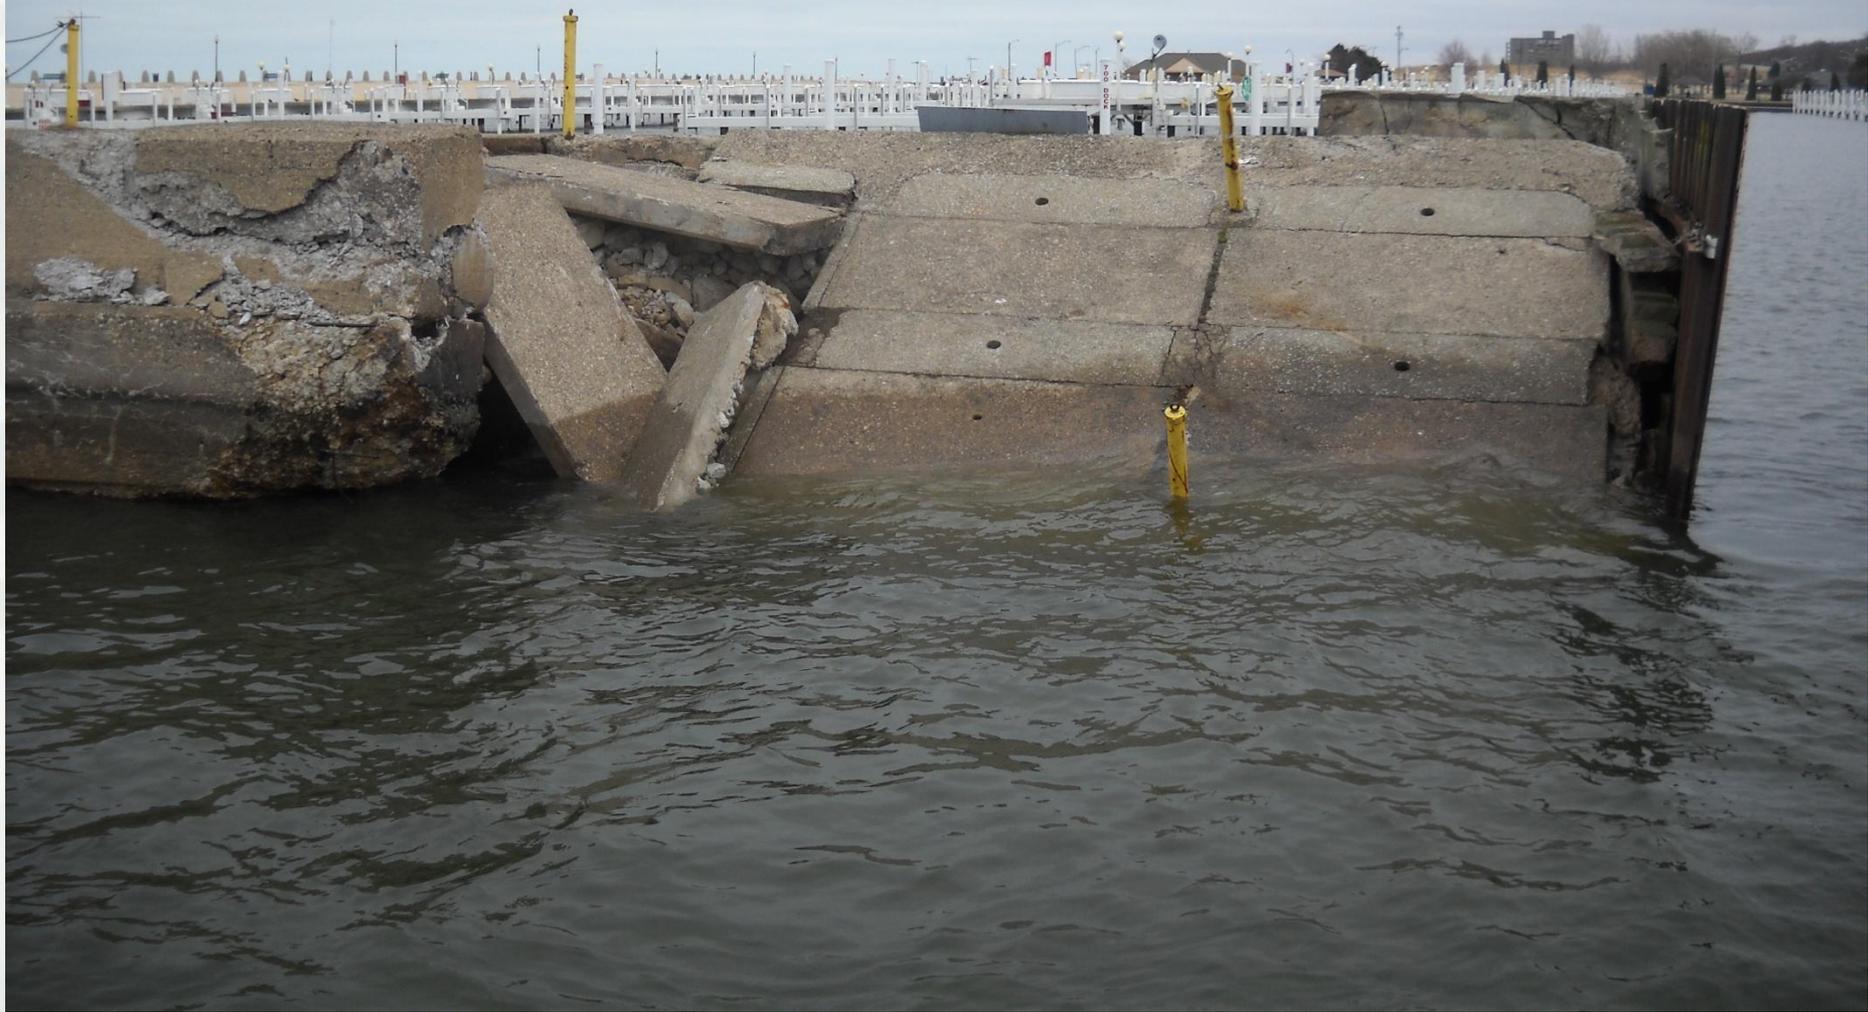
Complete collapse of first segment of  
East Pier Reach L

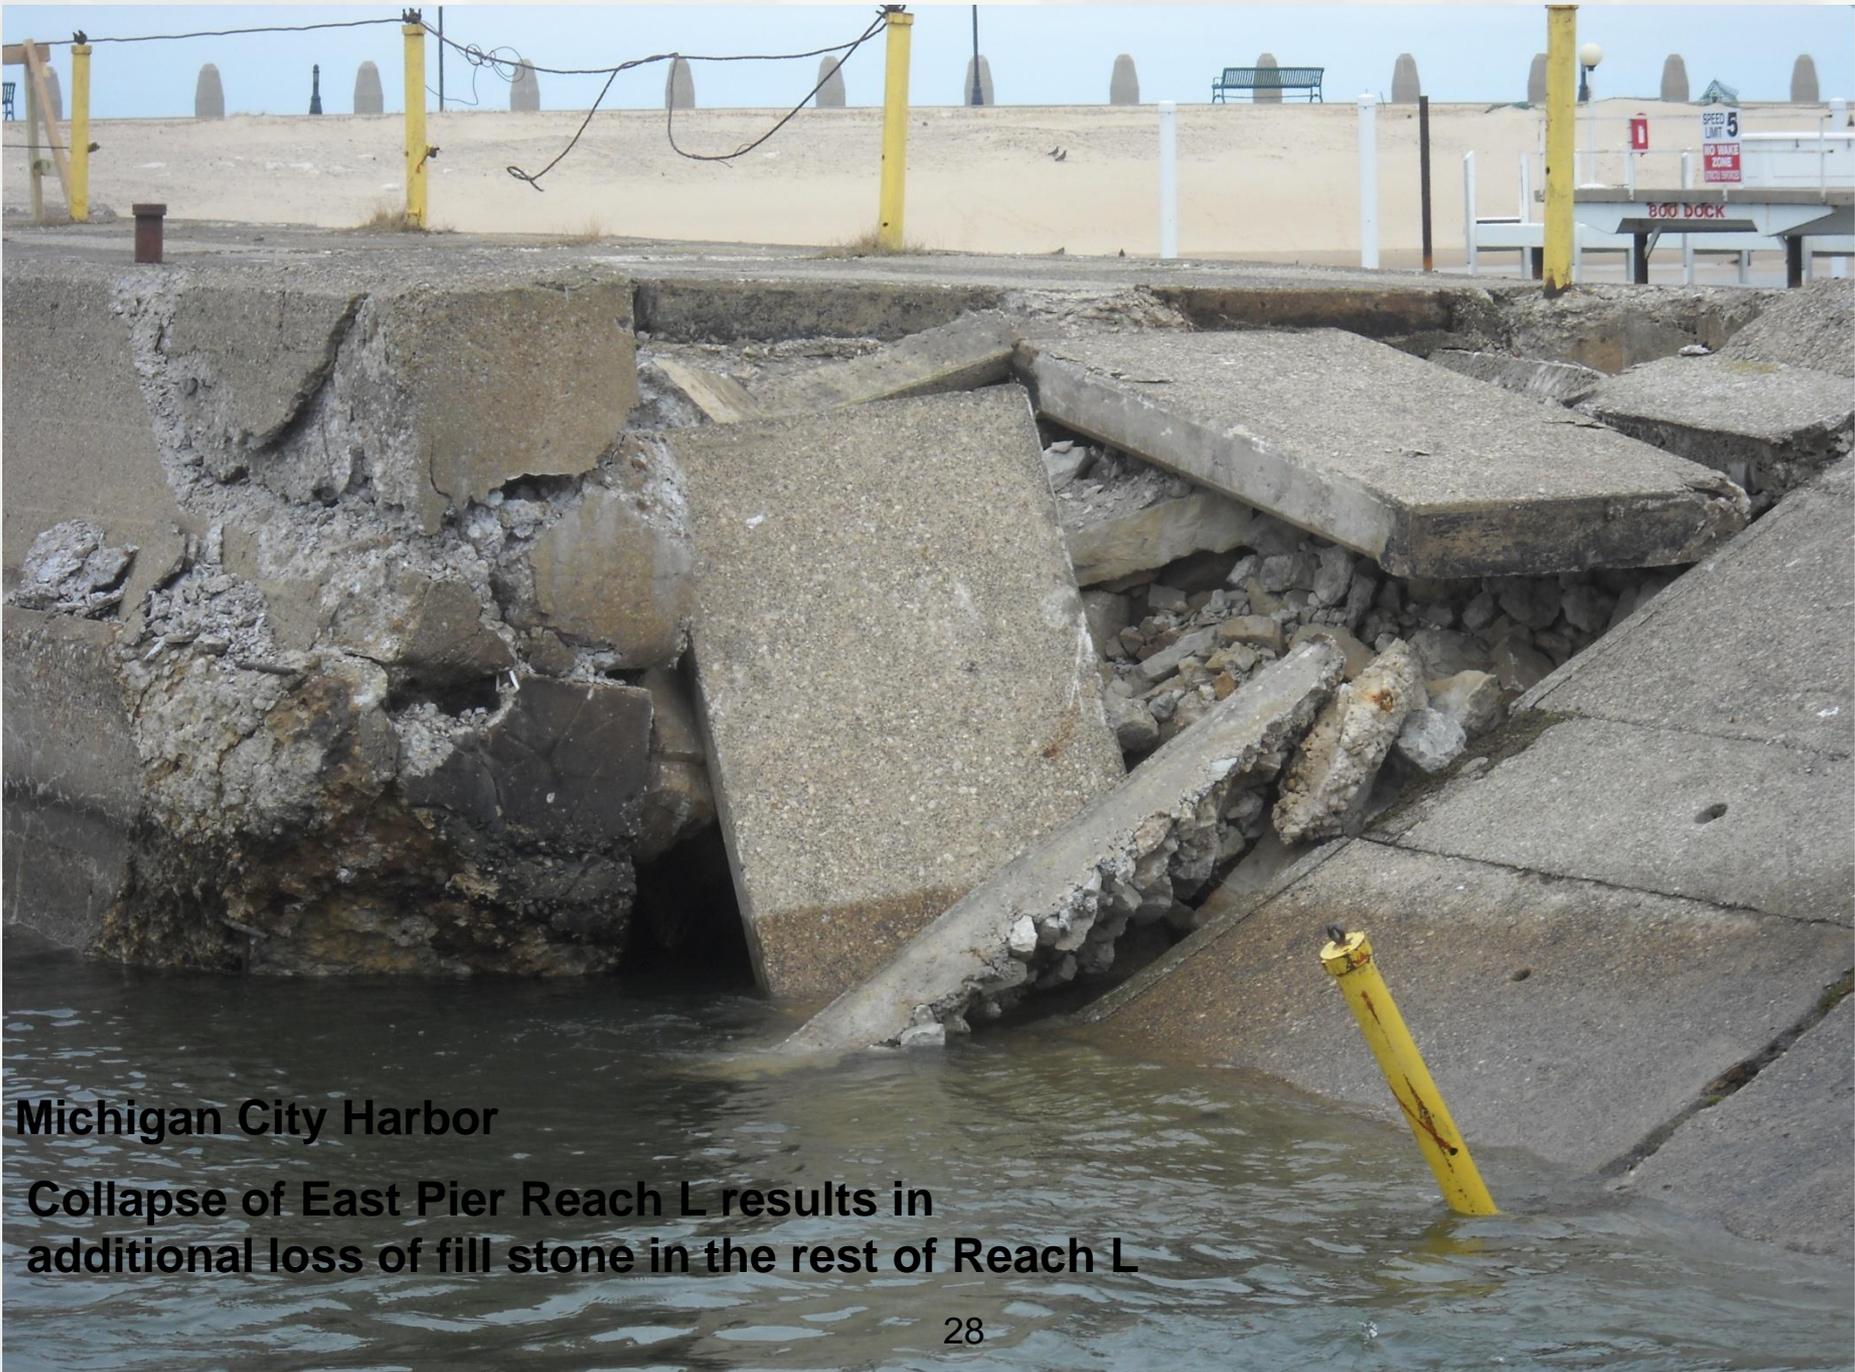
**Collapse of East Pier Reach L results in additional loss of fill stone in the rest of Reach L**

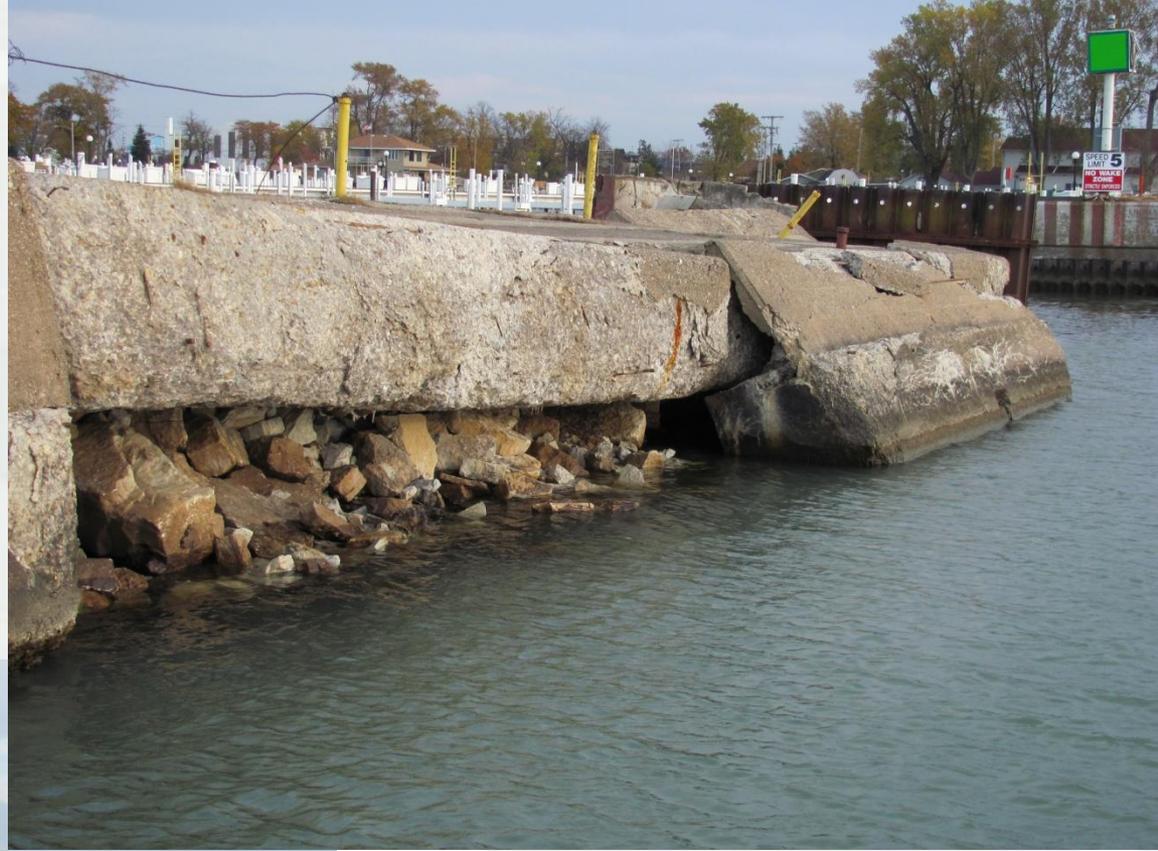
Onset of domino effect along  
Reach L of the East Pier

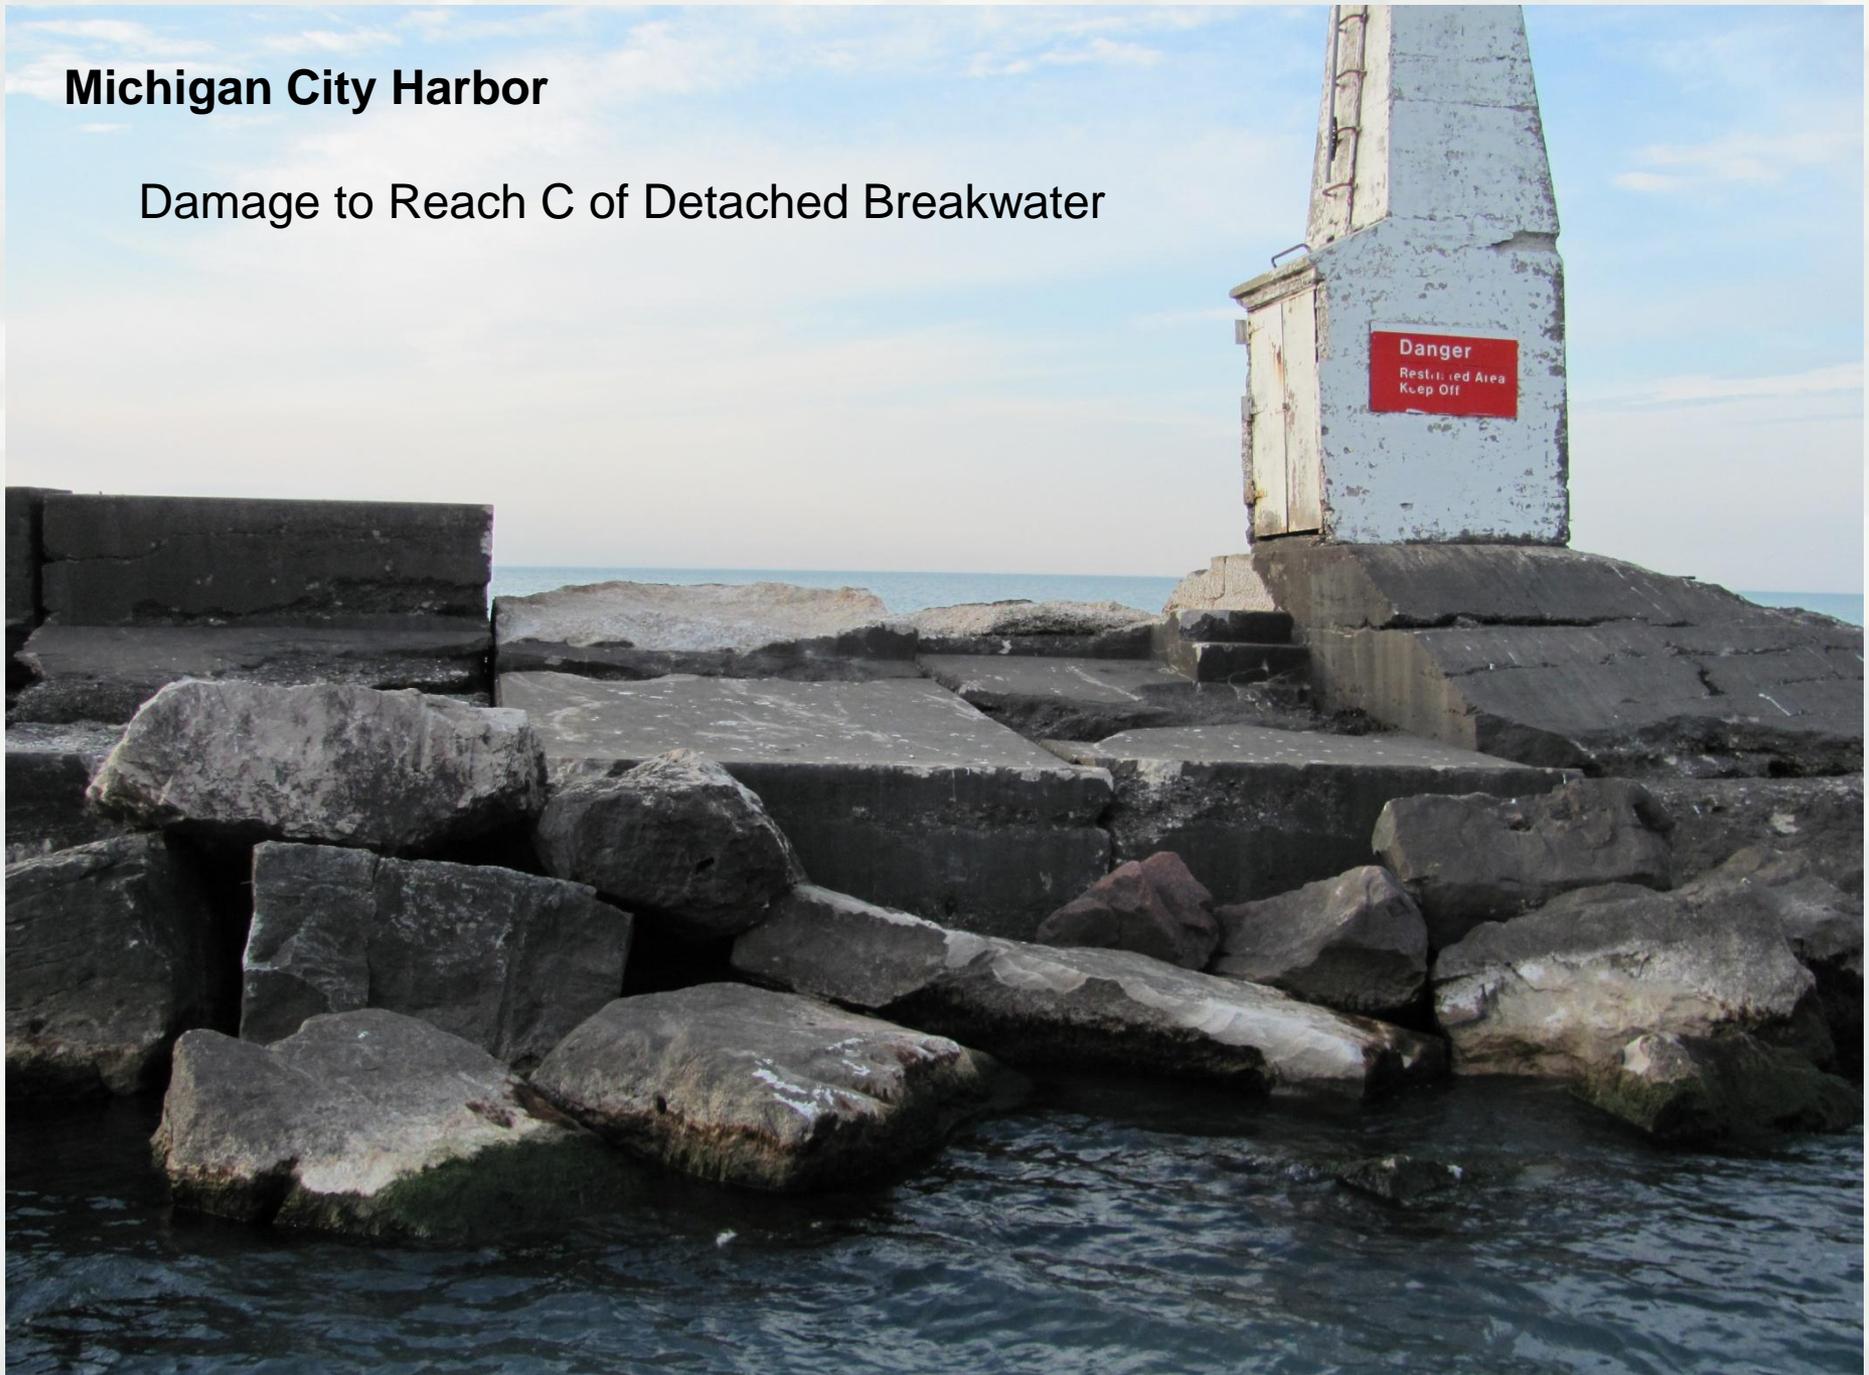
Damage to Reach C of Detached Breakwater

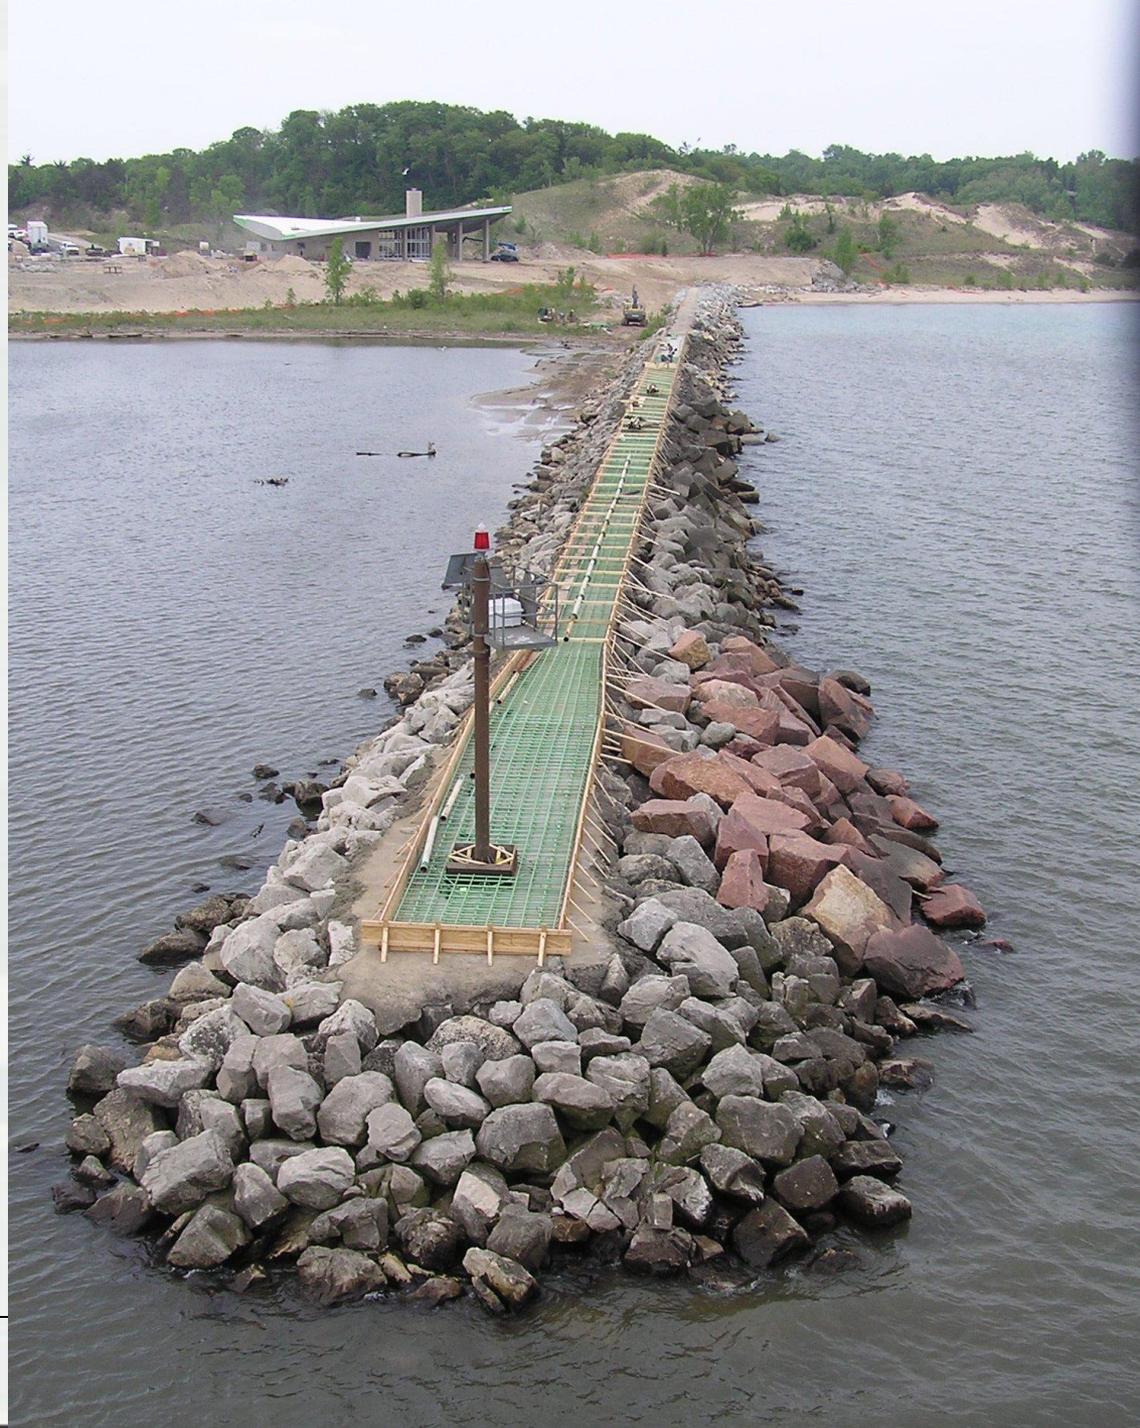
West Breakwater -  
Construction of the walkway  
was completed in 2008

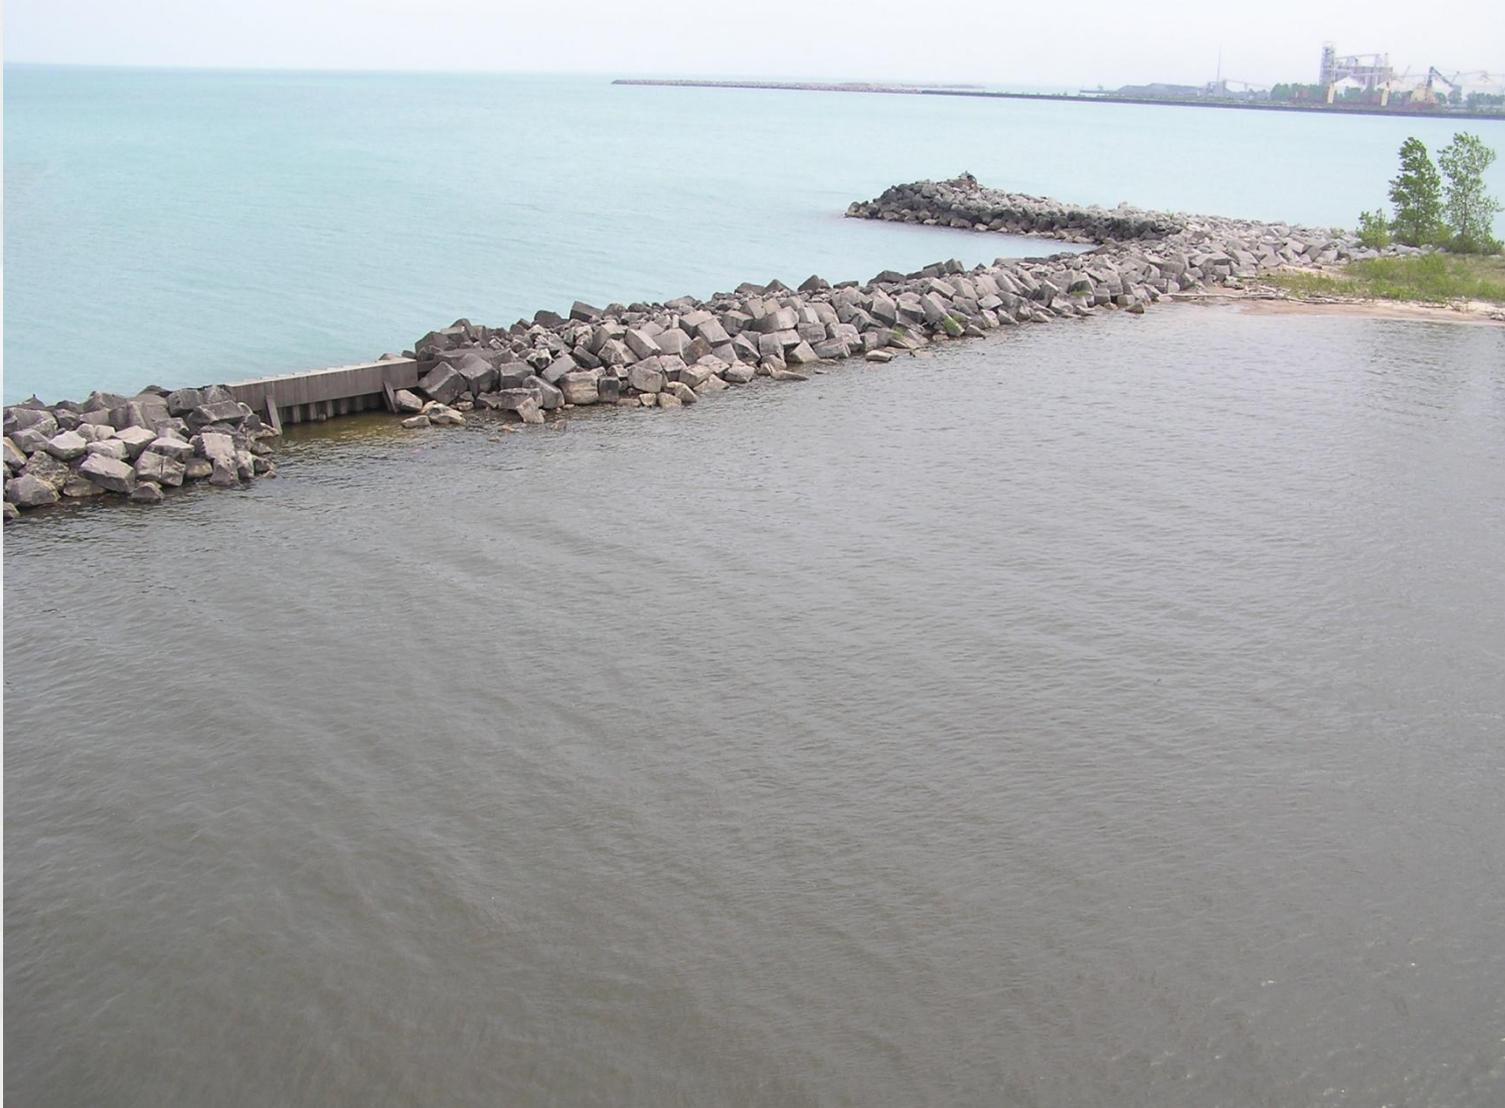
North Breakwater - the breakwater received a C rating due to loss of fill stone

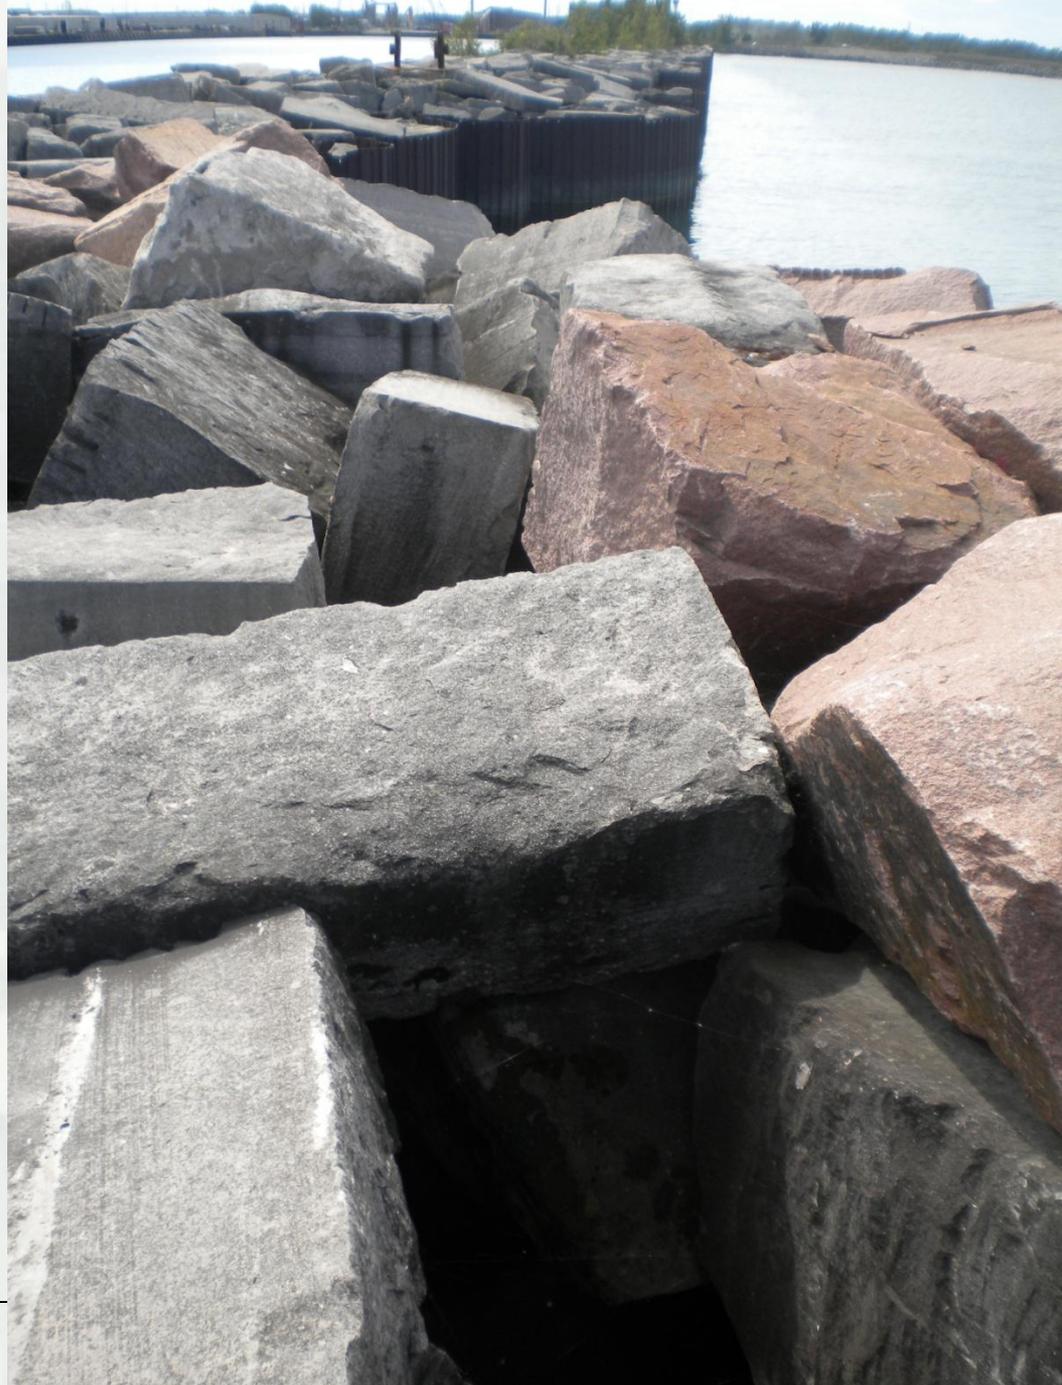
Loss of fill stone along  
Rubblemound due to heavy  
wave action

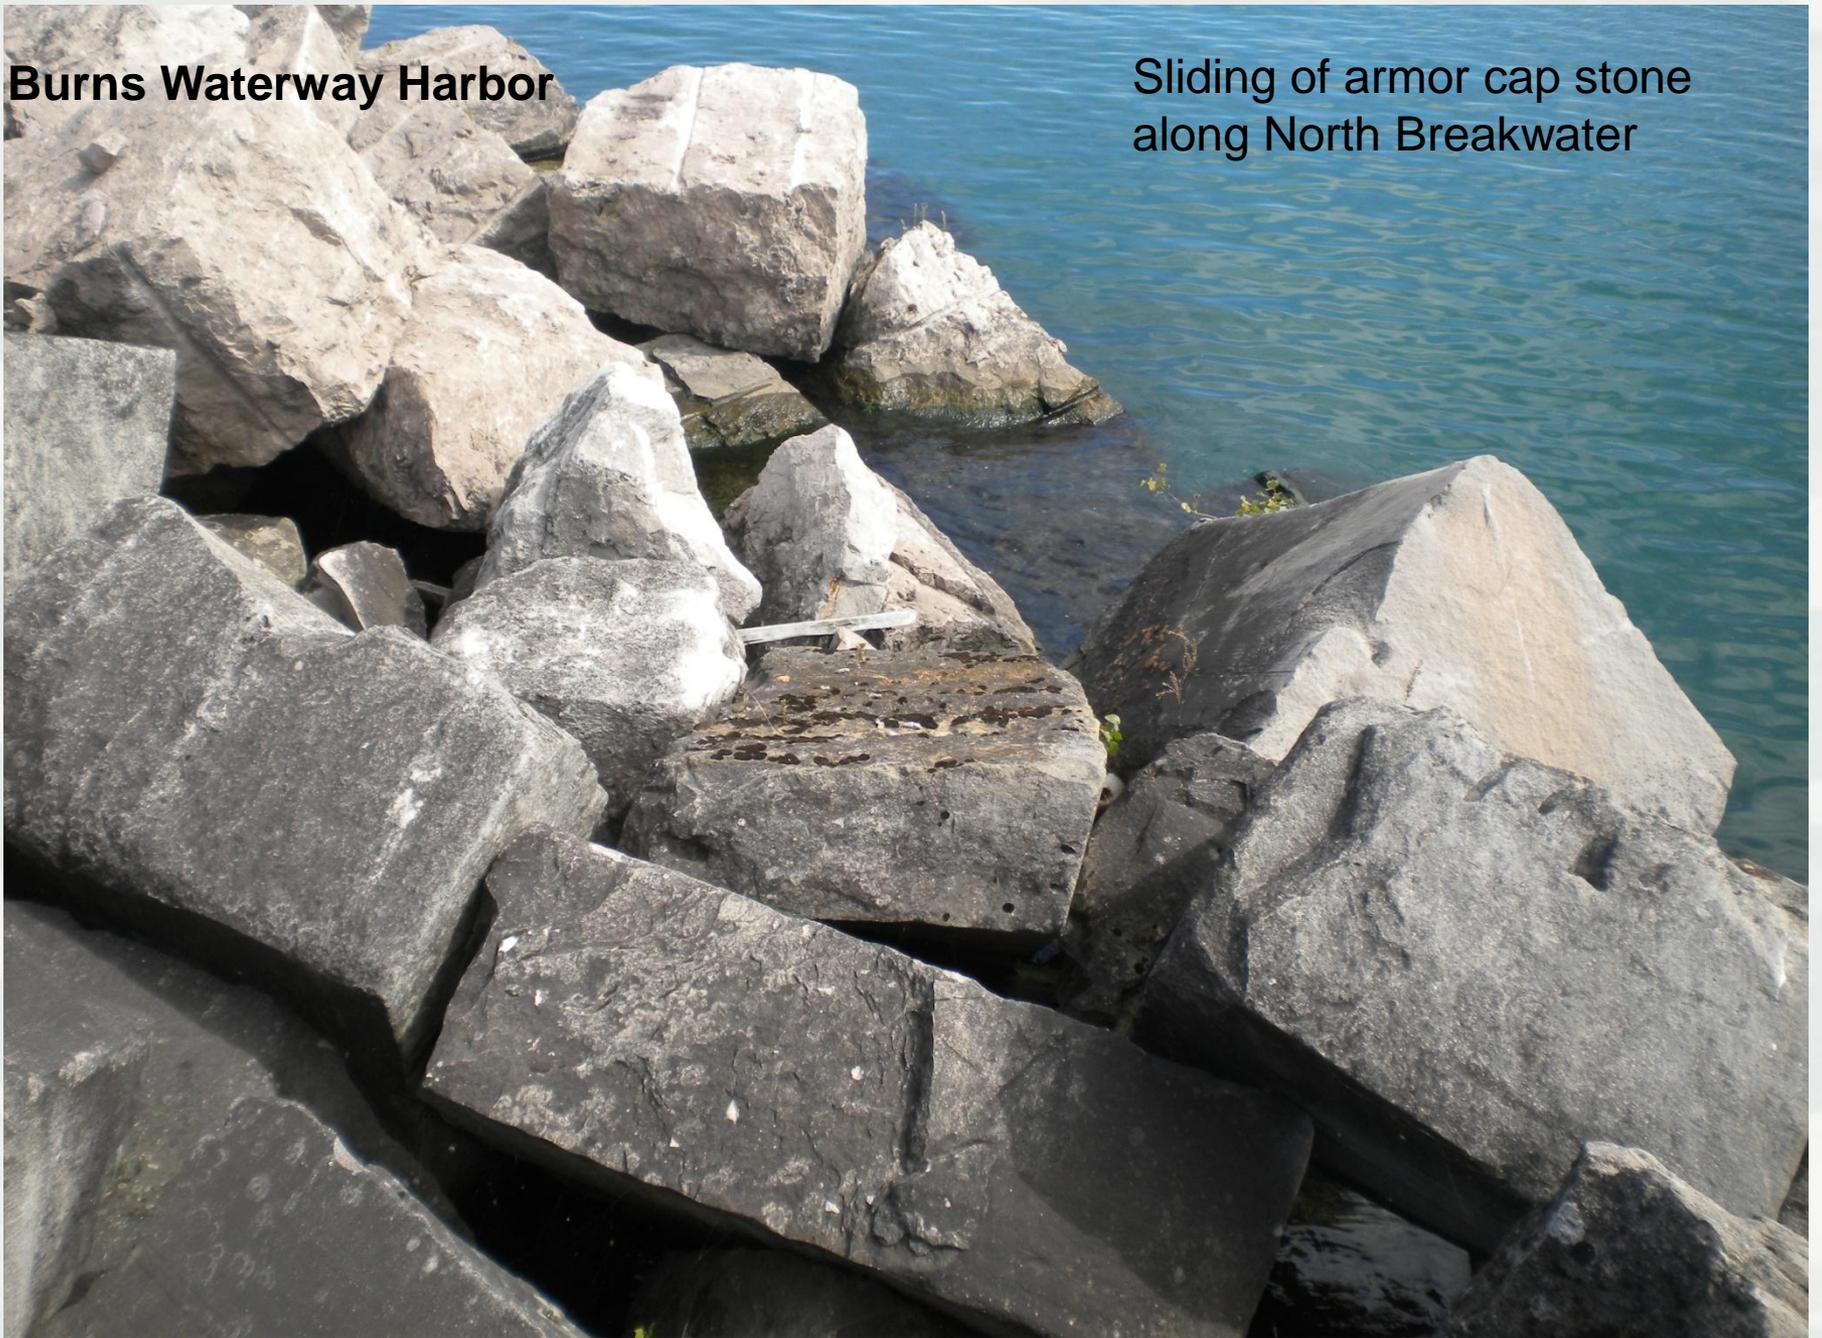
Sliding of armor cap stone  
along North Breakwater

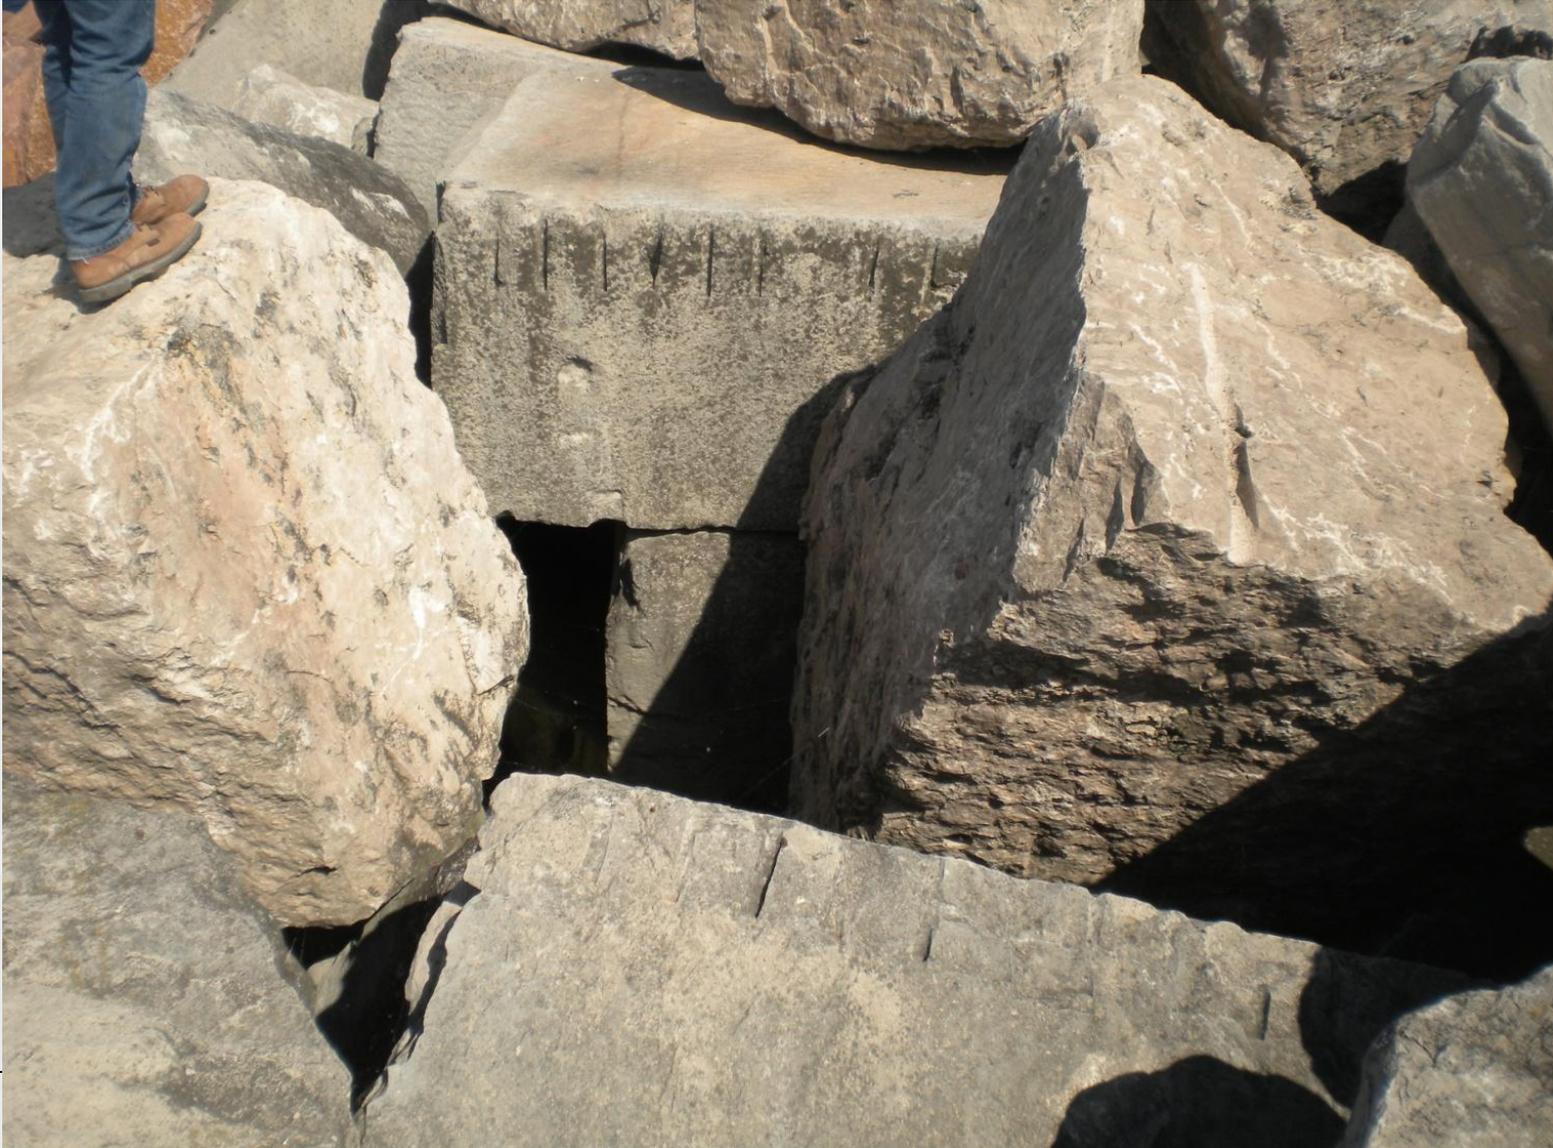
Loss of fill stone along North  
Breakwater due to heavy wave  
action.
