# Coastal Structures Risk Communication Southern Lake Michigan Harbors

Dave Wright  
Chief of Operations  
Detroit District

July 18, 2012

# Harbors of Southwest Michigan & Northern Indiana & Illinois

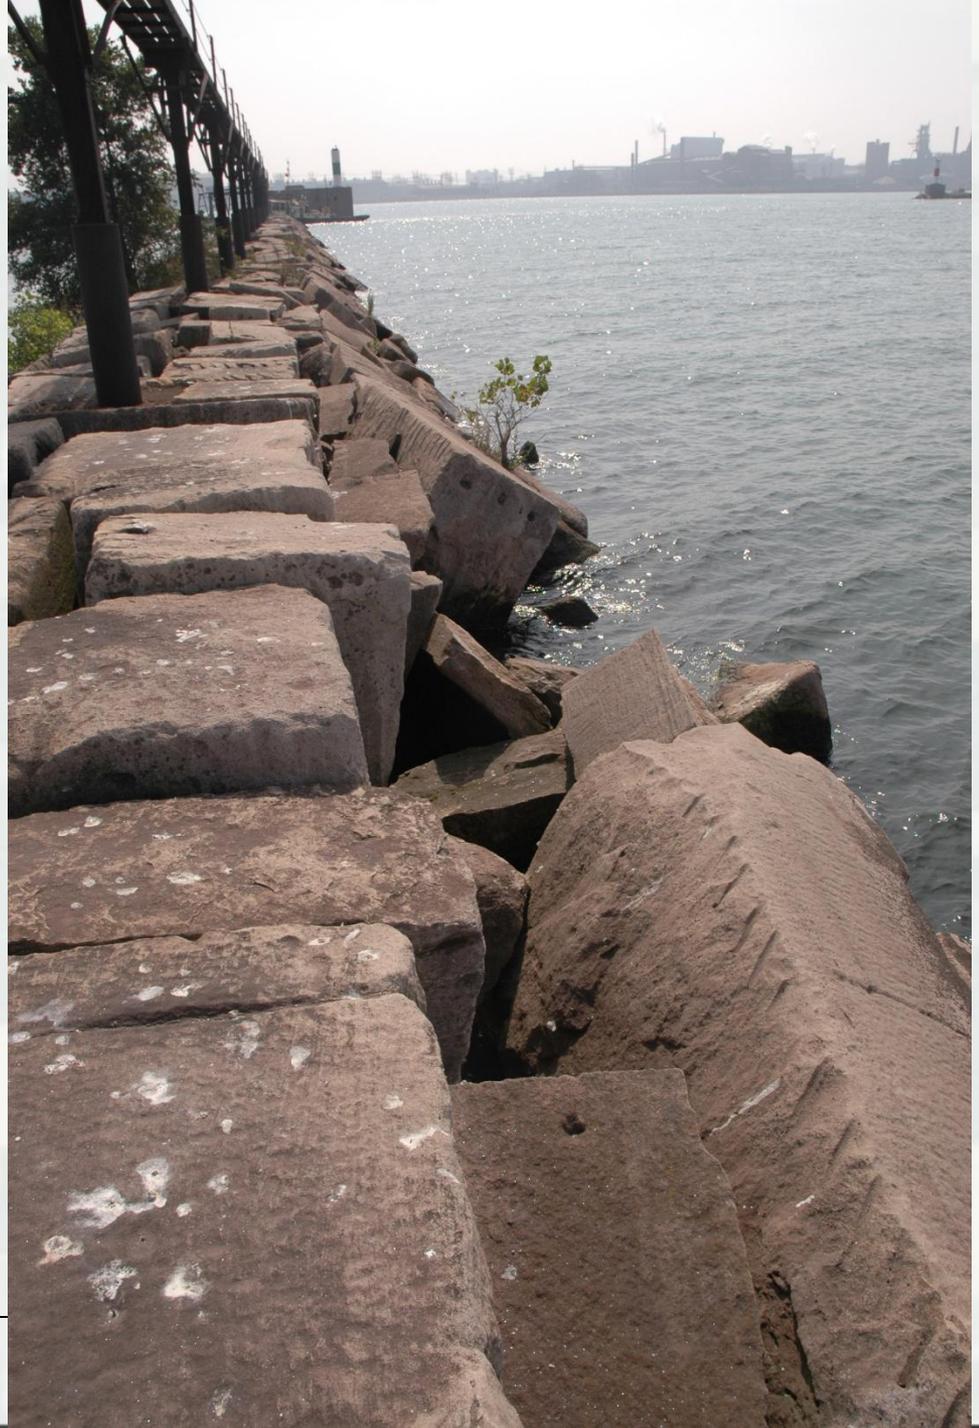
Collapse of laid-up structure due to loss of toe stone along Easterly Breakwater

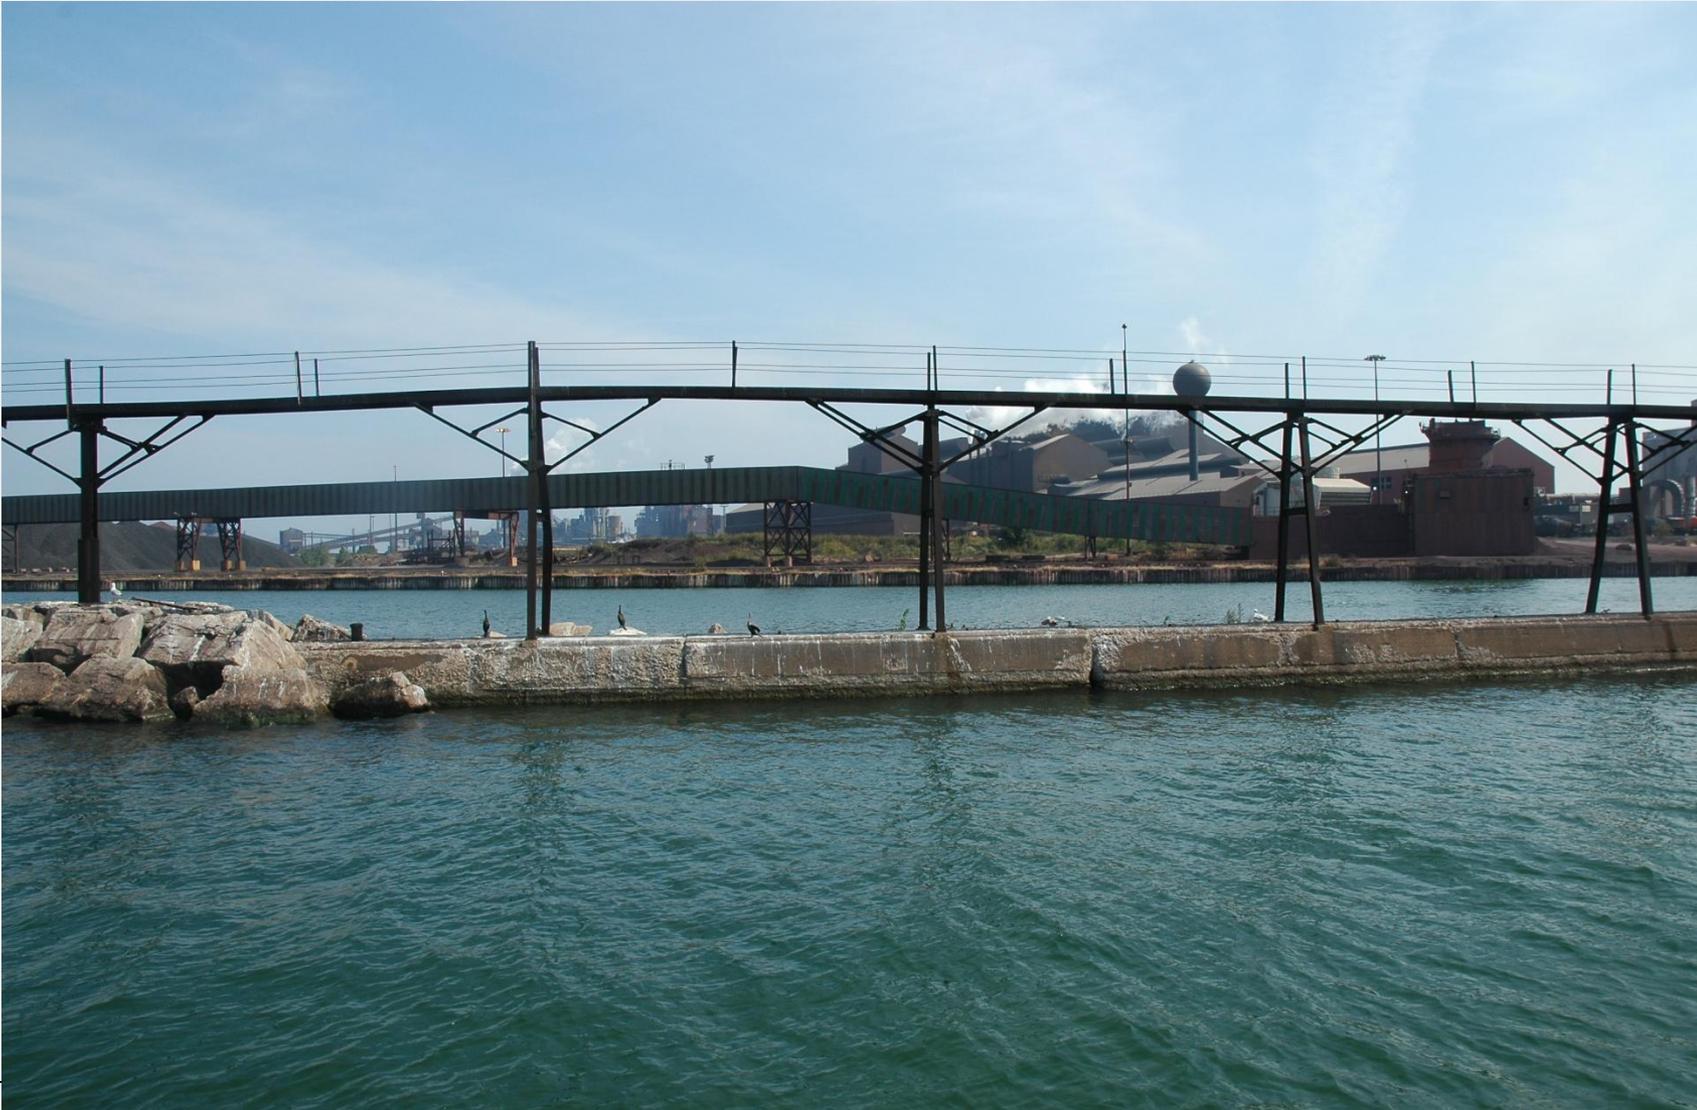
## Spalling of concrete caisson of Easterly Breakwater

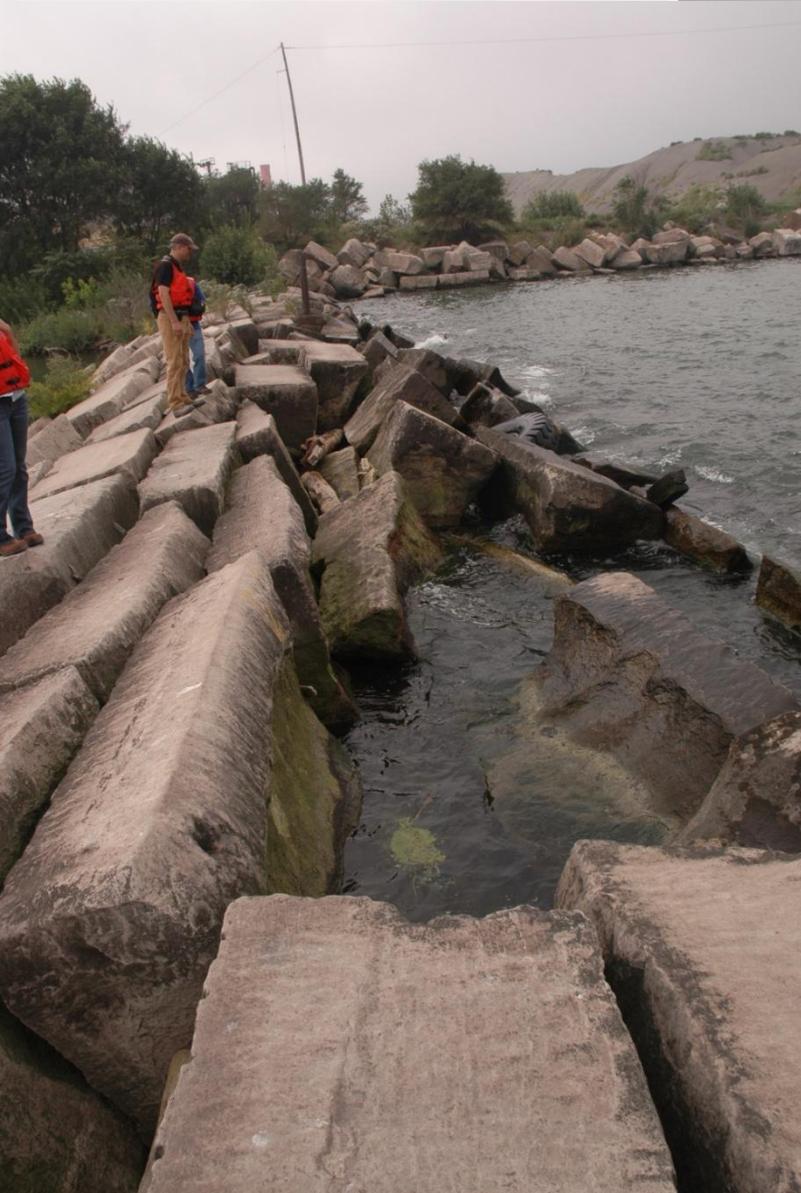
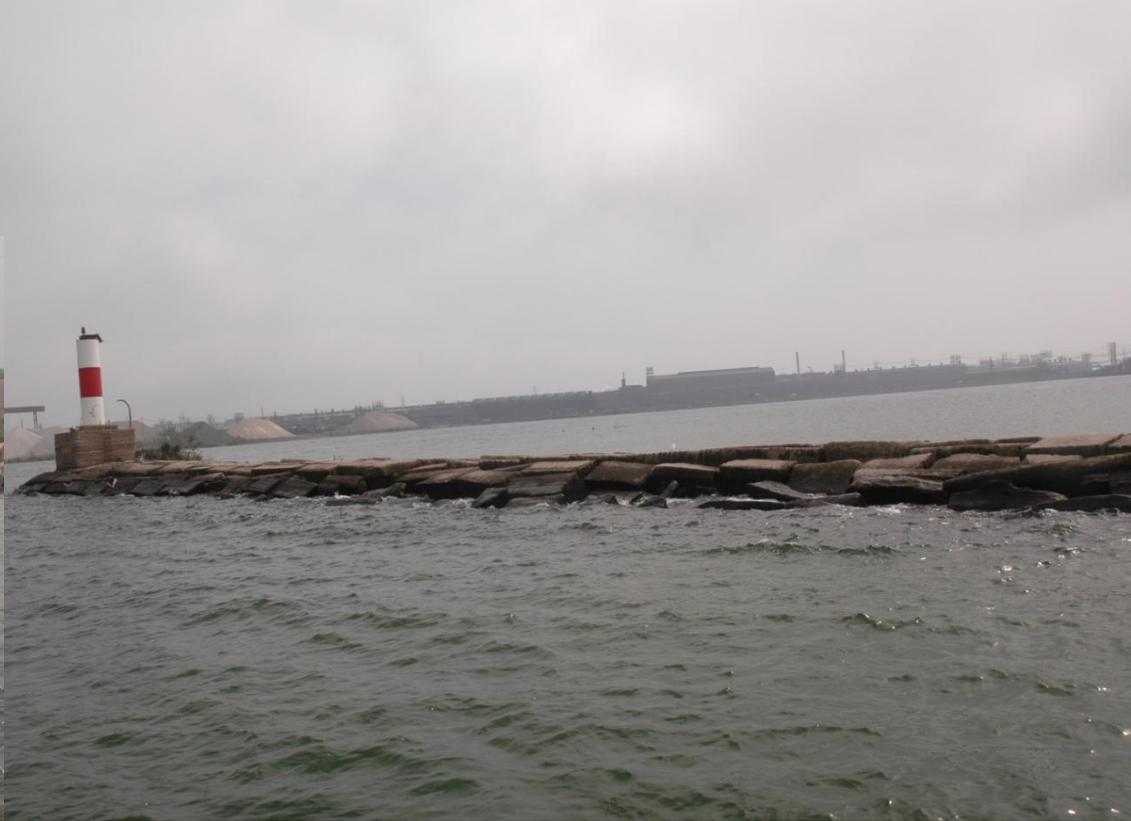
collapse of laid-up structure due to loss of toe stone along Northerly Breakwater

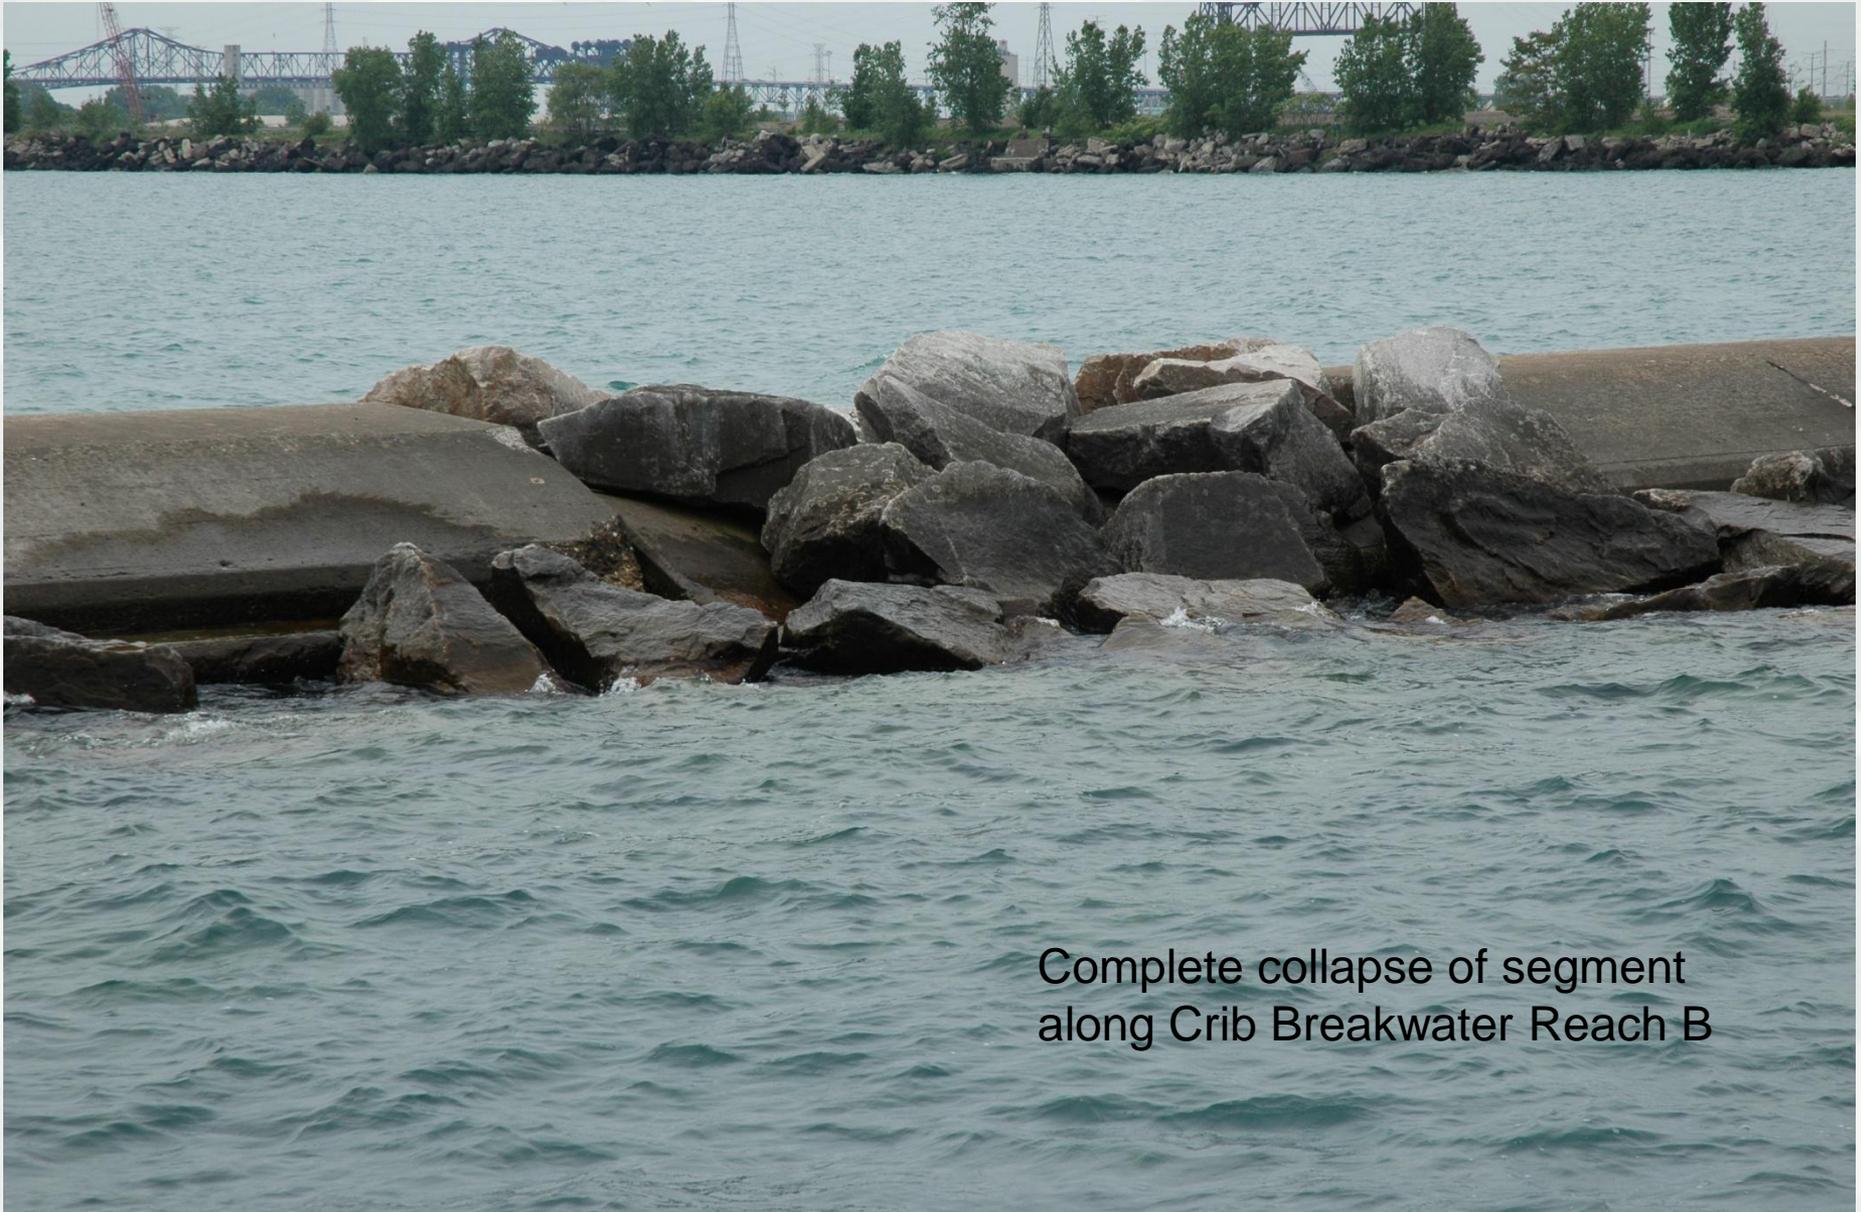
Complete collapse of segment  
along Crib Breakwater Reach B

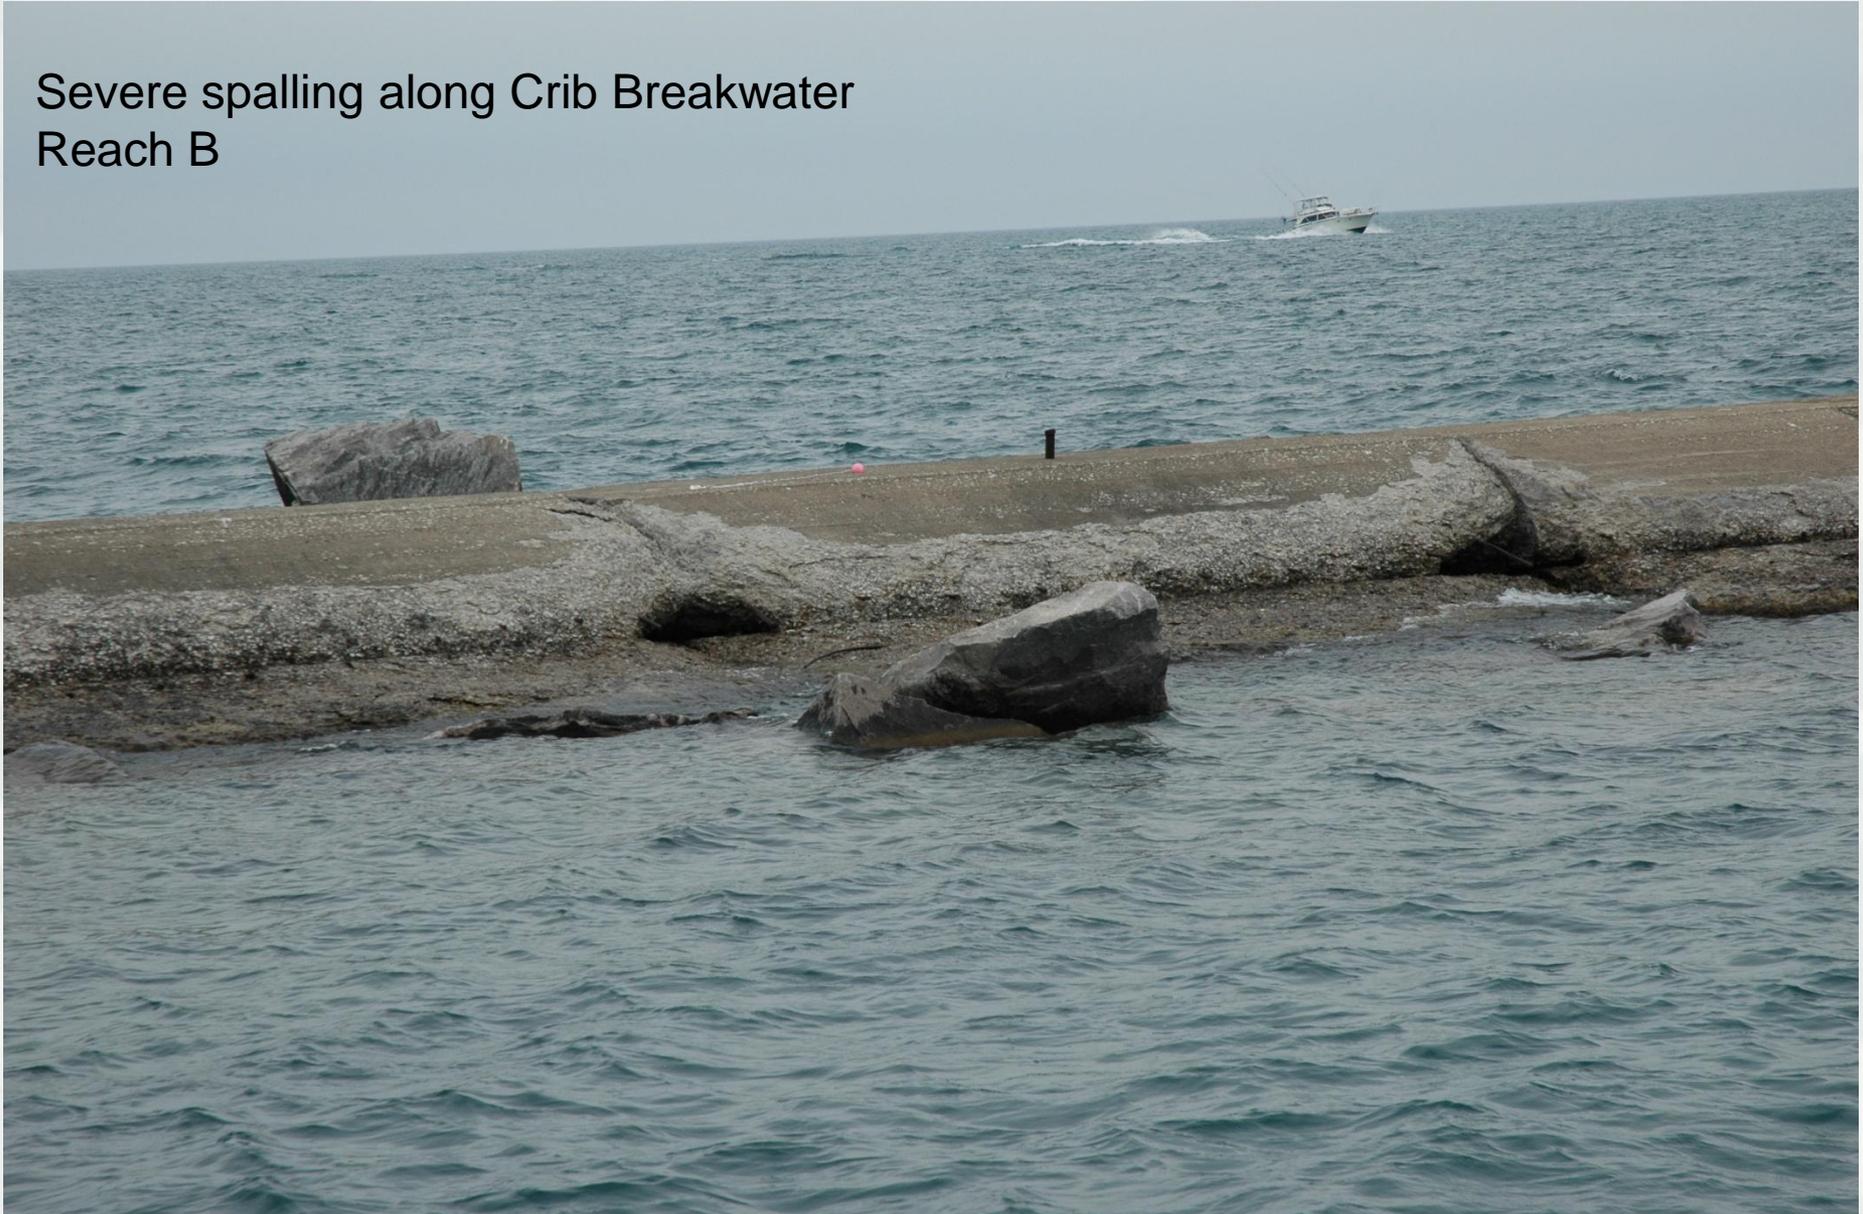
Severe spalling along Crib Breakwater  
Reach B

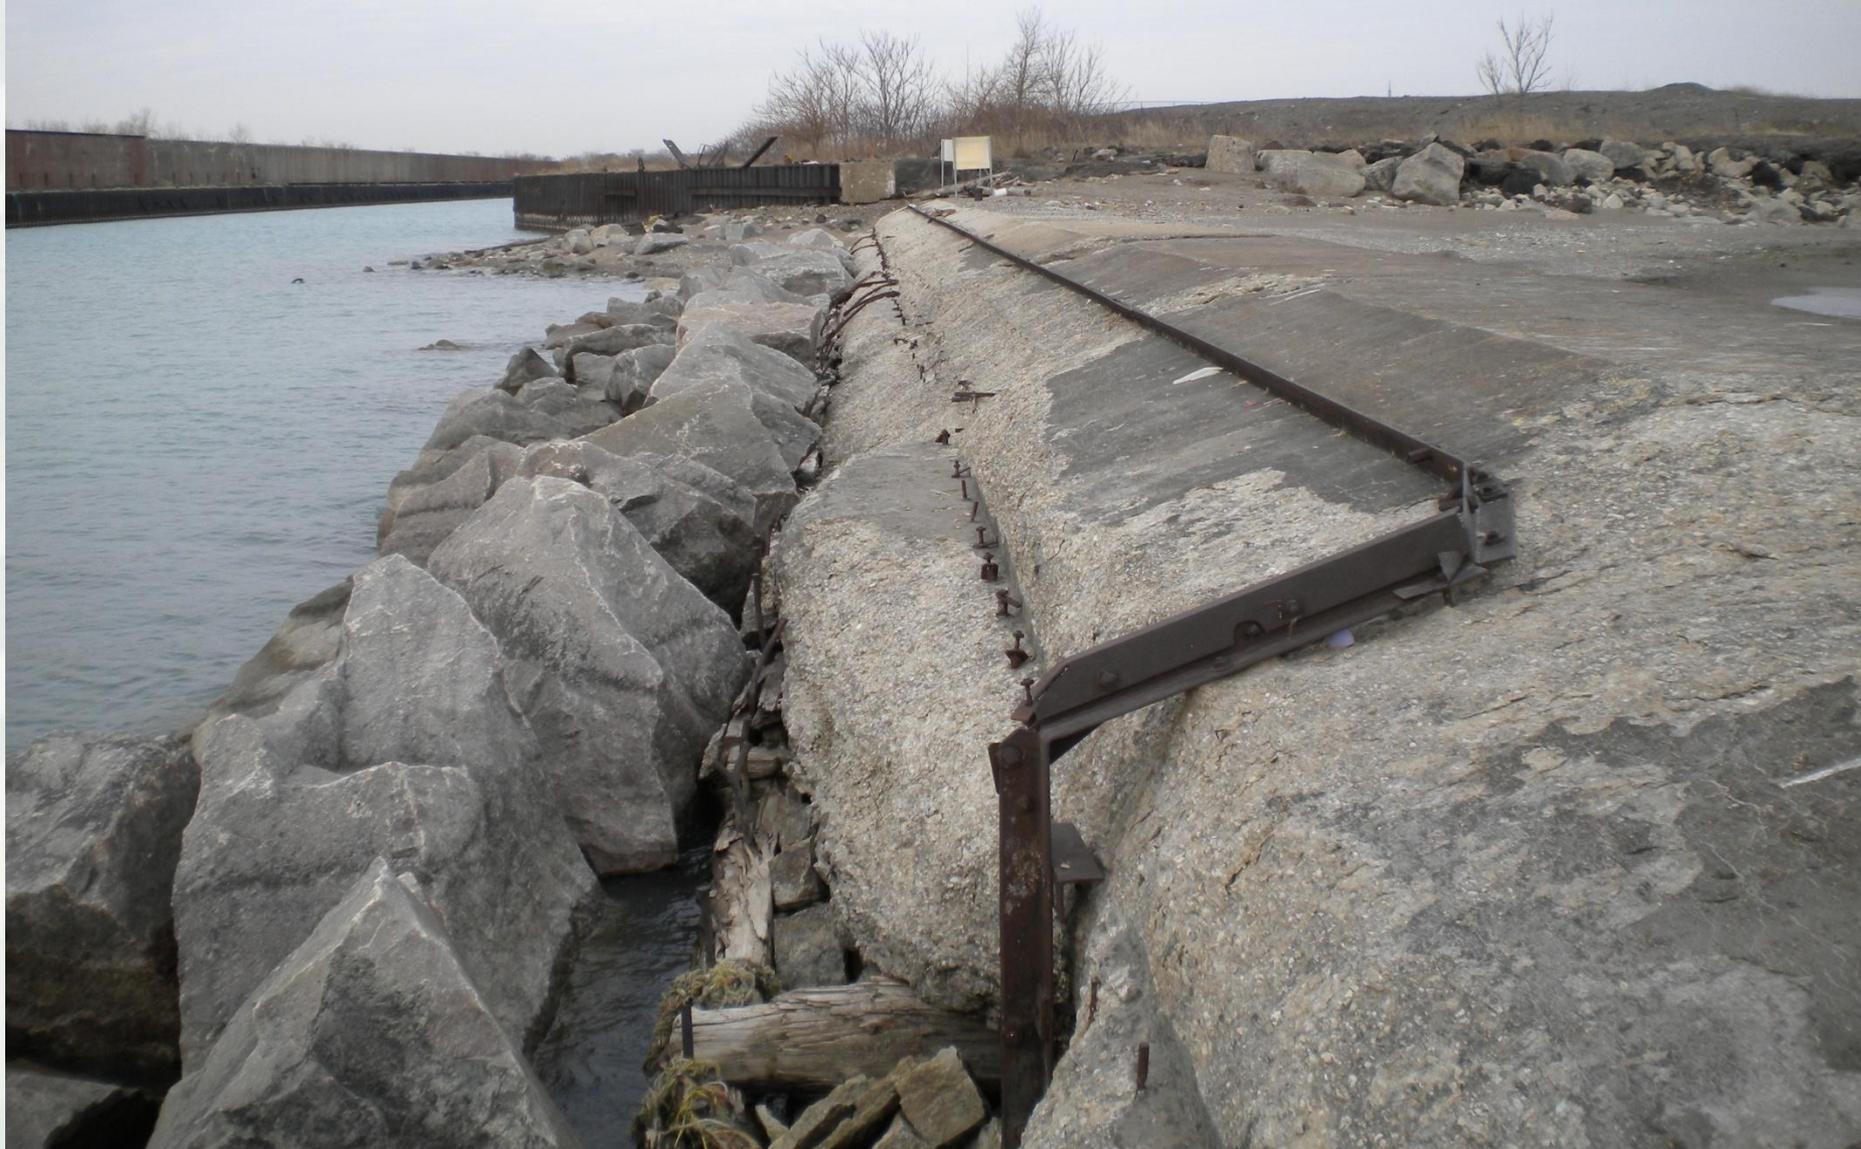
Exposed timbers due to extreme spalling along Crib Breakwater Reach A

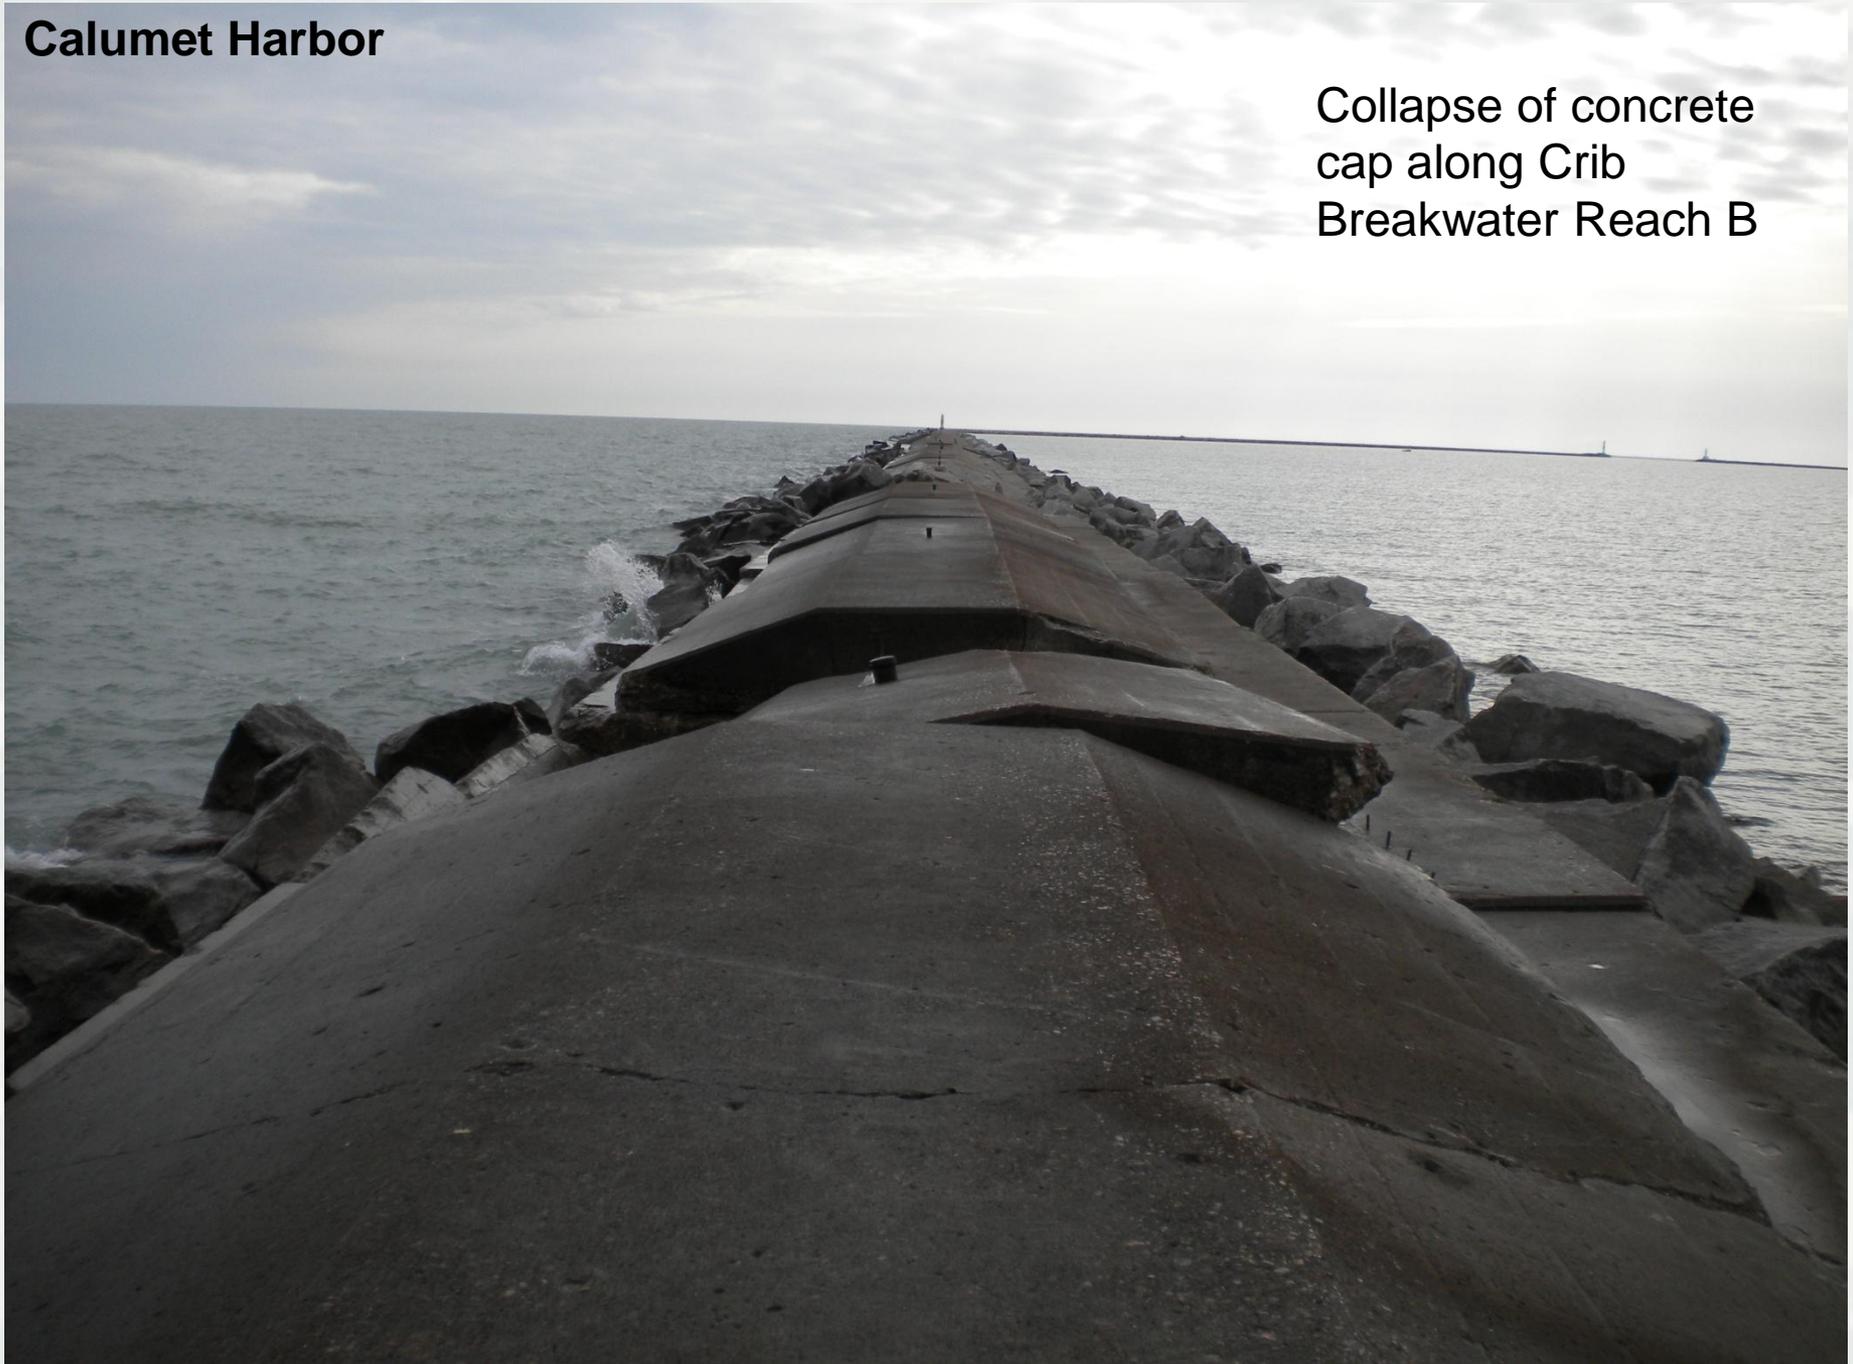
Collapse of concrete  
cap along Crib  
Breakwater Reach B

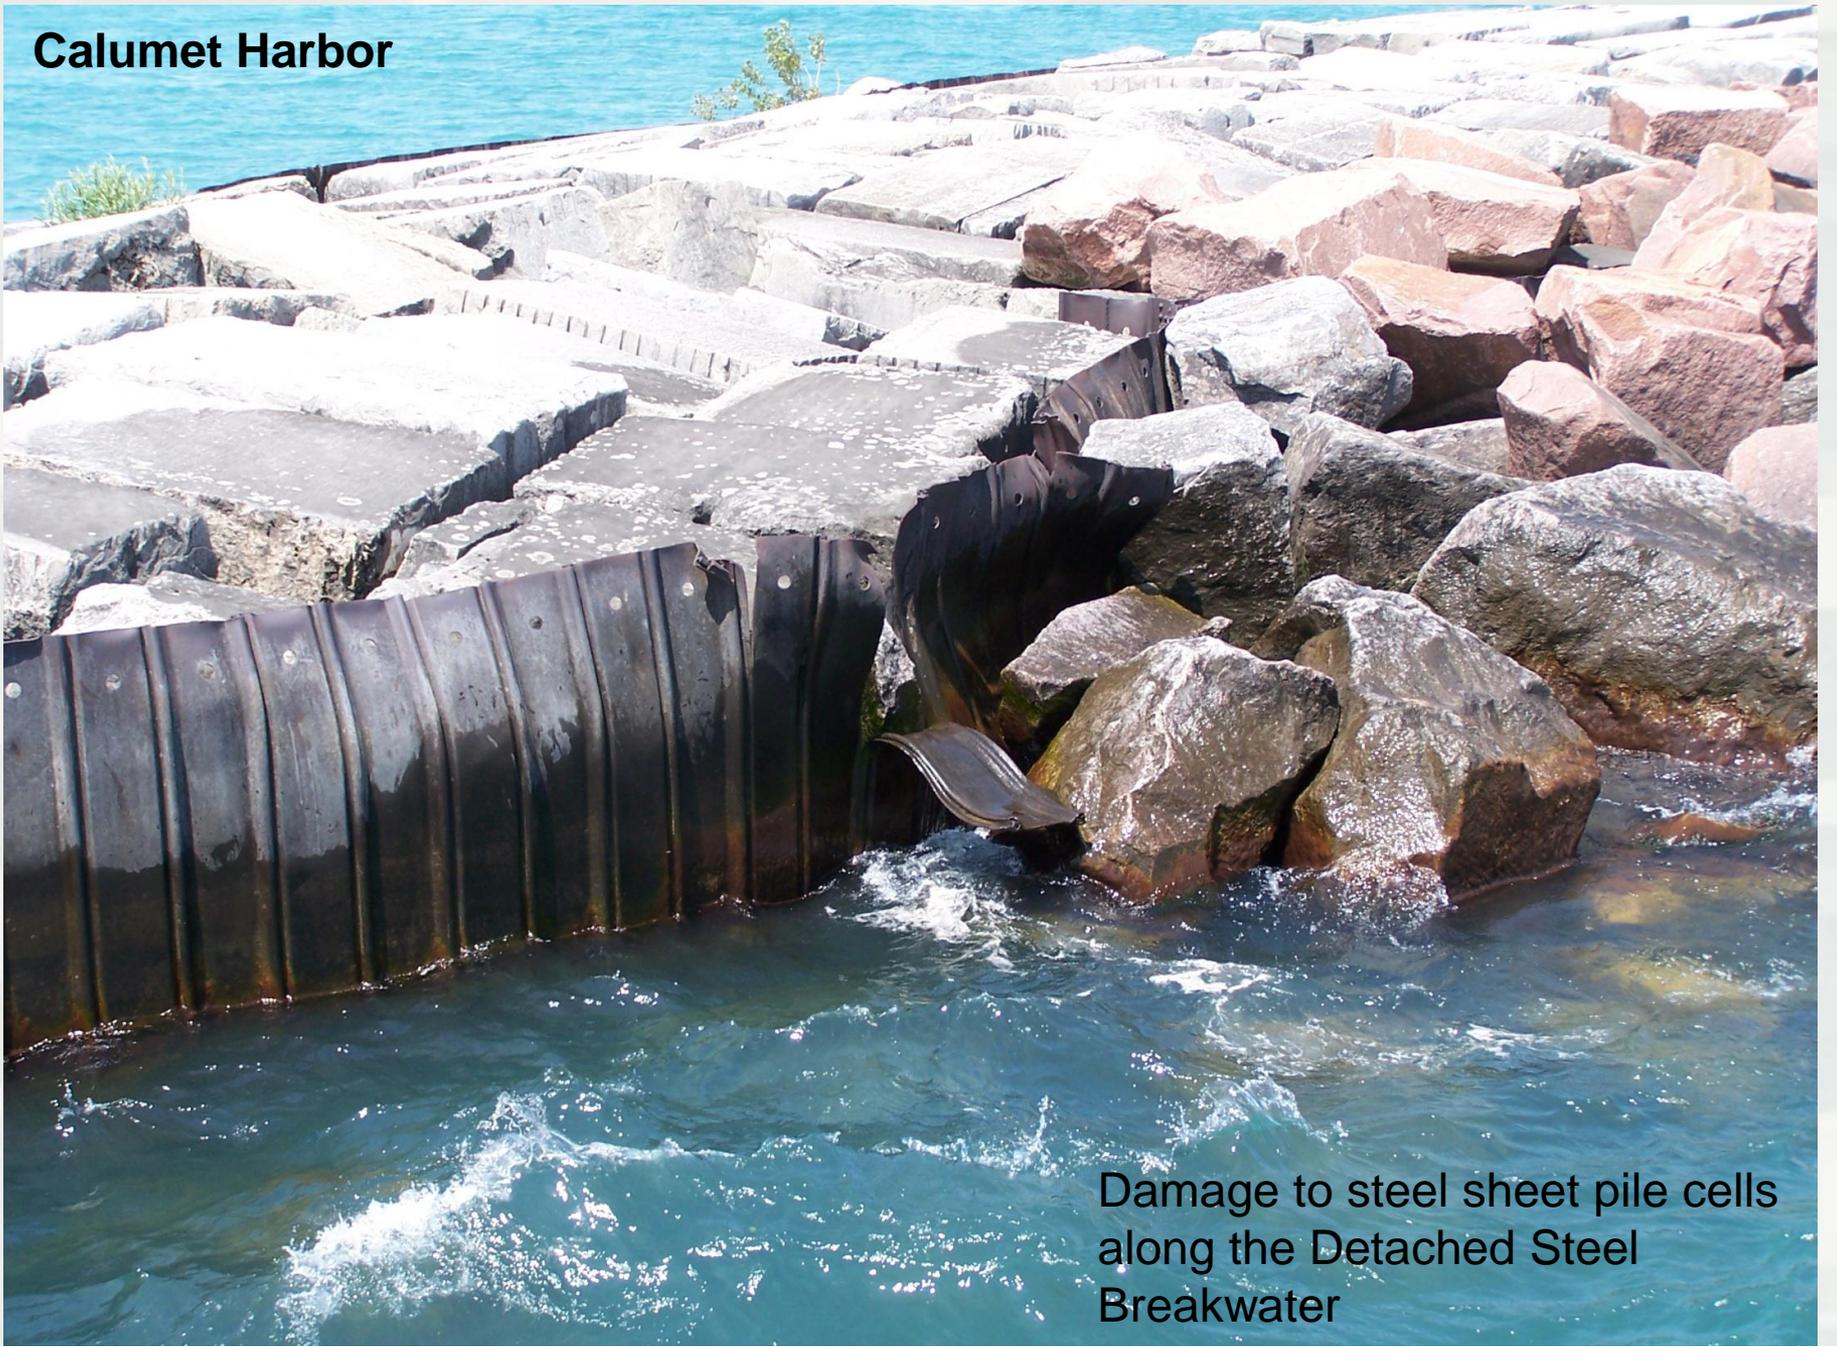
Damage to steel sheet pile cells along the Detached Steel Breakwater

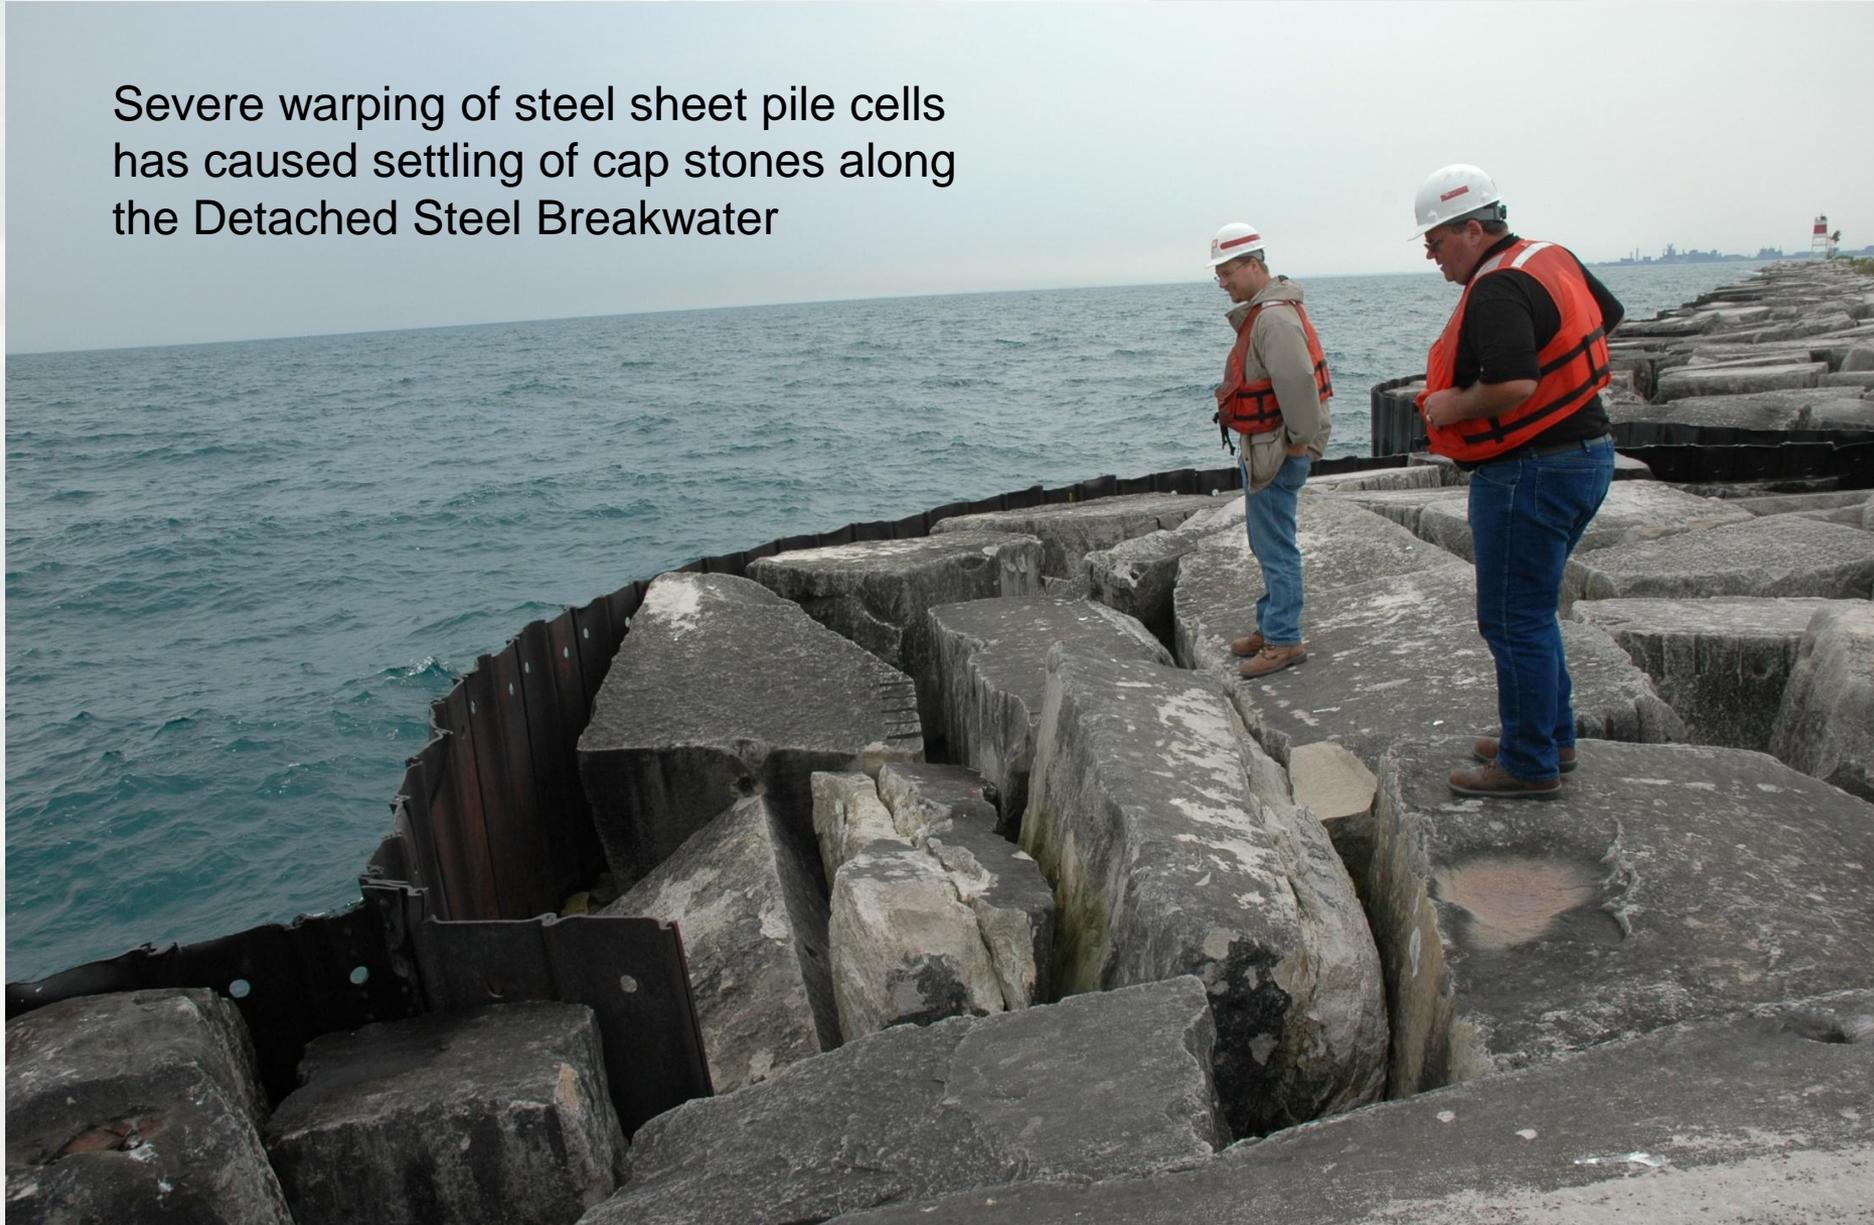
Severe warping of steel sheet pile cells has caused settling of cap stones along the Detached Steel Breakwater

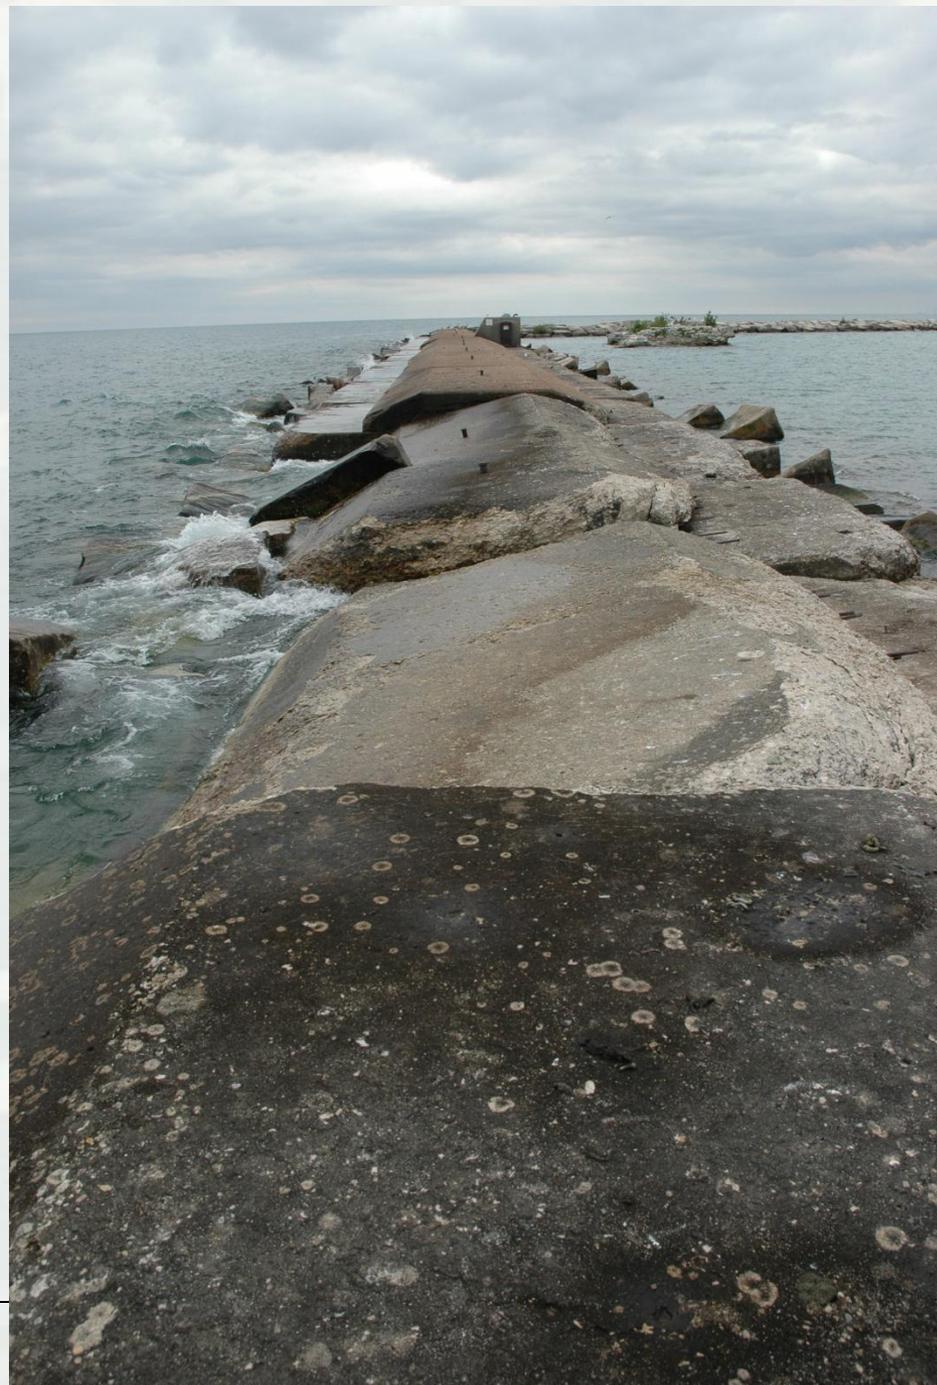
Collapse of concrete superstructure  
along Exterior Breakwater

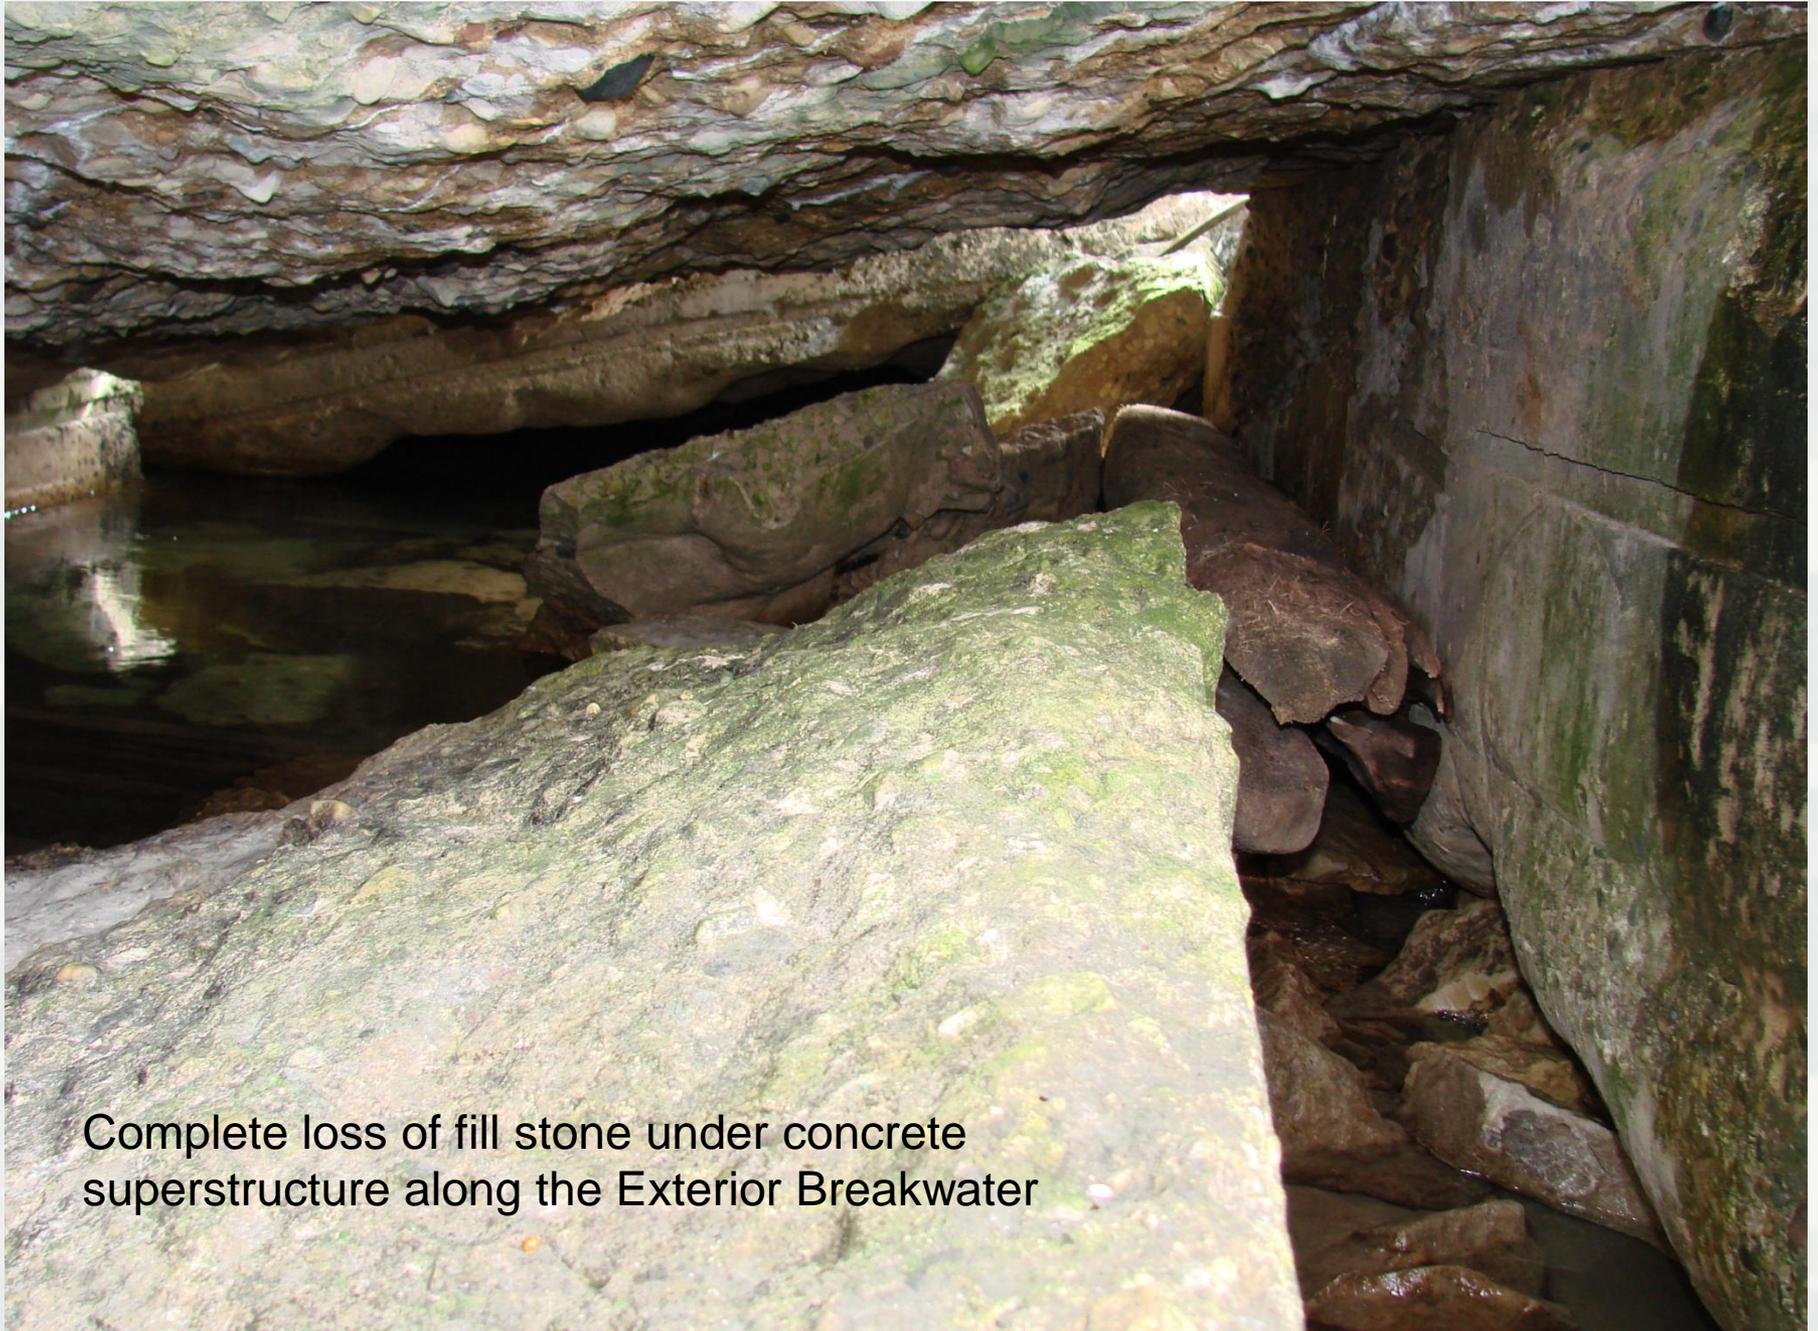
Complete loss of fill stone under concrete  
superstructure along the Exterior Breakwater
