# Coastal Structures Risk Communication Southern Lake Michigan Harbors

Dave Wright  
Chief of Operations  
Detroit District

July 18, 2012

# Harbors of Southwest Michigan & Northern Indiana & Illinois

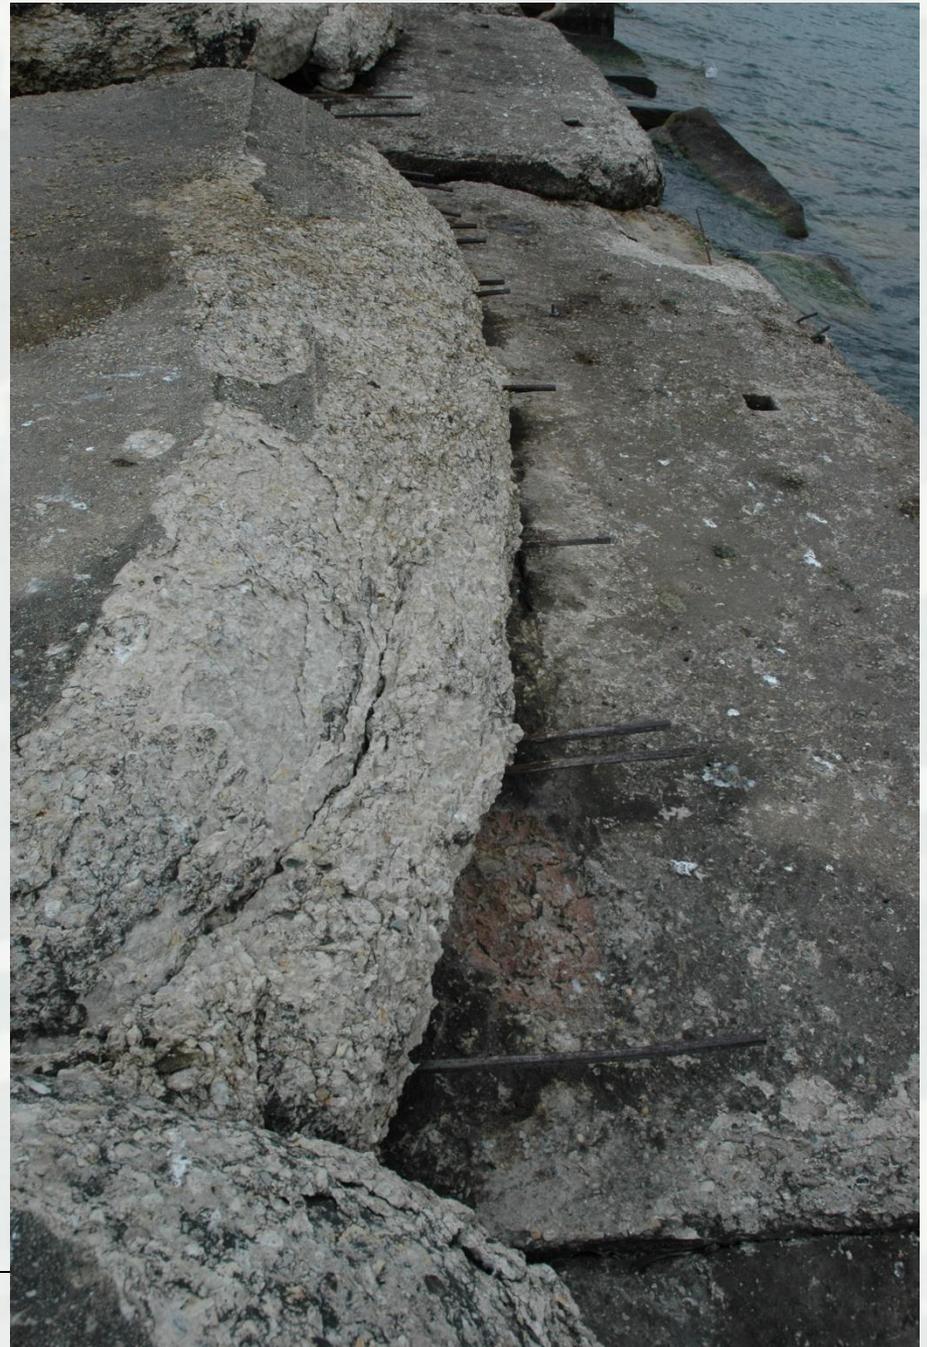
Extreme spalling and exposed rebar along the Exterior Breakwater

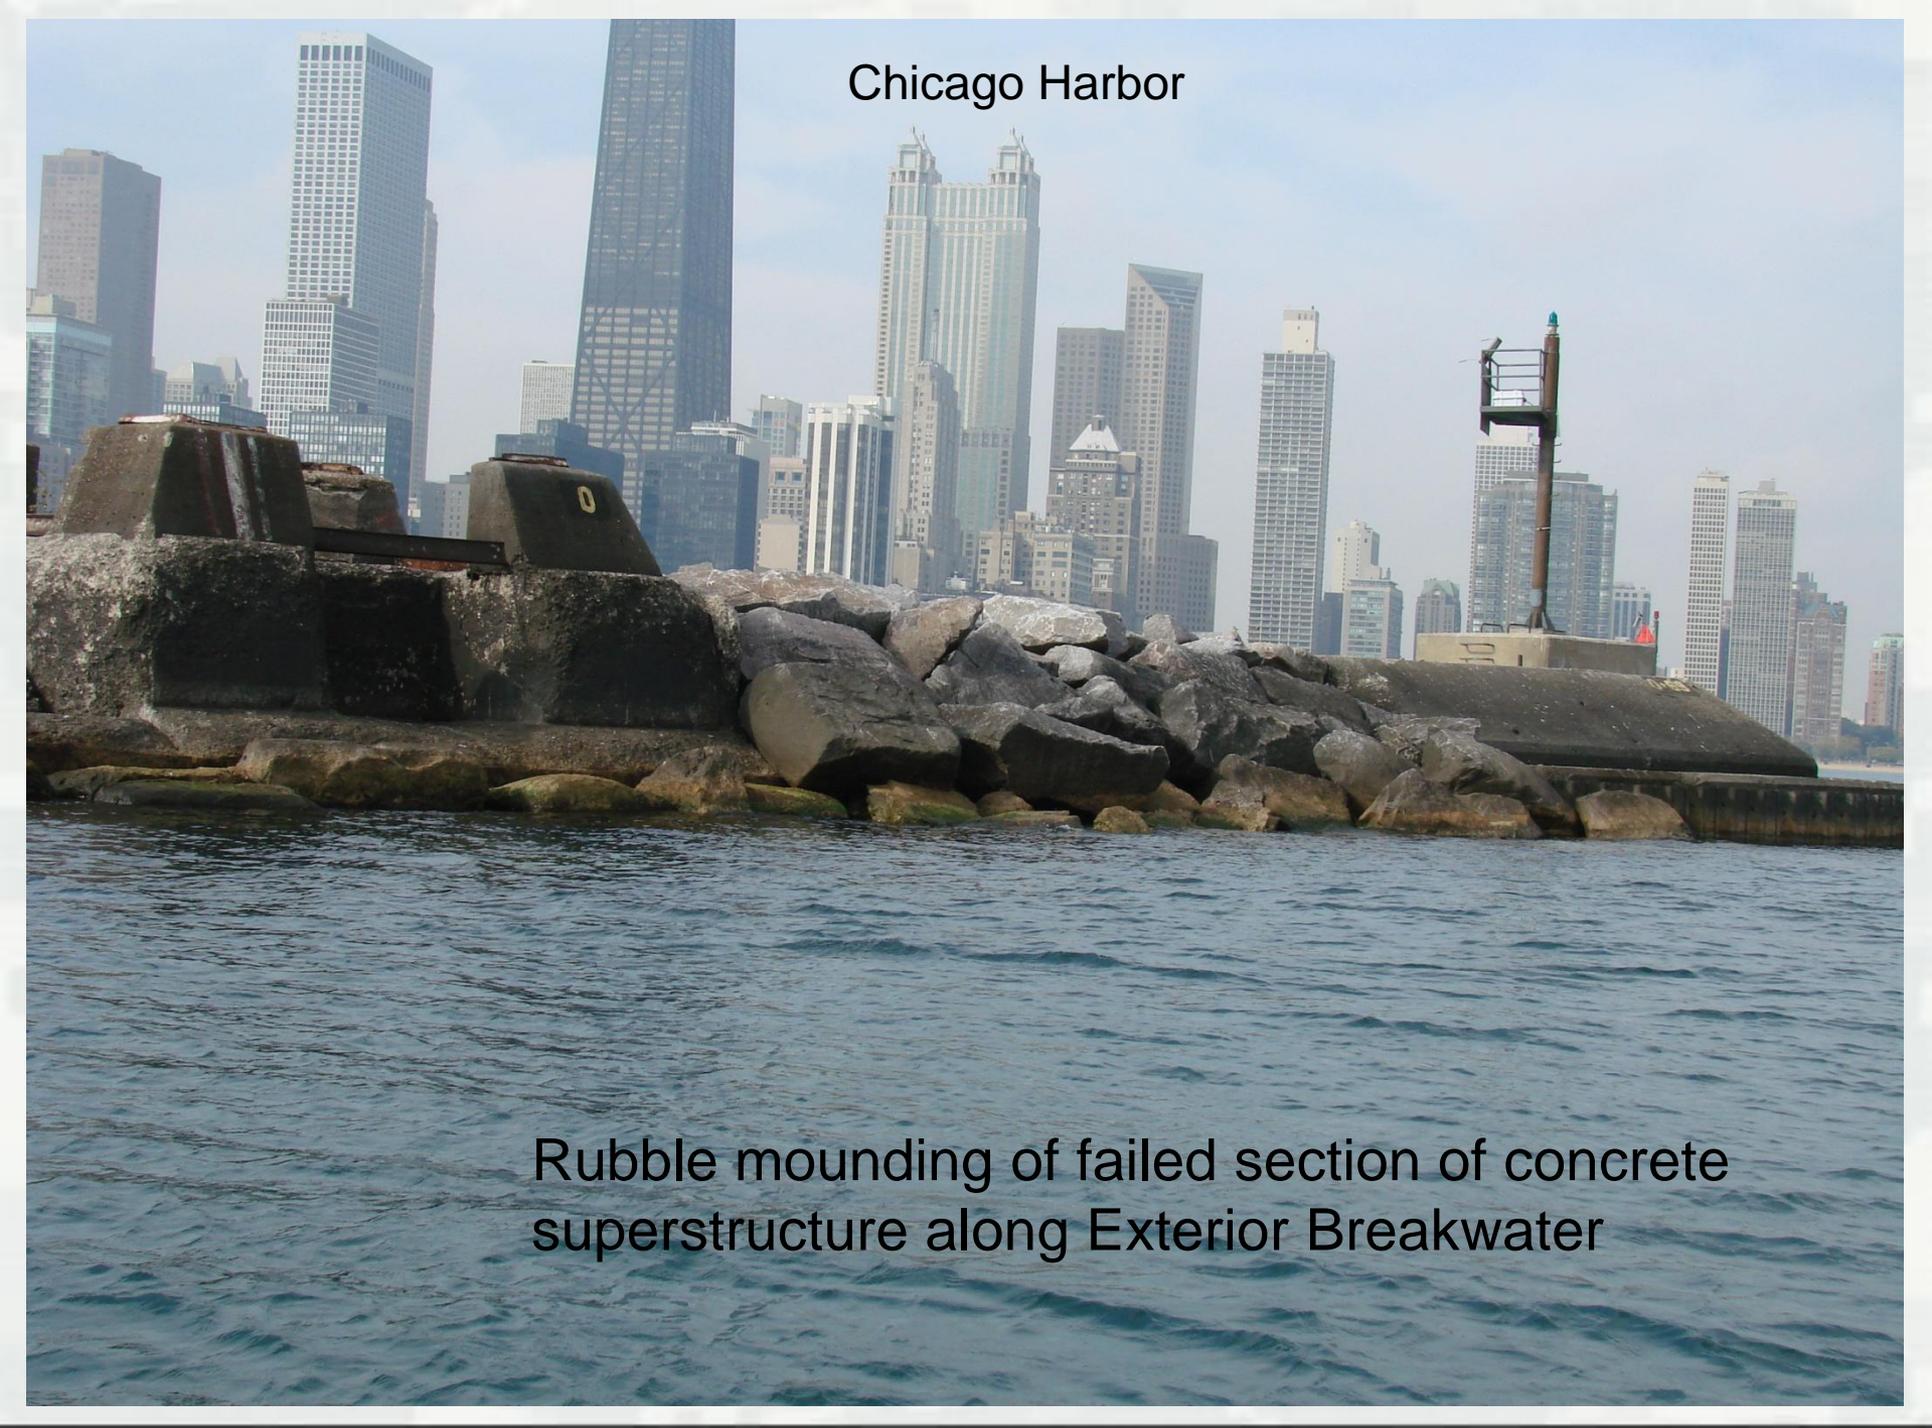
Rubble mounding of failed section of concrete superstructure along Exterior Breakwater

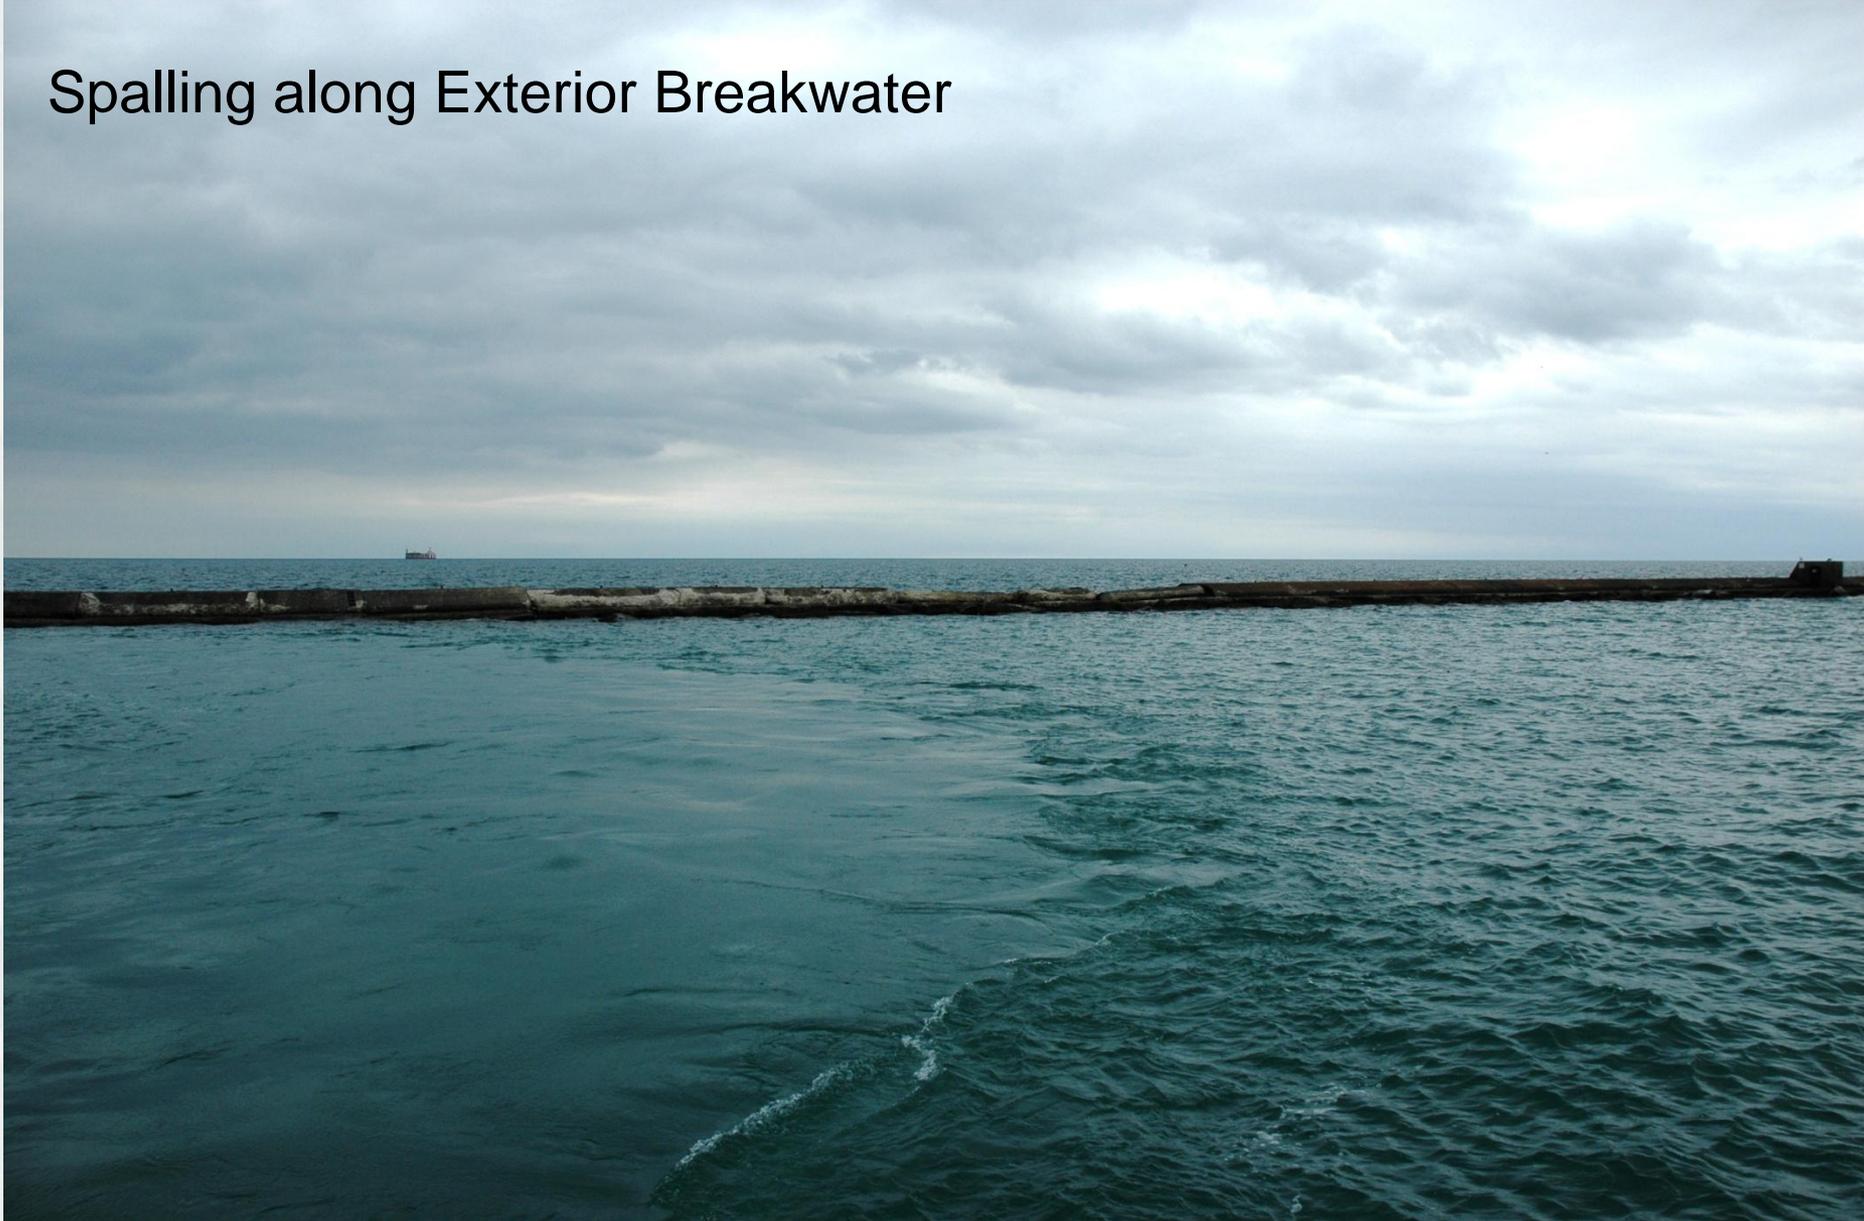
## Spalling along Exterior Breakwater

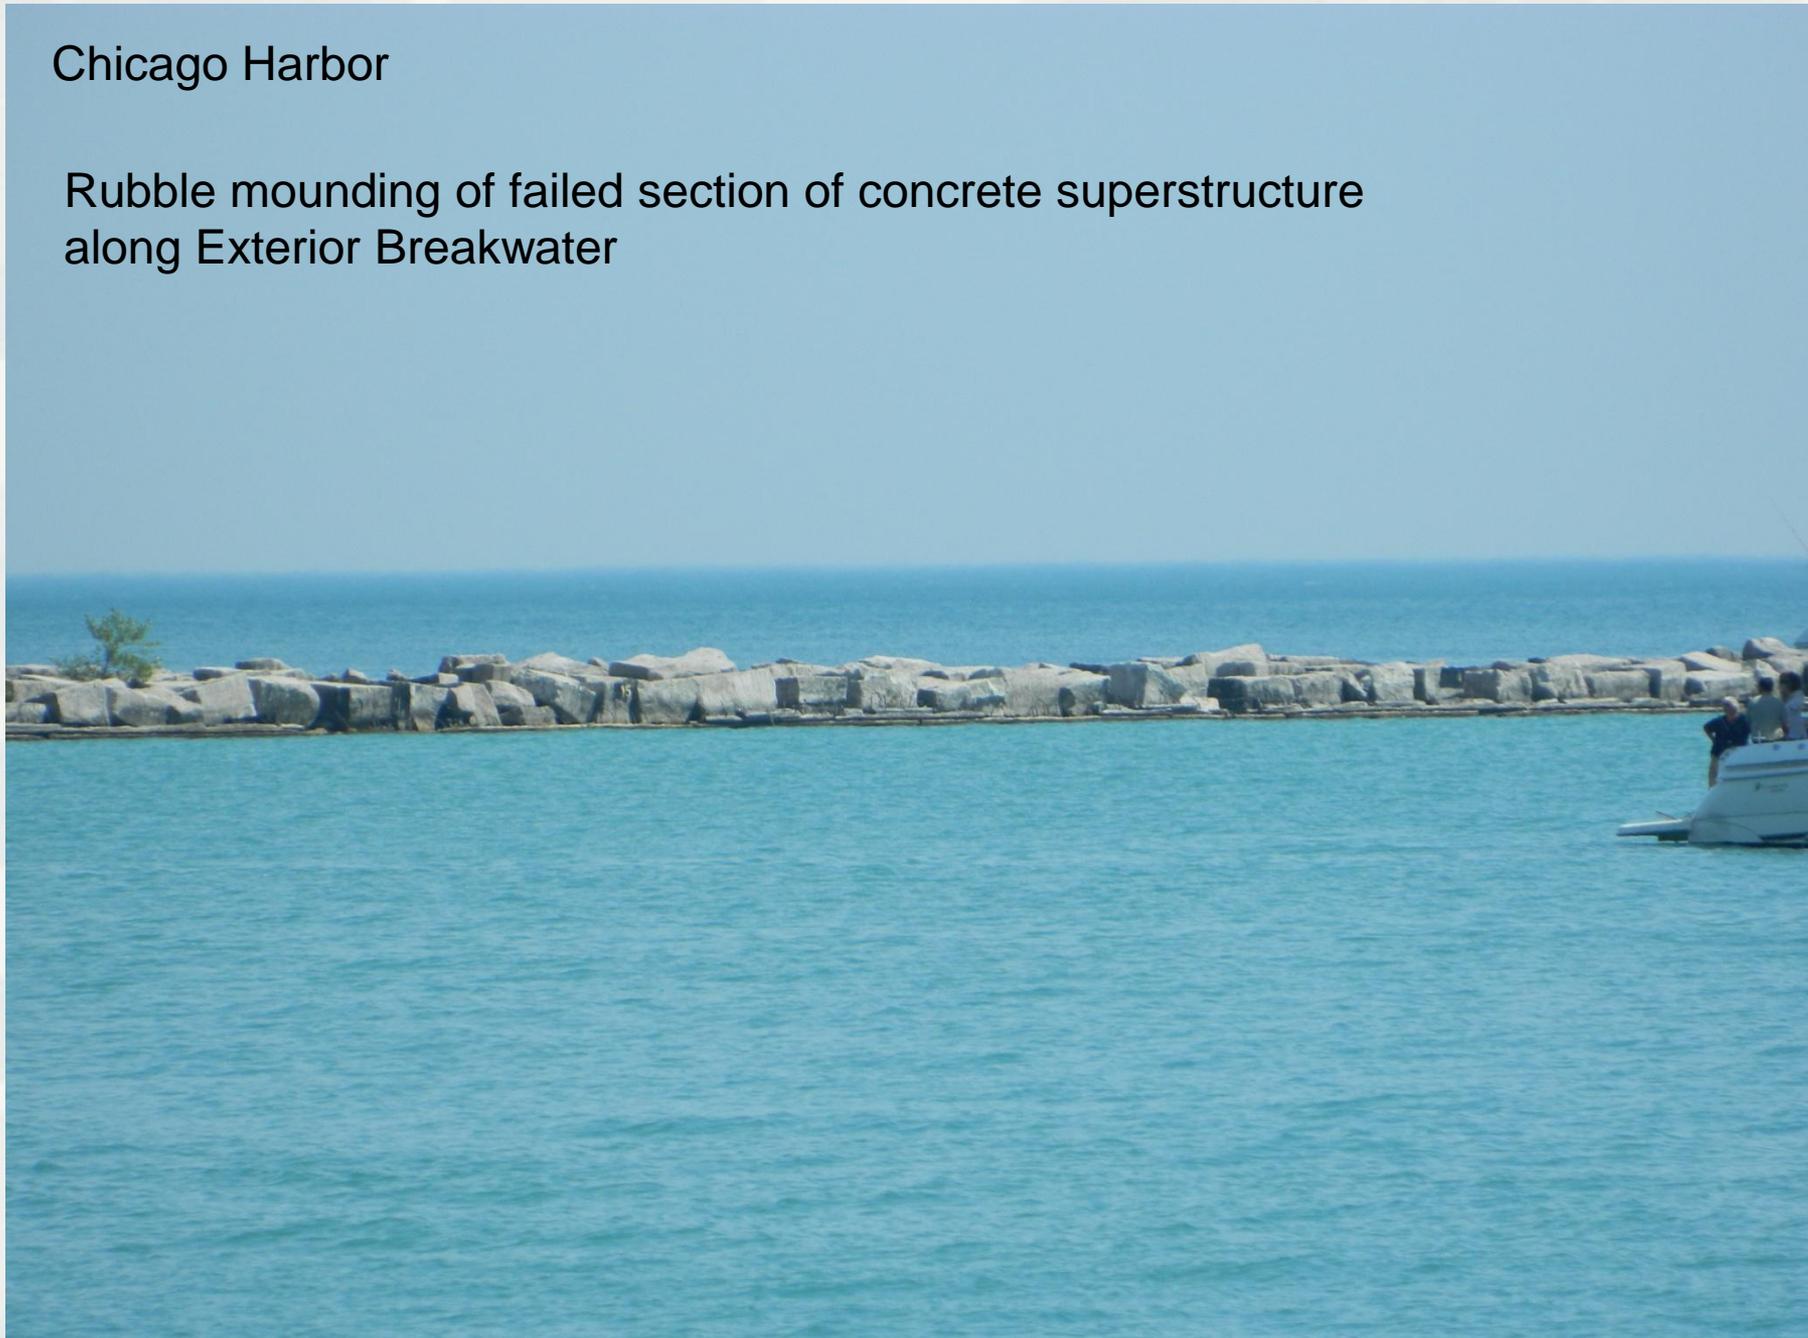
Rubble mounding of failed section of concrete superstructure  
along Exterior Breakwater

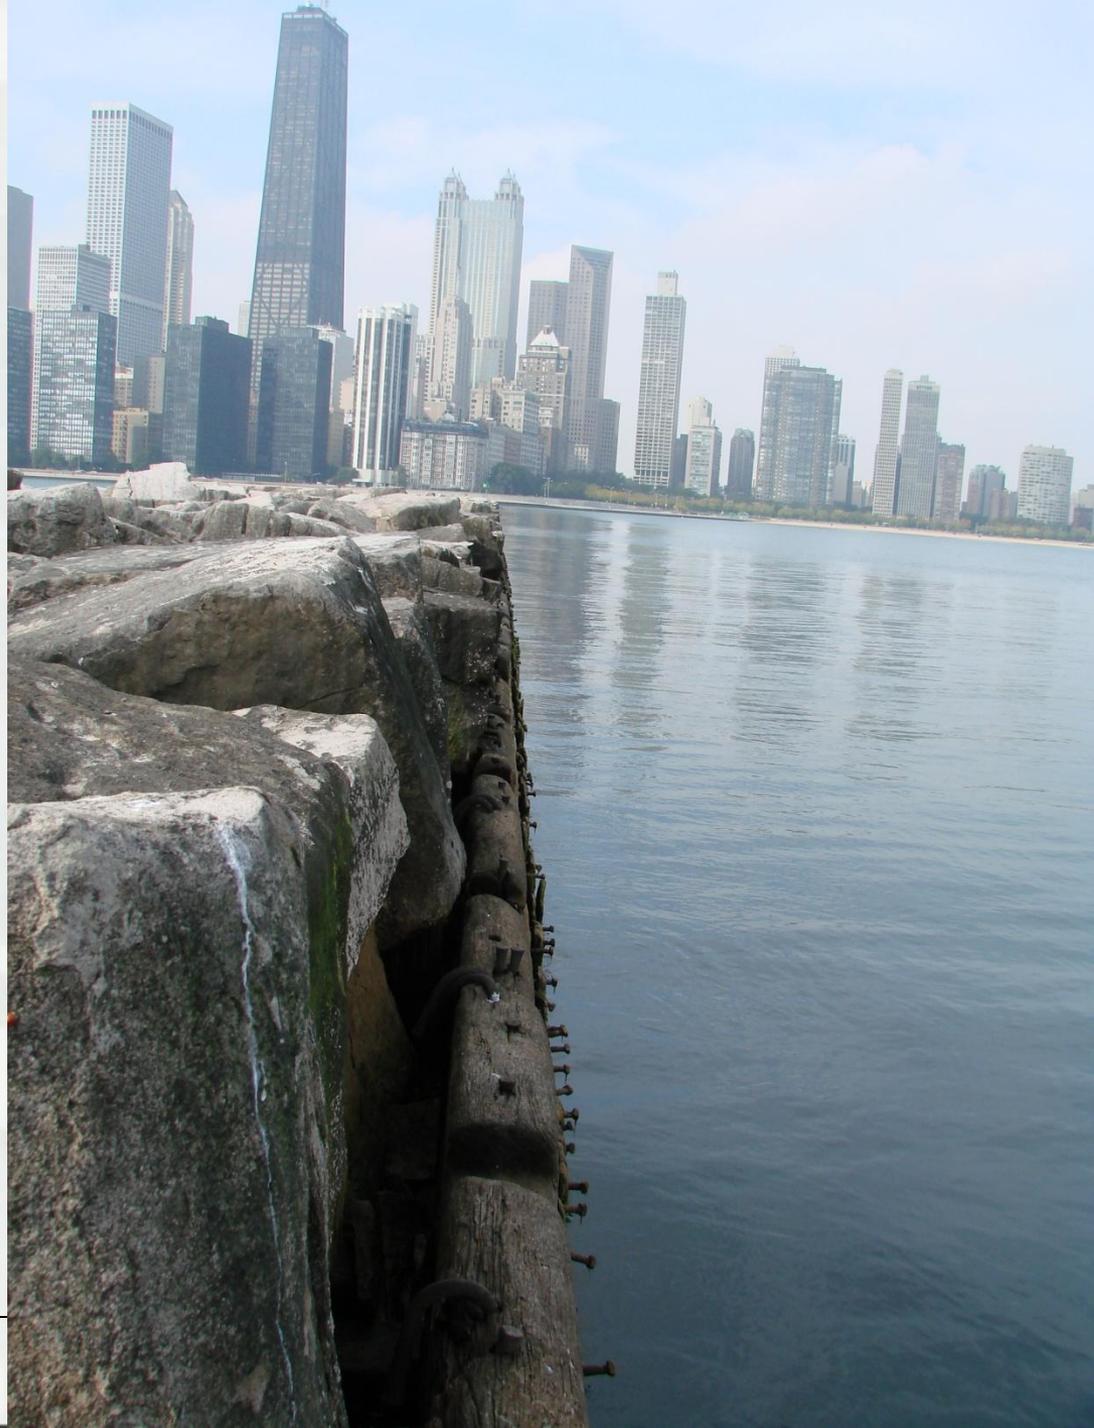
Significant timber crib exposure  
along the Southerly Extension

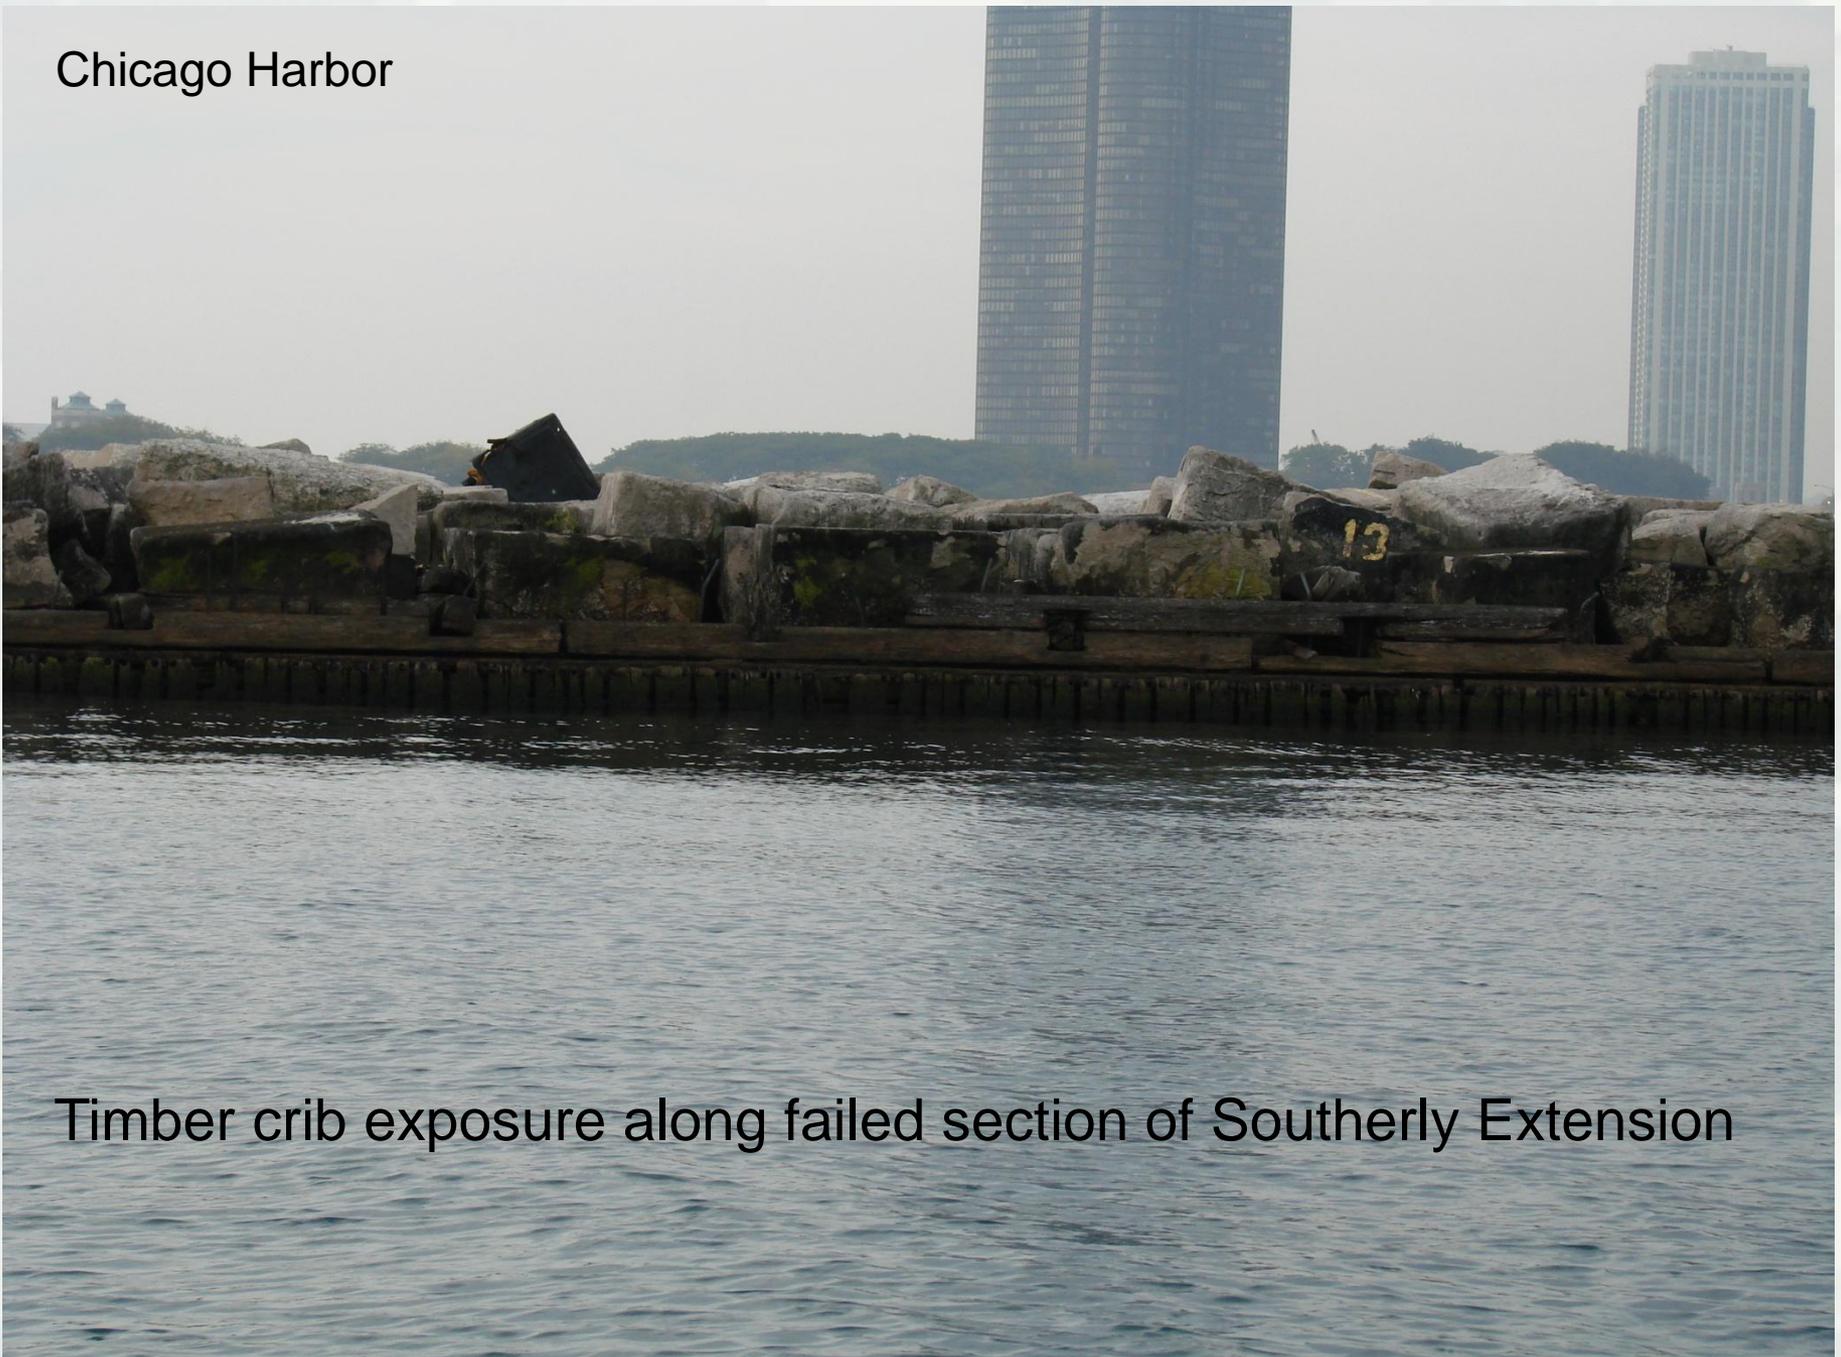
Timber crib exposure along failed section of Southerly Extension

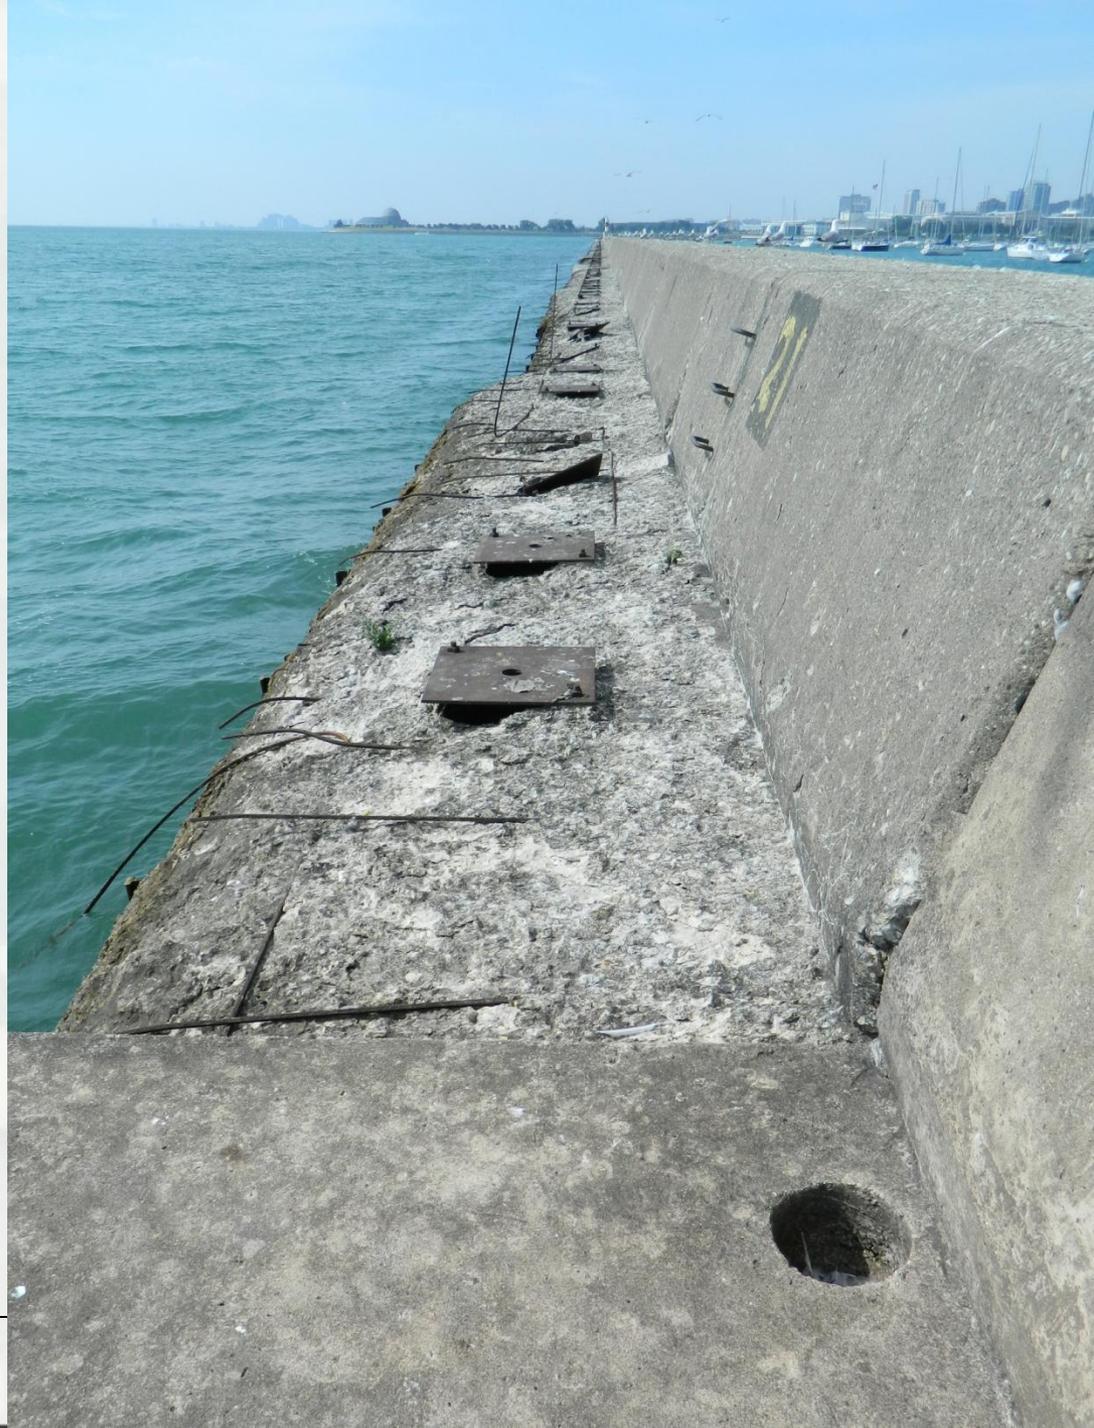
Extreme spalling and considerable exposure of rebar along Inner Breakwater
