Great Lakes Navigation System

Buffalo District

U.S. Army Corps of Engineers
Chief, Operations Branch

9 FEB 2016

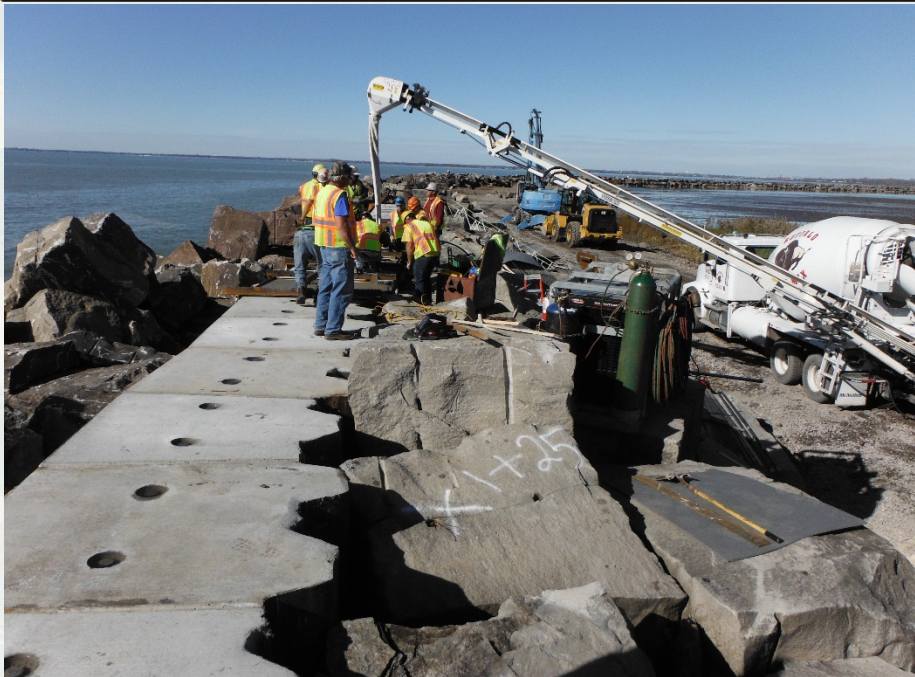
Looking down dike wall, showing finished concrete blocks and new blocks being poured.

Why: Improve the structural integrity of the lakeside stone dike by repurposing existing armor stone downslope, adding additional grouted and non-grouted stone underlayers, casting concrete blocks at the crest, and placing new armor stone on the lakeside crest.

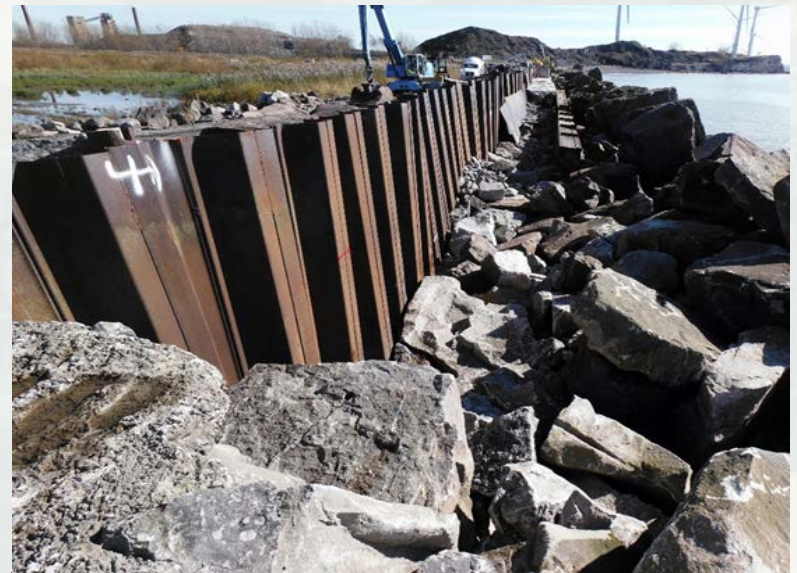
Looking toward shore, showing old armor removed and underlayer installed. Further out you can see that the underlayer has been grouted.

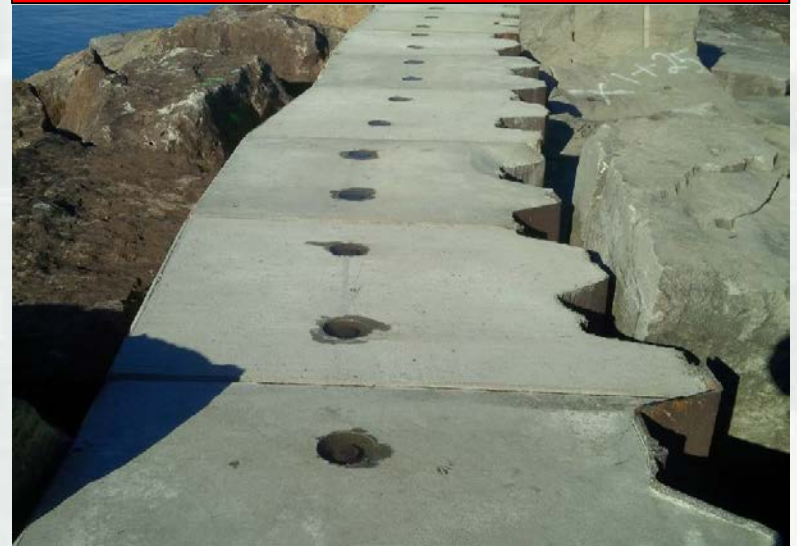
Finished reach with new armor stone placed on lakeside of the crest. At the end of the 2015 construction season the repair will be 33% completed.

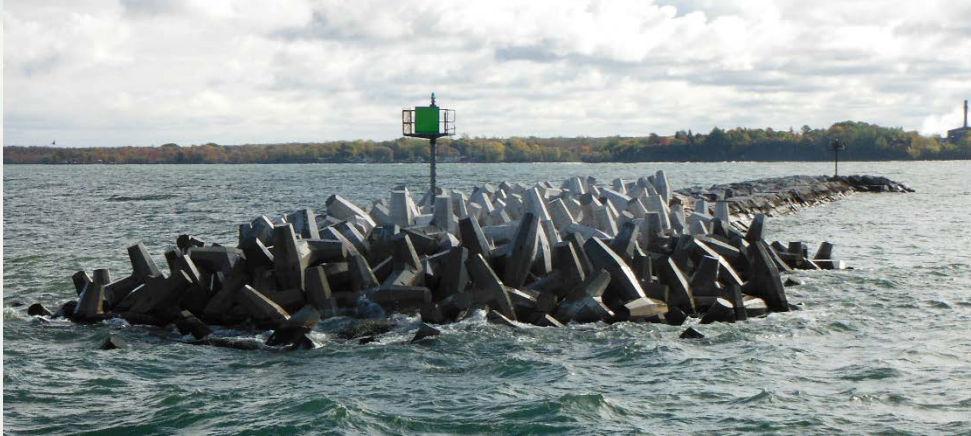
Finished Project with Dolosse at Western End

The contractor, Durocher Marine Division / Kokosing Construction Company, worked vigilantly to repair the exposed and submerged breakwater using a combination of armor stones and dolosse. All together they placed 973 dolosse, 51,863 tons of armor stone, 40,316 tons of underlayer stone, and 13,068 tons of bedding stone, and completing the project 12 months ahead of schedule.

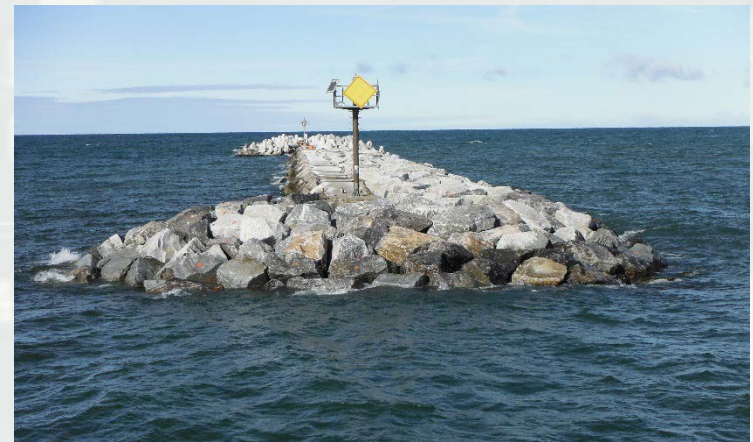
Finished Project with View of Eastern End

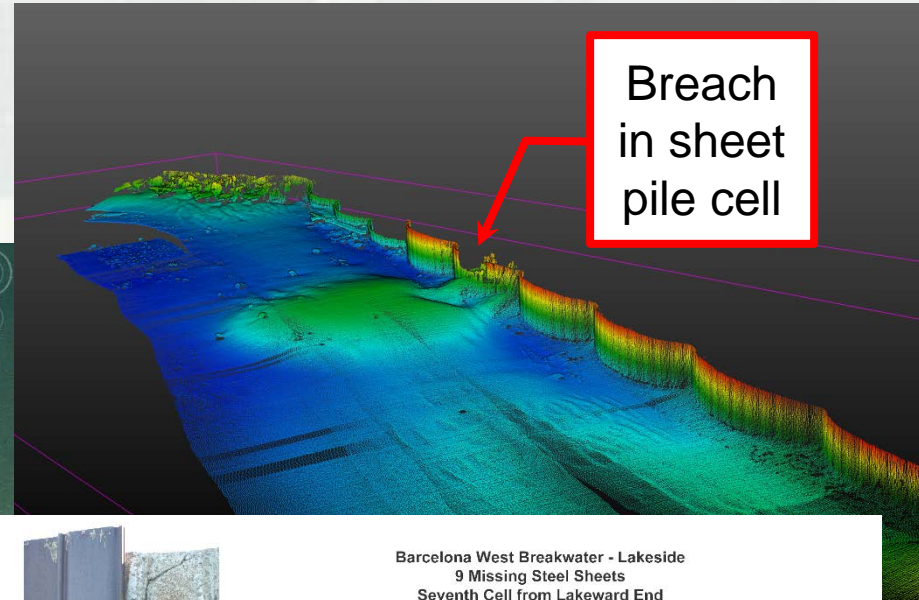
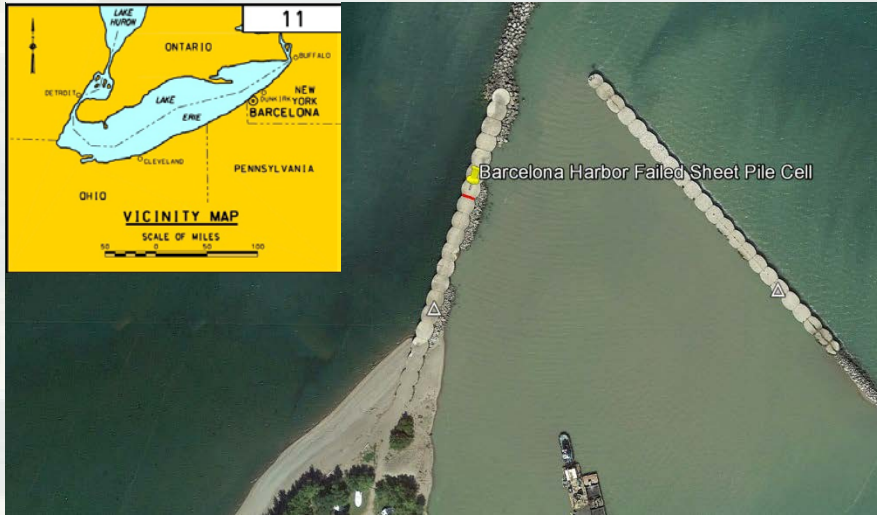
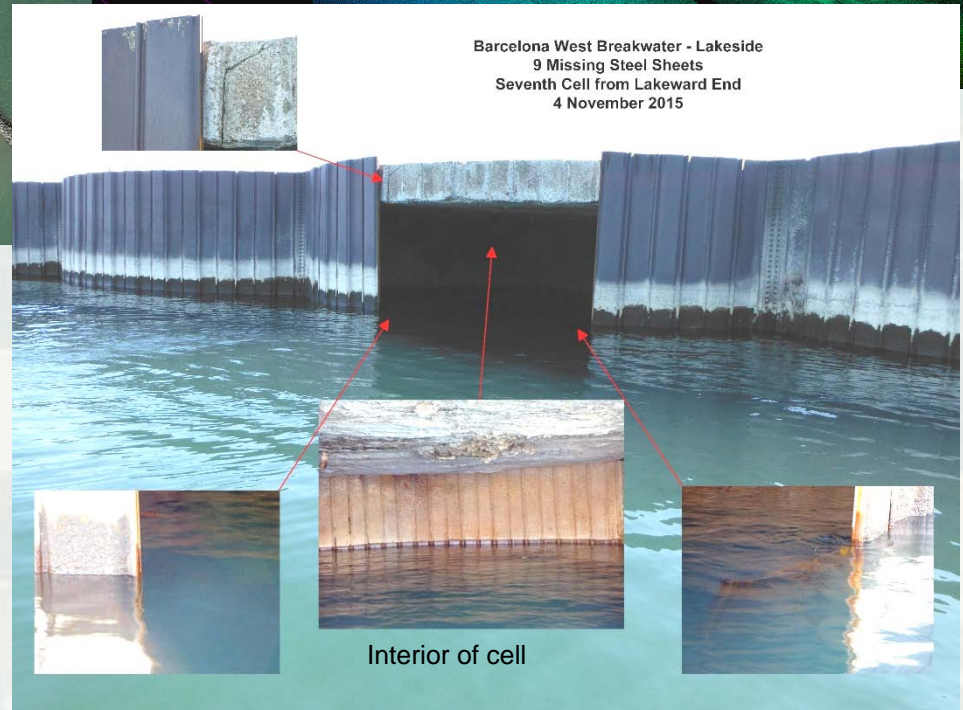
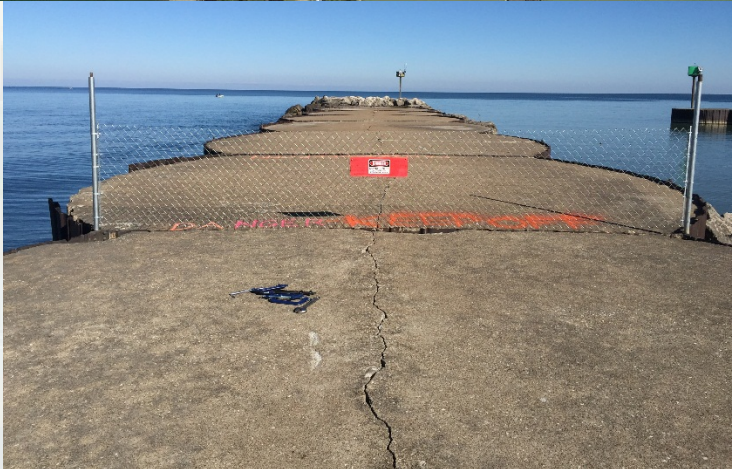
Barcelona Harbor, NY

Cellular sheet pile failure was caused by storms of 29 OCT – 02 NOV.
Complete loss of internal fill down to water line left the concrete cap suspended only by edge friction. LRB staff mobilized on 04 NOV, assessed the structure condition, and closed the structure to public access due to danger of collapse. A request for emergency repair funds is being prepared.

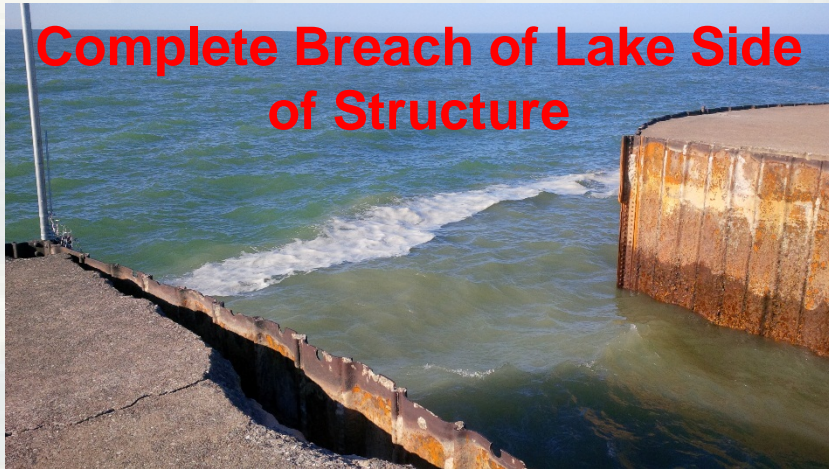
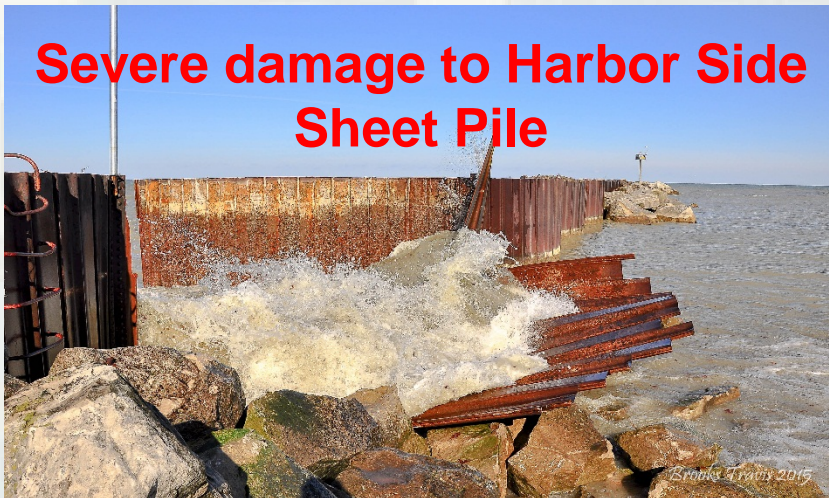
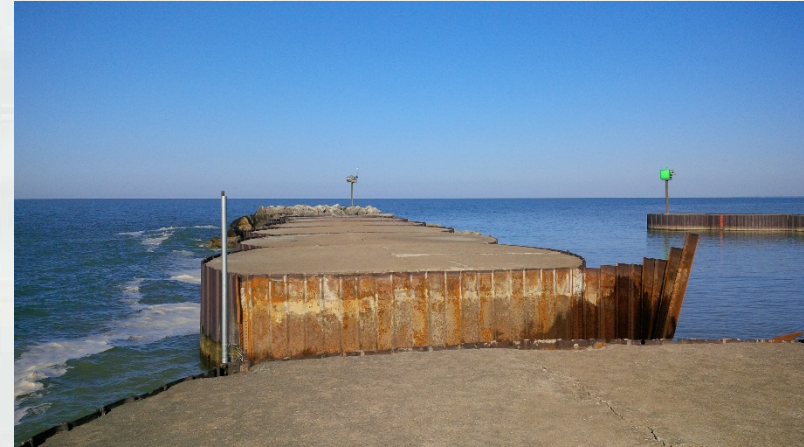
Barcelona Harbor, NY

Cellular sheet pile failure worsened during the storm of 12–13 NOV. LRB staff made a site visit on 16 NOV to document the additional damage and consult with local stakeholders. Complete loss of the lake side sheet pile and the concrete cap occurred. The harbor side sheet pile was severely damaged and the cell effectively no longer exists. Sheet pile has separated from the landward adjacent cell and it appears that there is a void of approximately 3' depth below the concrete cap of that cell. Another storm with winds of up to 50 mph is predicted for 18 NOV. An additional site survey will be conducted to determine if the damage from this storm effects the adjacent cells.

Previously damaged cell is now completely missing

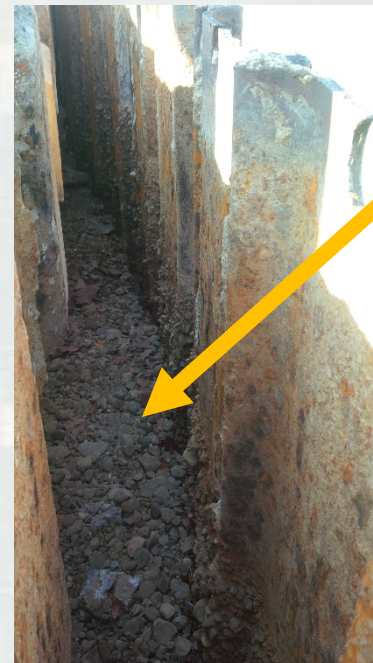
Separated sheet pile and missing fill at adjacent cell
