OPEN COAST REACH DELINEATION AND RE-ATTRIBUTION OF SHORE CLASSIFICATION MAPPING, LAKE MICHIGAN PROTOTYPE COUNTIES

LAKE MICHIGAN POTENTIAL DAMAGES STUDY

Contract DACW35-00-P-0075

DECEMBER 2000

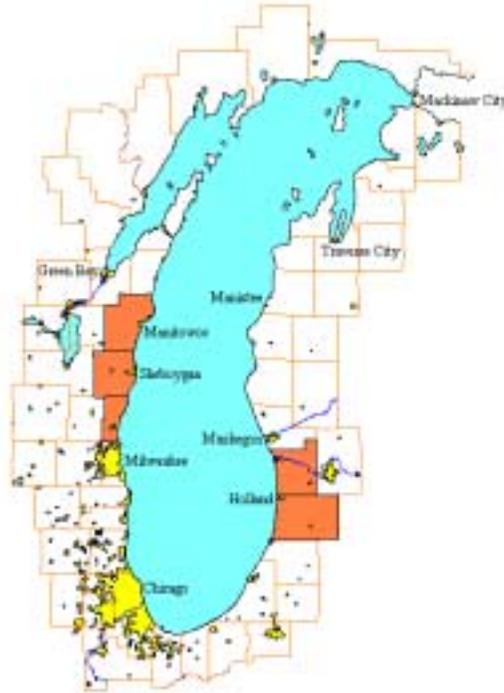
Figure 1 - Lake Michigan Prototype Counties (shaded)

In 2000, USACE Detroit District requested the re-attribution of reach and coastal zone information within the five prototype counties that have been the focus of LMPDS investigations in 1999 and 2000 (Figure 1). These were:

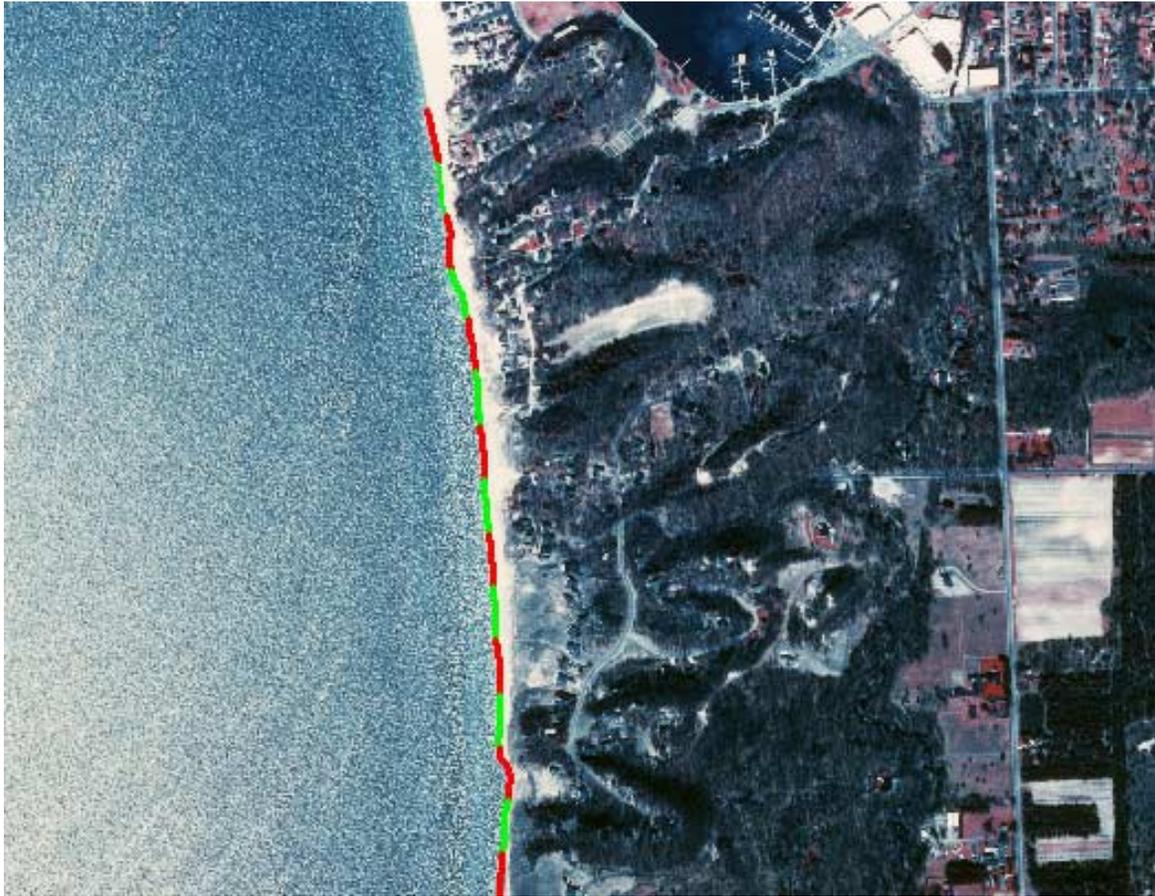
Figure 2 - New 100 m Reach Segments, Allegan County (as depicted in ArcView)

To define new reaches for each county, the new digital shoreline was imported into ArcMap and then segmented into 100 meter reach segments using the Divide Tool. For Michigan counties (Ottawa and Allegan), reaches began with a zero point at the northern border of the county. For Wisconsin counties (Sheboygan, Manitowoc and Ozaukee), reaches began with a zero point at the southern border of the county. This was in keeping with the original clockwise progression of reach numbering around the lake. This new segmented shoreline shape file was then brought back into ArcView as a separate GIS coverage for each county (see Figure 2).

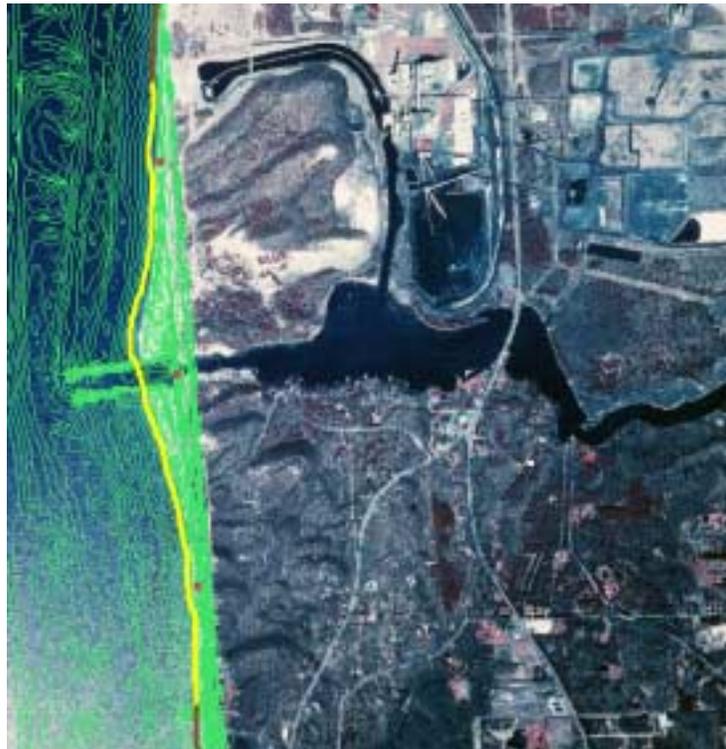
Figure 3 - SHOALS Data Being Used for Nearshore Re-Attribution

To obtain more detail on nearshore bathymetry and potentially better definitions of nearshore geology, USACE Detroit undertook the collection of bathymetric LIDAR (light detection and ranging) data using the USACE Scanning Hydrographic Operational Airborne Lidar Survey (SHOALS) system for the five prototype counties. Processing of the SHOALS data was completed in early 2000 and was used in this activity as a data source for determining the transition zones between different nearshore geologic shore types. Unfortunately, due to poor weather conditions prior to the SHOALS survey, complete coverage in the targeted areas was not achieved. Also, where SHOALS data was collected, high turbidity in harbor entrance areas and in some nearshore areas prevented the light beam from penetrating to obtain a bottom depth reading. As such SHOALS data was unable to be used in some areas.

Where SHOALS data was available, it was used in conjunction with the original nearshore classification data to try and accurately determine the transitions between different nearshore types. Both data sets, along with the new digital shoreline, were imported into ArcView (Figure 3) and where the original data sets showed a change from one shore type to another, the SHOALS contours were examined to see if they could assist in determining a more precise location of the change.
