US Army Corps
of Engineers
Detroit District

Great Lakes Update

Winter Work at the Soo Locks

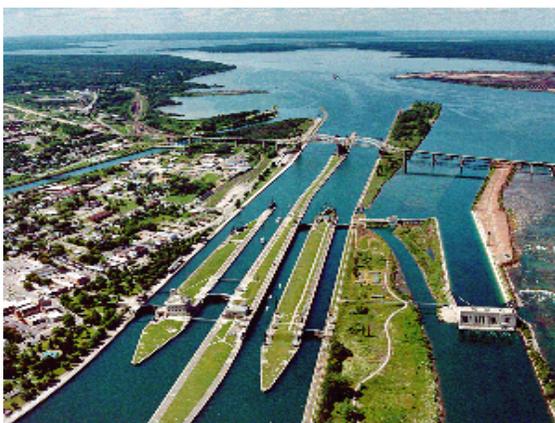
Figure 1: The World Famous Soo Locks

Currently the Soo Lock complex is made up of 4 navigation locks, the unused Sabin, the seldom used Davis and the heavily used MacArthur and Poe Locks. The MacArthur is the smaller of the two measuring 800 feet long and 80 feet wide. The larger Poe Lock is 1200 feet long, 110 feet

wide and has a water depth of 32 feet. It is the only lock on the Great Lakes able to accommodate a 1000-foot freighter.

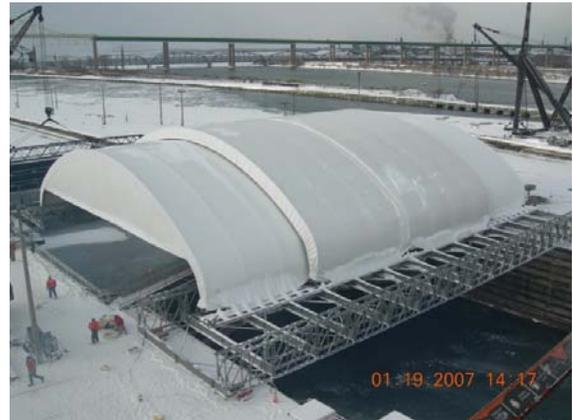
A large temporary tent (Figure 2) was installed this year to create a climate controlled environment for workers. It turned out to be very beneficial as temperatures plunged to sub-zero readings during much of the work. Blizzard conditions also would have made much of the work impossible without the tent.

Figure 2: Tent enclosing the upper gates on the Poe Lock.

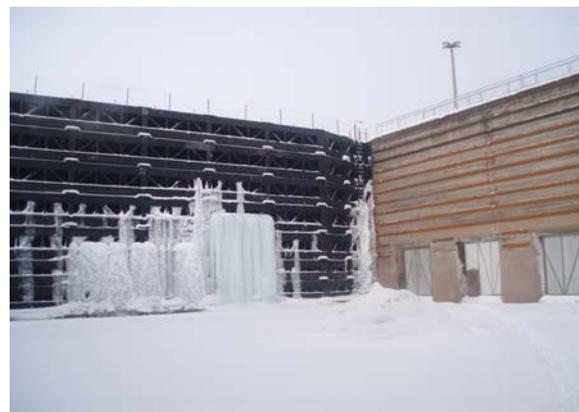
Before much of the work began on the lock, it was dewatered. This is accomplished by installing a temporary wall just upstream of the upper lock gates to stop the flow of water into the lock. This wall is made up of several large steel structures called stop logs (Figure 3). When stacked, the stop logs act as a temporary dam, preventing water from passing. The stop logs were installed using permanent cranes located at the upper end of the lock complex.

Figure 3: View of the stop logs from the bottom of the dewatered Poe Lock. The stop log structure is approx. 60 feet in height.

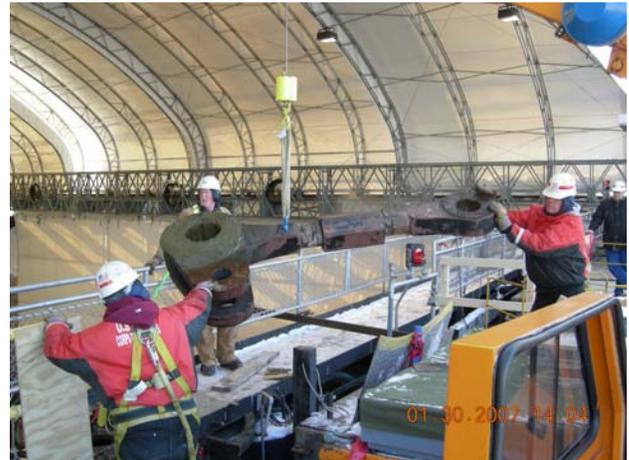
After dewatering, the work on the gate began. One of the first tasks was to lift the gate in order to inspect and remove the mechanisms that operate it. The gate opens and closes by rotating on a pintle. A pintle can best be described as an upright pin or bolt used as a pivot. The cause of the gate “jumping” was damage to the pintle system. To lift the massive gate, a special set of jacks was used to slowly elevate it. Once the gate was high enough, the parts of the pintle system that could be removed were taken out for inspection (Figure 5). Permanent parts were inspected in the tent structure.

Figure 5: Workers removing part of the gate pintle mechanism in the tent structure

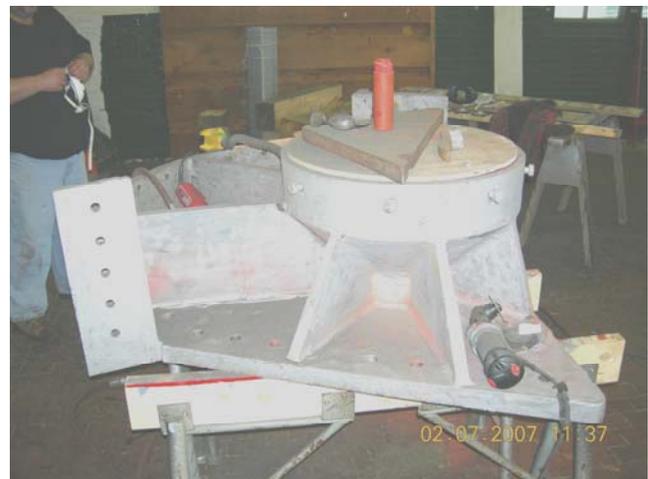
The base of the pintle is permanently embedded in the concrete making up the lock. It was found that parts of this base had considerable wear. This wear was the main cause of the gate “jumping.” The excess wear allowed the gate to move more than it should. Weld was applied to the areas in question. The parts of the pintle that were removed for inspection were found to have many cracks. These cracks were repaired and the parts were reinstalled (Figure 6).

Figure 6: Pintle mechanism in the weld shop

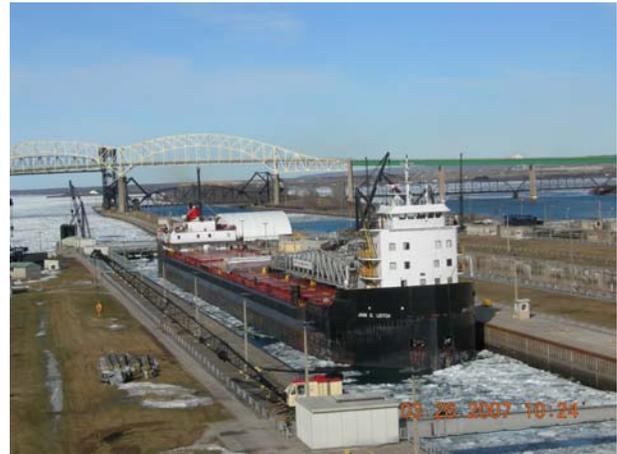
The first vessel through the refurbished Poe Lock was the bulk carrier Roger Blough of the U.S. Fleet. The Blough was down bound for Gary, Indiana with a load of taconite pellets. It is estimated that approximately two dozen vessels utilized the Poe during the first few days of the navigation season (Figure 7).

Figure 7: Vessel John D. Leitch downbound in the Poe Lock, March 28, 2007.
