U.S. PILE DIKE RUINS

SOO AREA, STRAITS OF MACKINAC
GRAND MARAIS HARBOR
FEDERAL NAVIGATION CHANNEL

GRAND MARAIS HARBOR
OLD BREAKWATER RUINS
CONDITION SURVEY

Sheet reference number:
GMH-08
Sheet 8 of 10

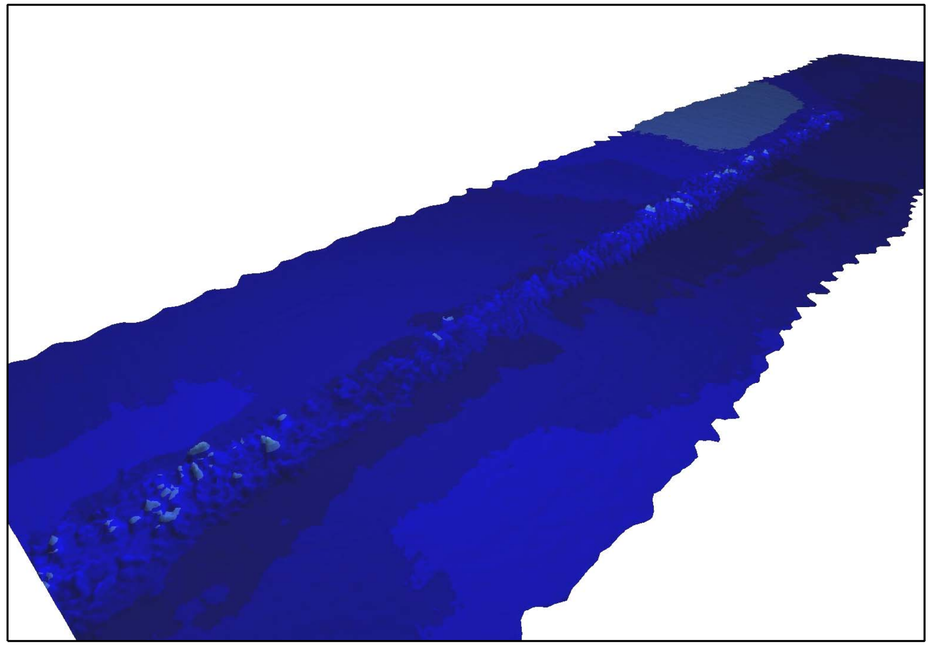
PILE DIKE RUINS LOOKING WEST TO EAST

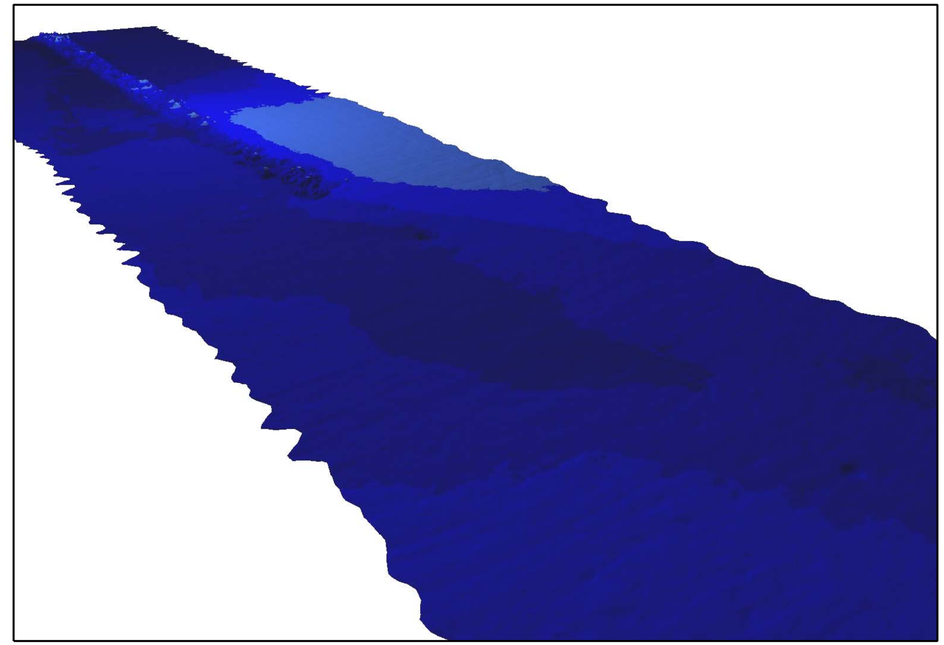
PILE DIKE RUINS LOOKING EAST TO WEST
