# Coastal Structures Risk Communication Mid-Northern Michigan Harbors

Dave Wright  
Chief of Operations  
Detroit District

May 17, 2013

# Harbors of “Mid-Northern” Michigan

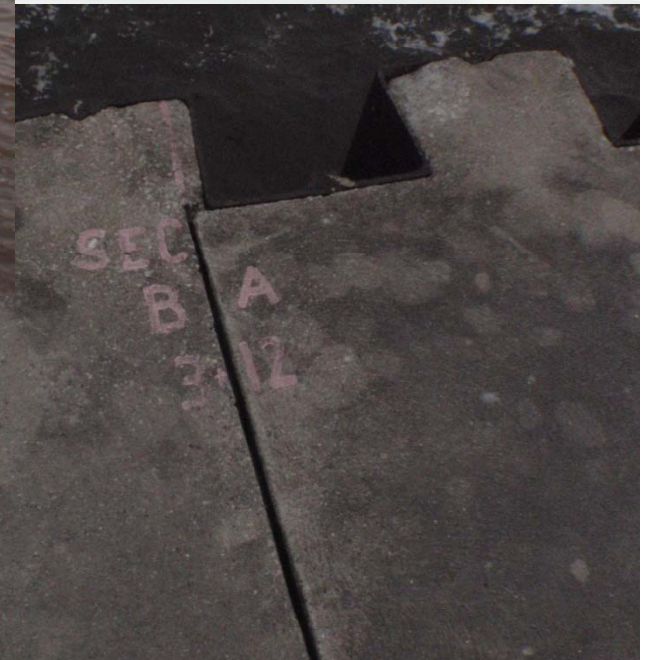
## Manistee Harbor – S. Breakwater

Heavy Spalling, chipping and cracking is increasing at and side slopes on concrete cap. Loss of crib stone is sign of timber crib damage. The crib is exposed with low water levels.

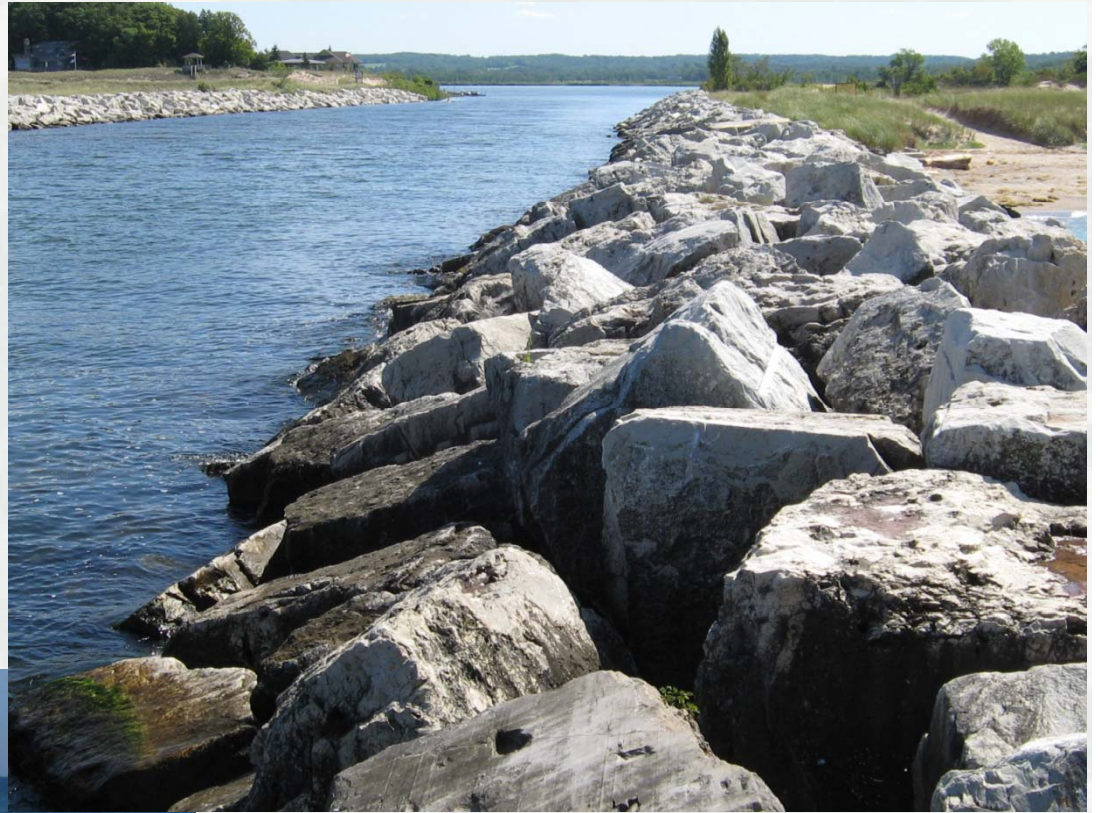
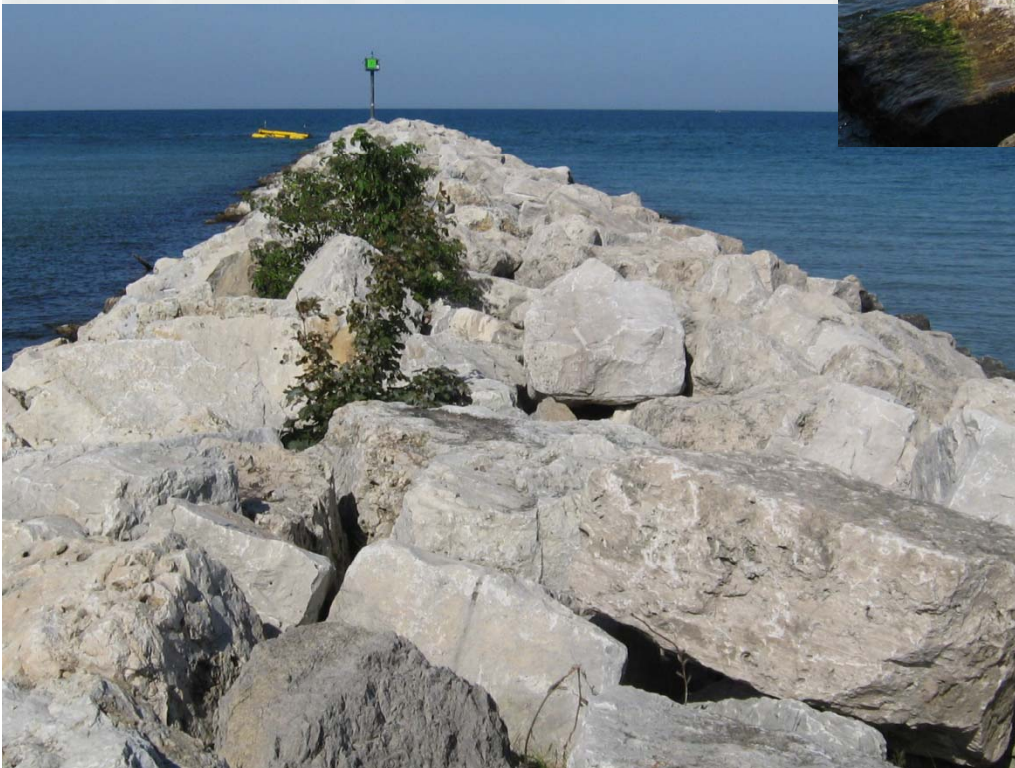
## Arcadia Harbor --

-Some stone settlement on  
the channel side

-Chinking stone should be  
added to secure the armor

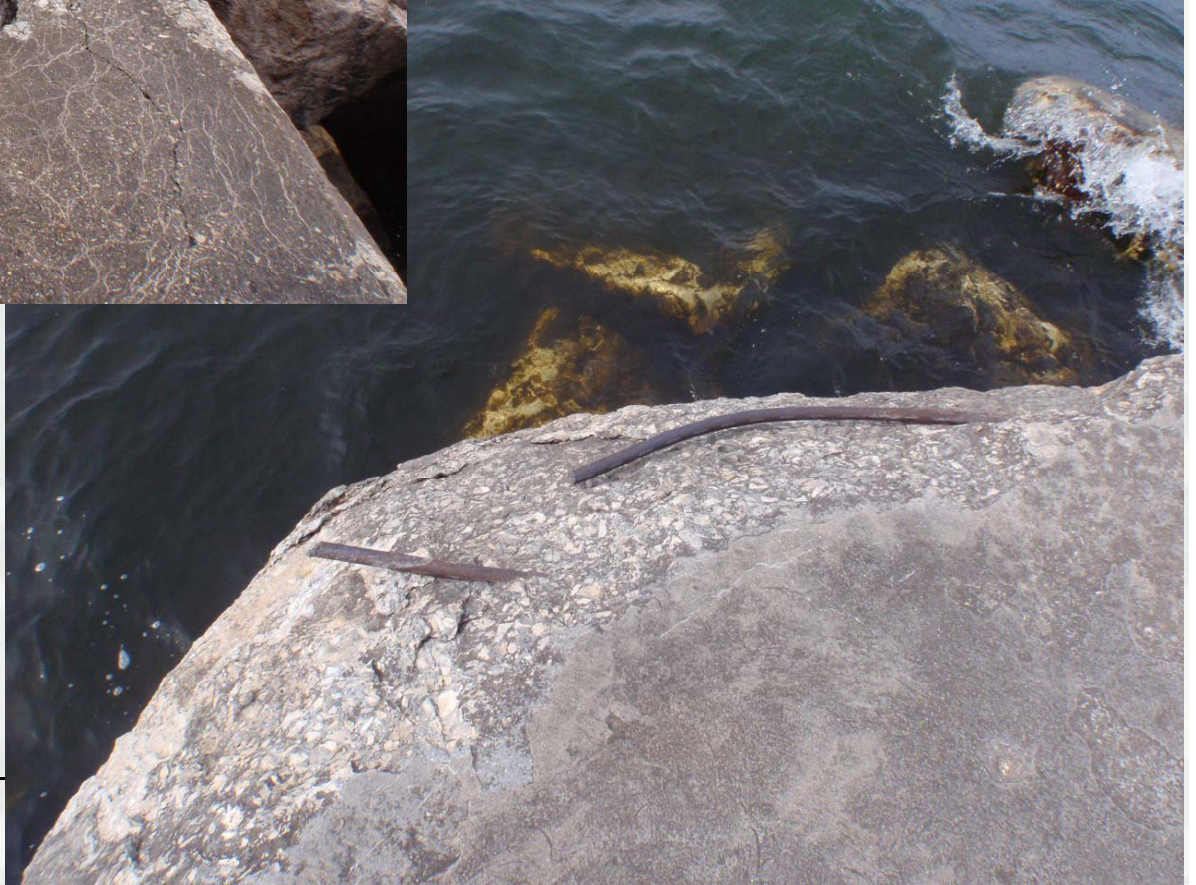
## Frankfort Harbor – North Breakwater

Heavy cracking. Severe chipping at block edge, rounded corners with re-rod exposed, numerous areas of spalling.

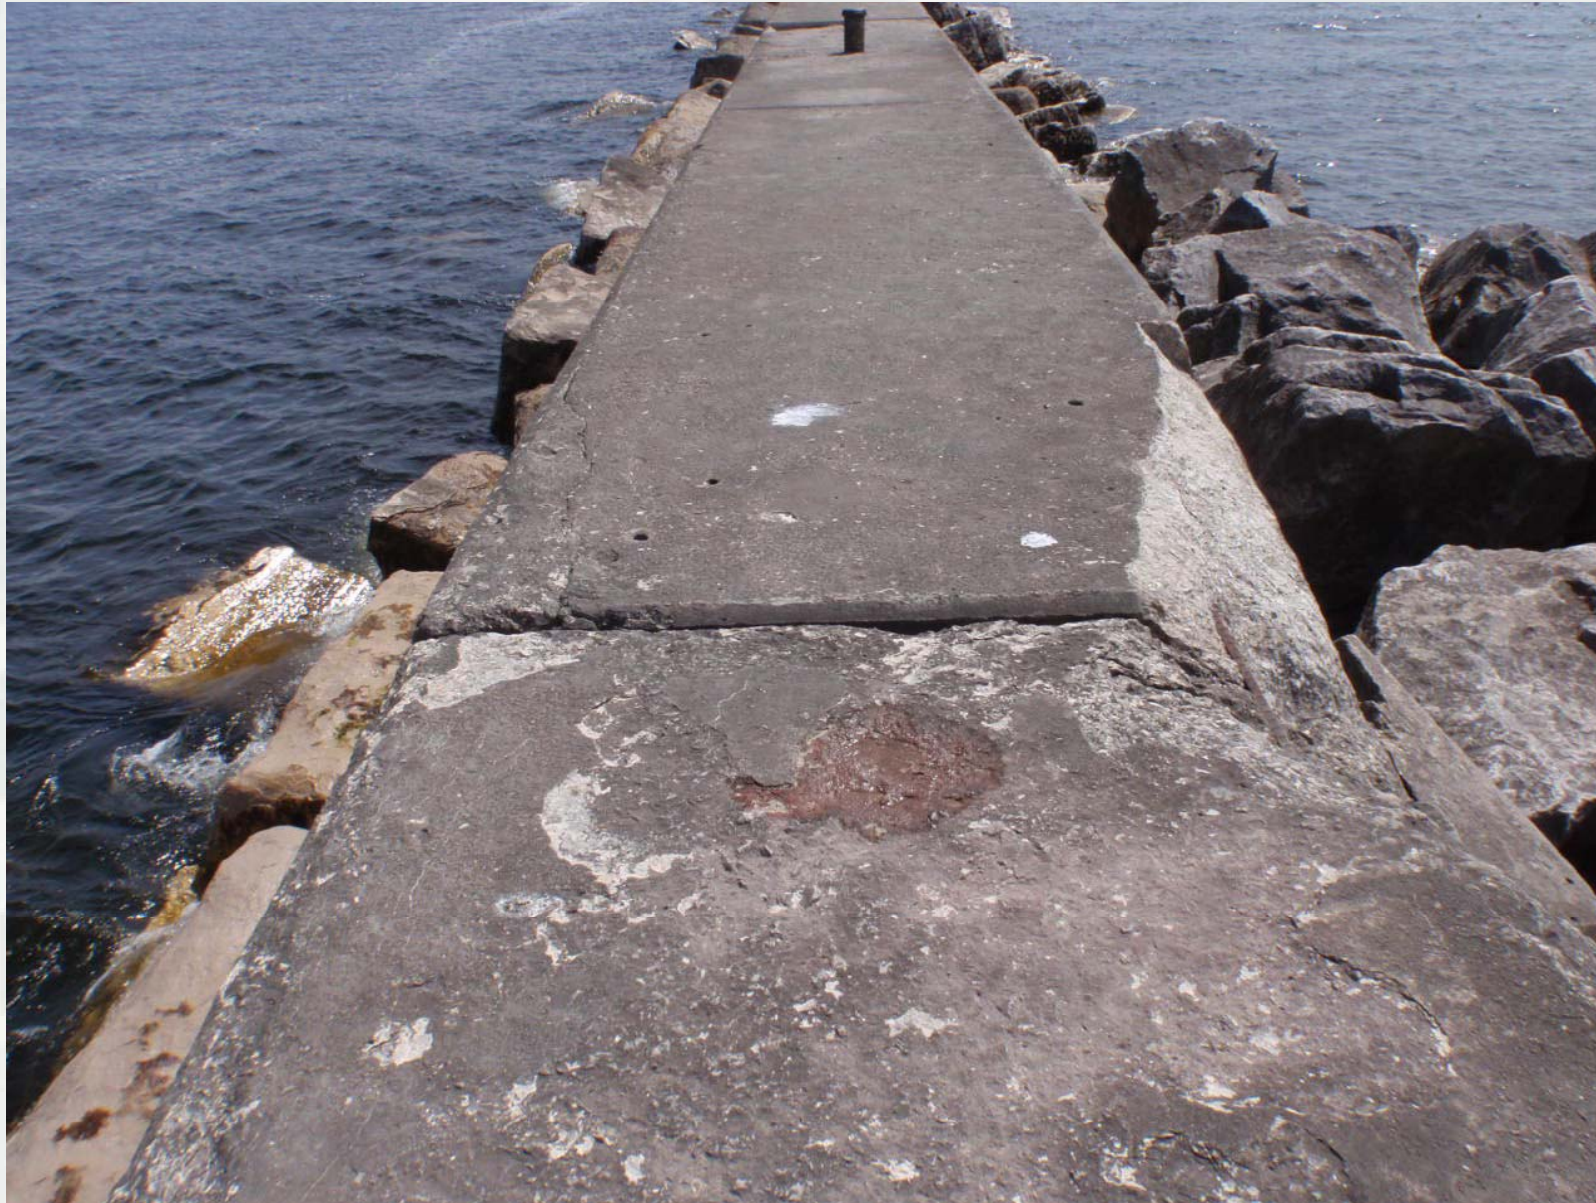
## Frankfort Harbor – South Breakwater

Caulk failure at expansion joints in the concrete blocks is causing chipping. Water surges through block seams with minor wave action.

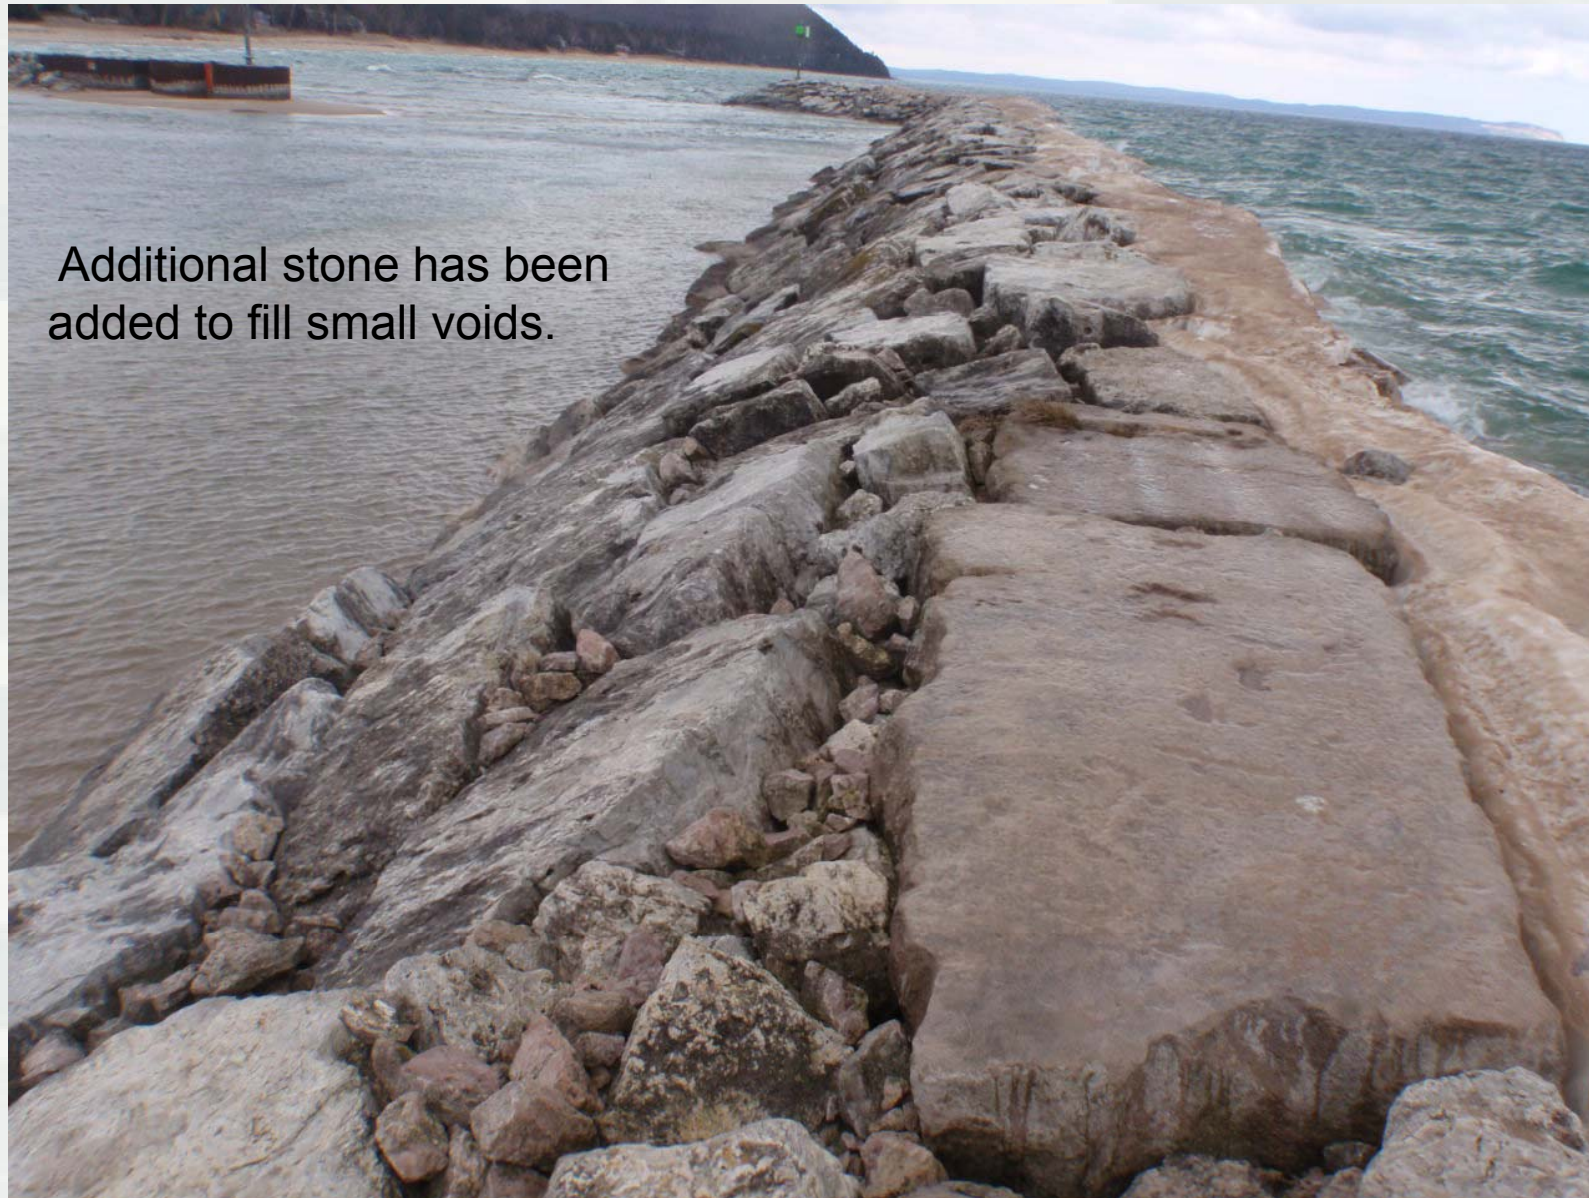
## Leland Harbor – North Rubblemound breakwater

The stone is extremely well placed and chinked. The riprap is in the very good range. There are no big voids or slope steeping.

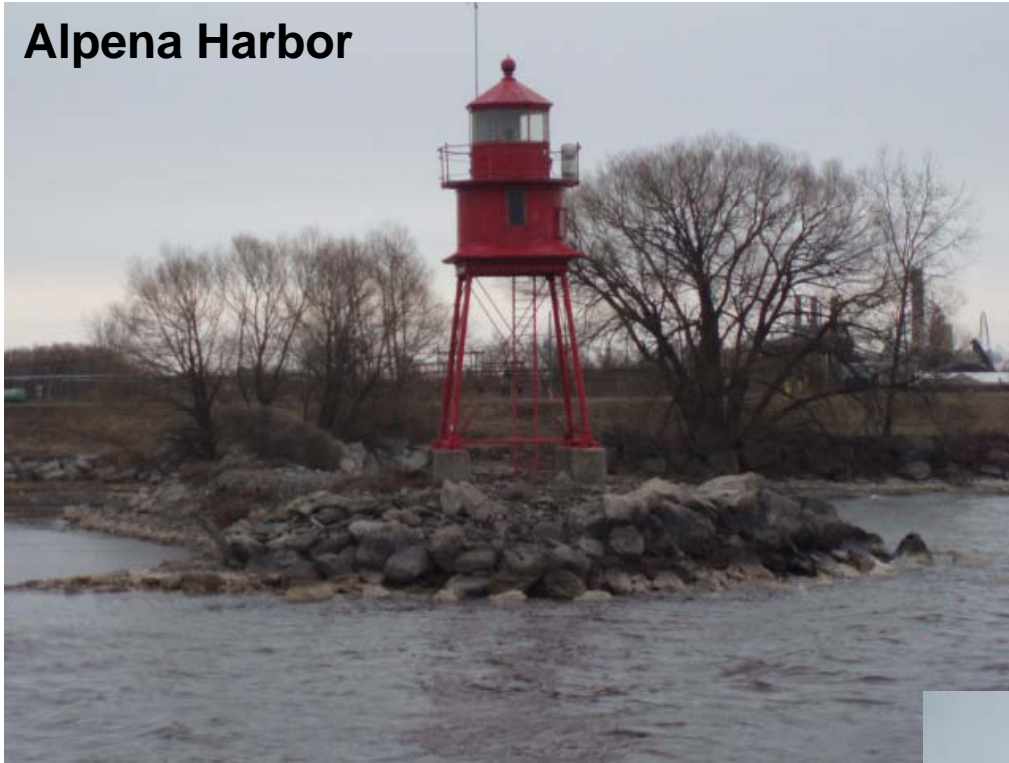
North breakwater

Rubblemound breakwaters –  
minimal stone loss and movement

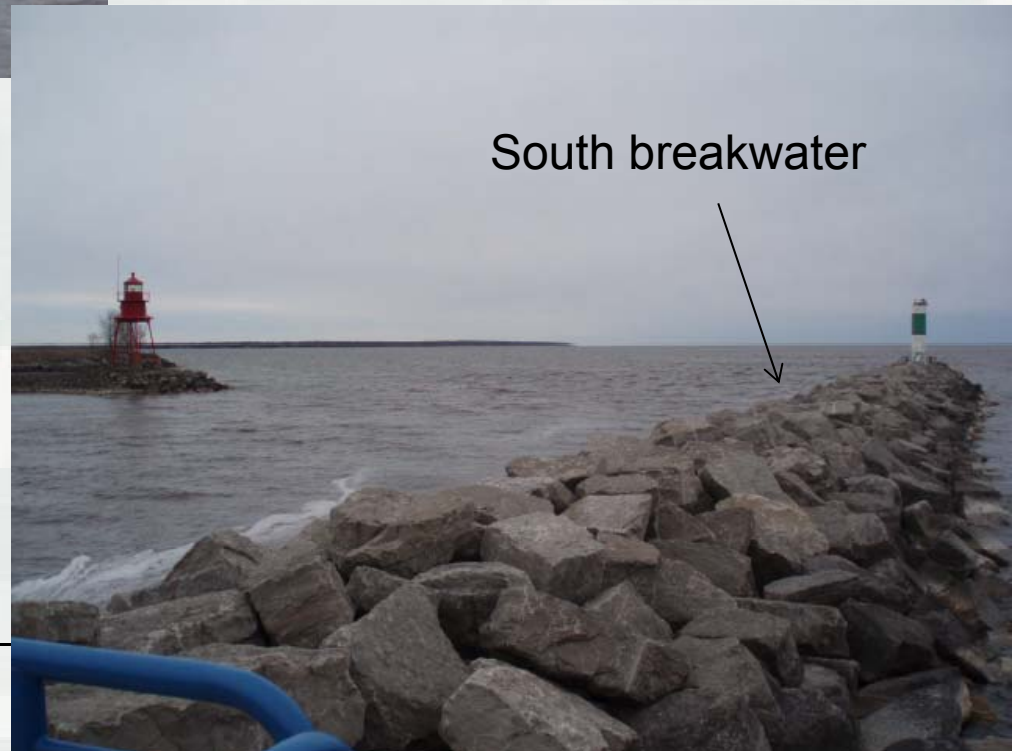
South breakwater

Rubblemound breakwaters – paint and signage are needed

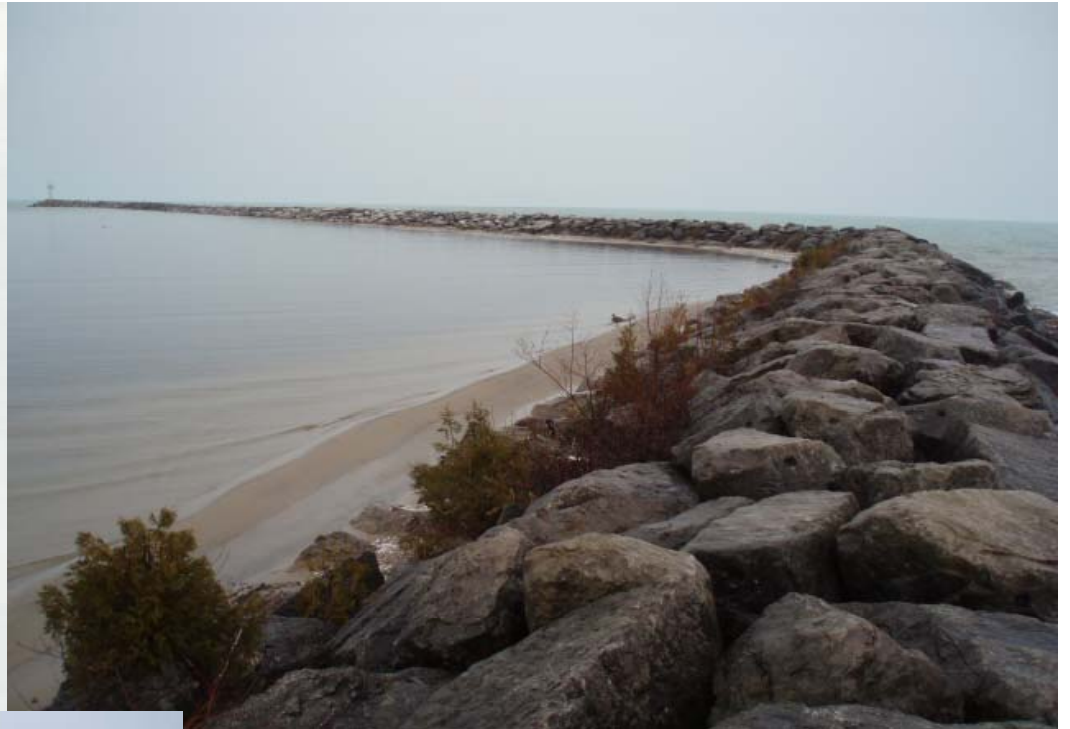
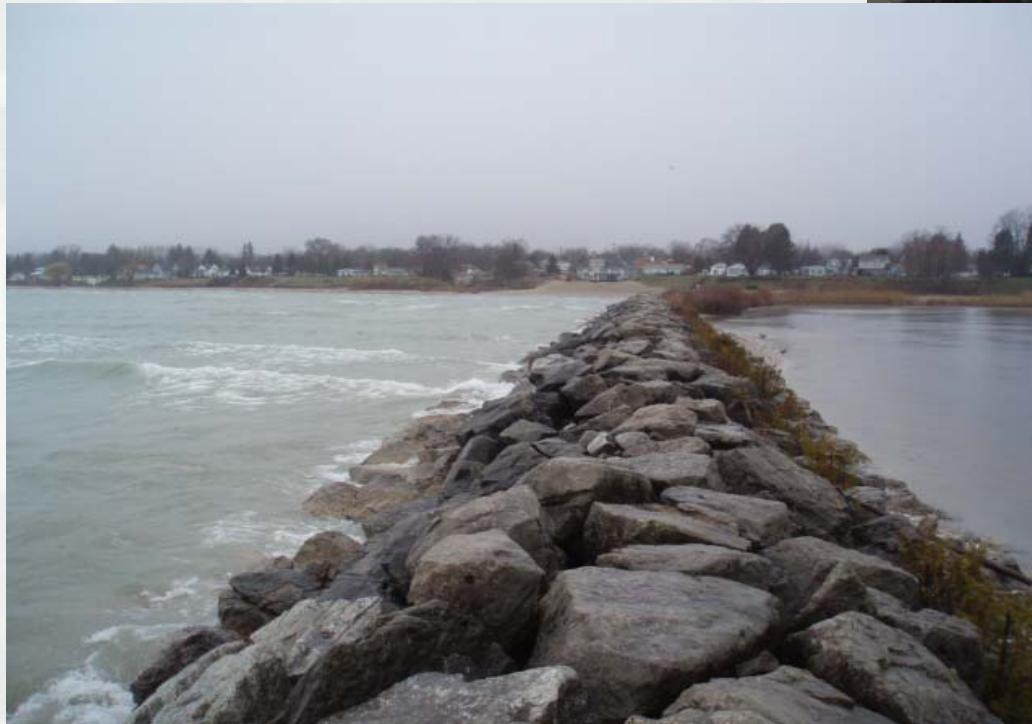
## Harrisville Harbor – South Breakwater

Vegetation between armor stone
