# Coastal Structures Risk Communication Southern Lake Michigan Harbors

Dave Wright  
Chief of Operations  
Detroit District

July 18, 2012

# Harbors of Southwest Michigan & Northern Indiana & Illinois

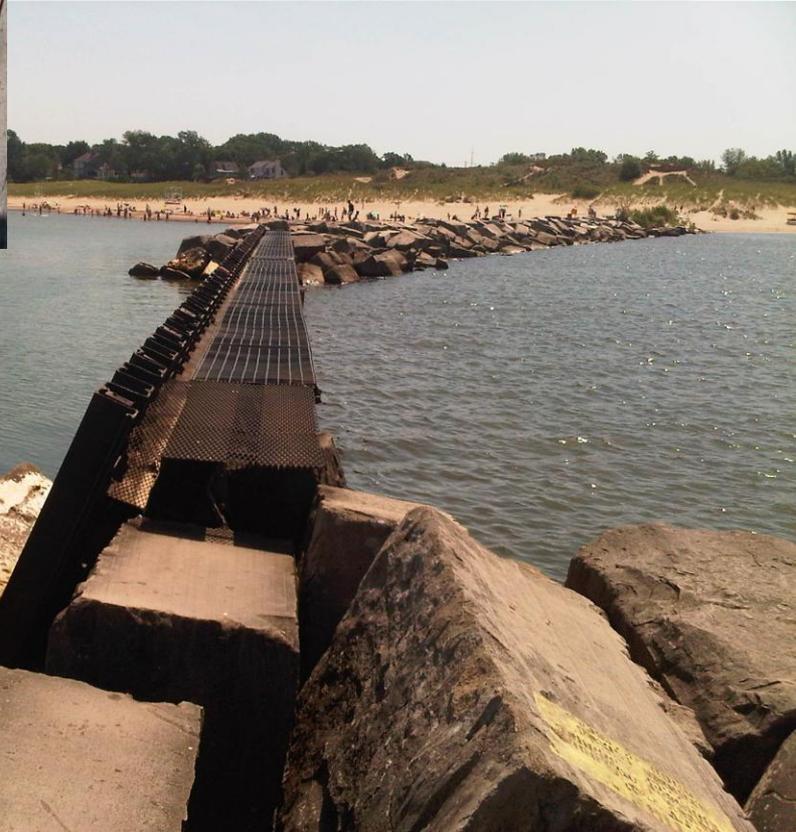
New Buffalo - North Breakwater

Un-even Grating

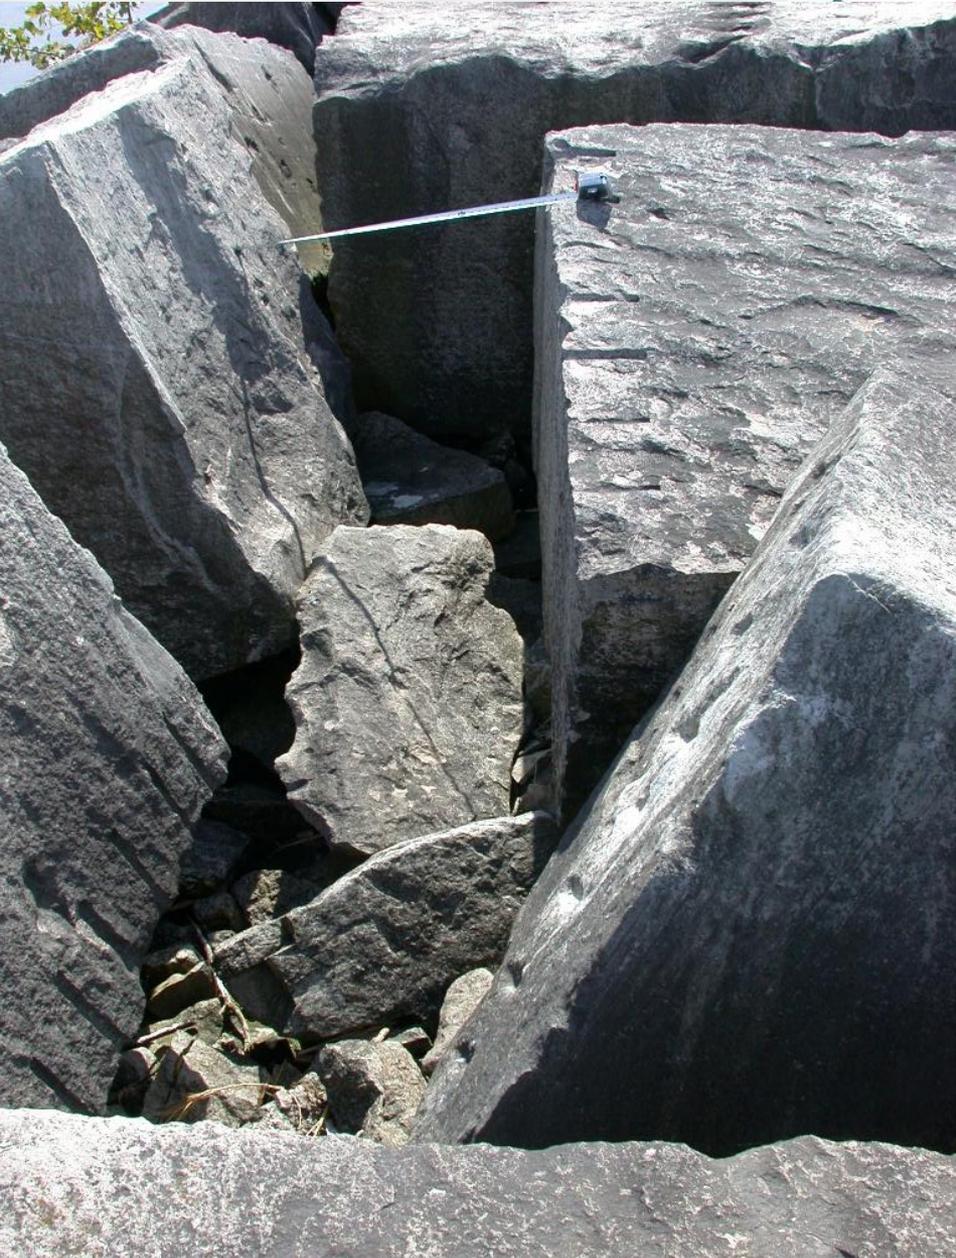
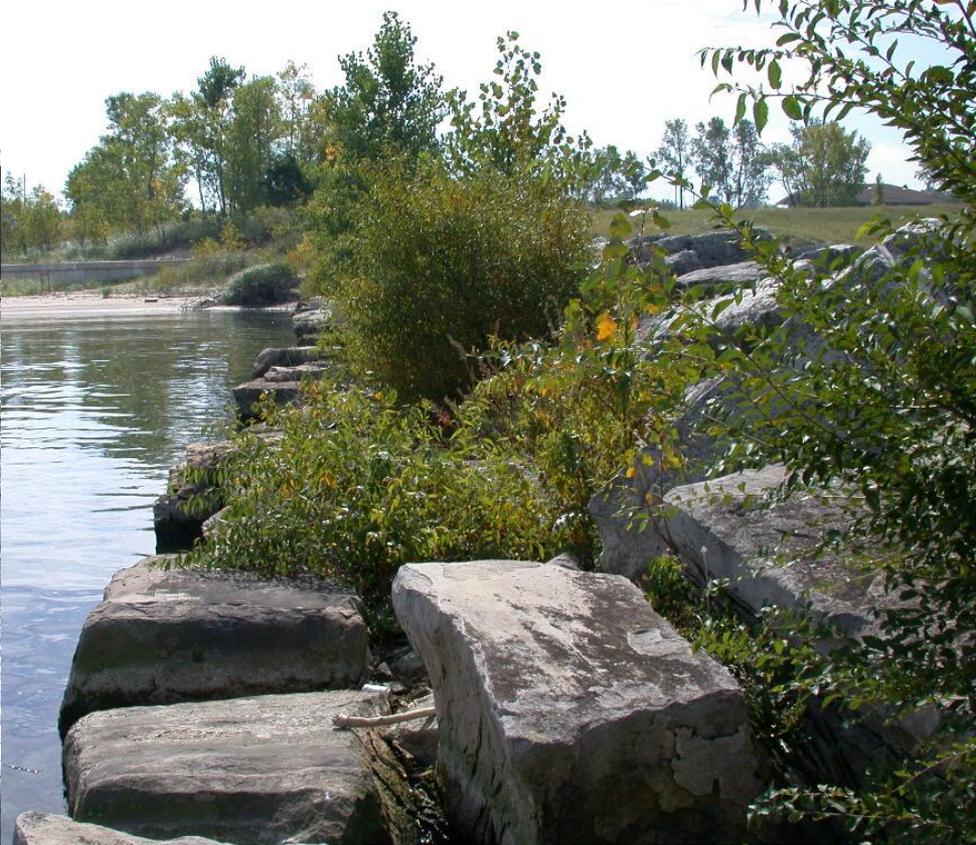
# New Buffalo - South Breakwater Stone Deteriorating

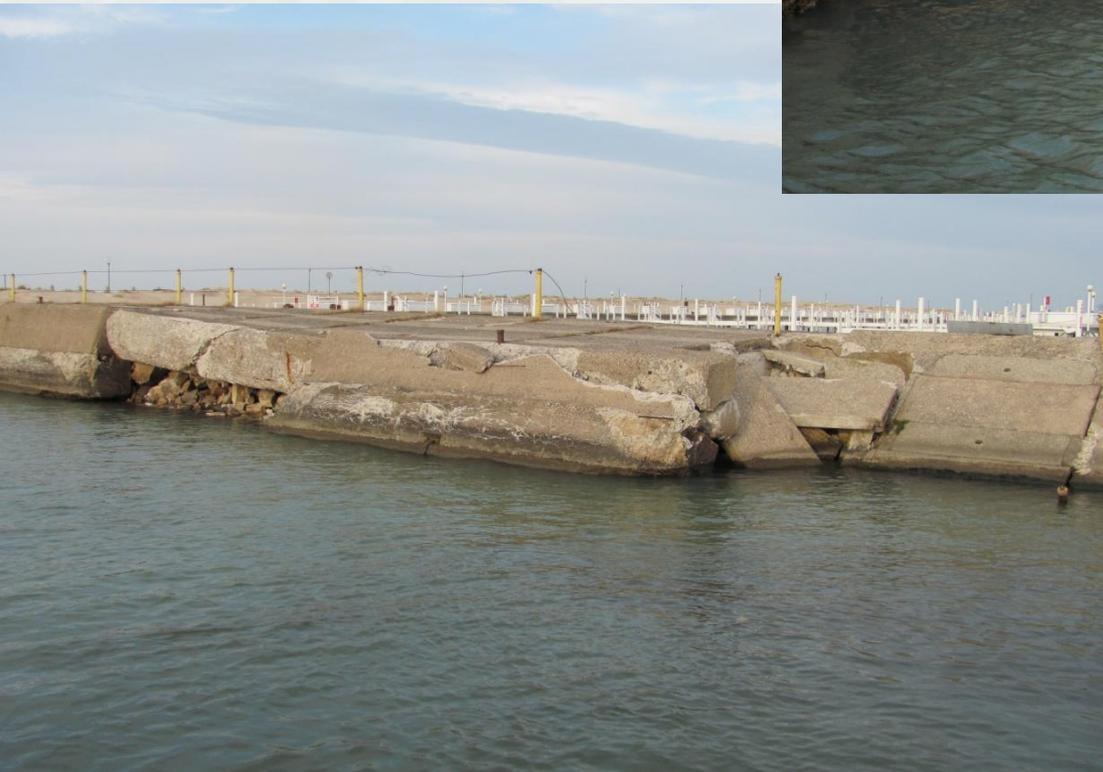
**Collapse of East Pier Reach L results in additional loss of fill stone in the rest of Reach L**

Onset of domino effect along  
Reach L of the East Pier

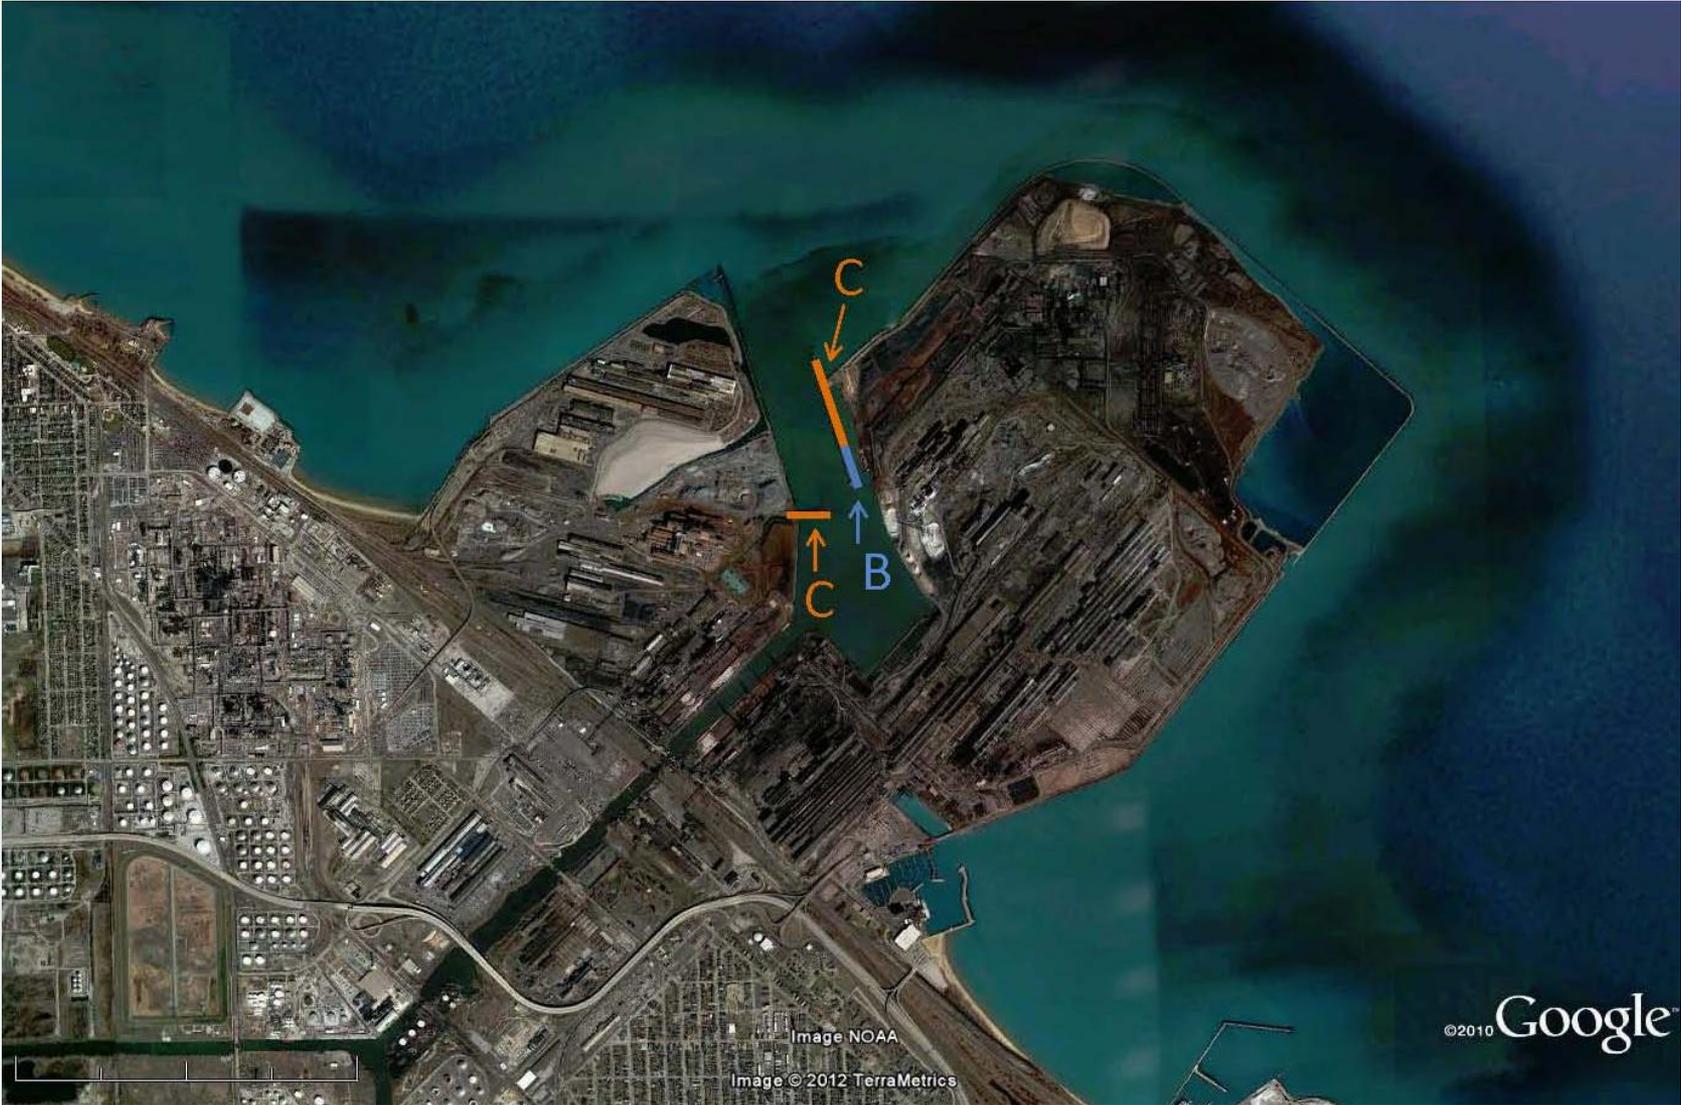
**Indiana Harbor:**  
C – Medium Risk of Failure

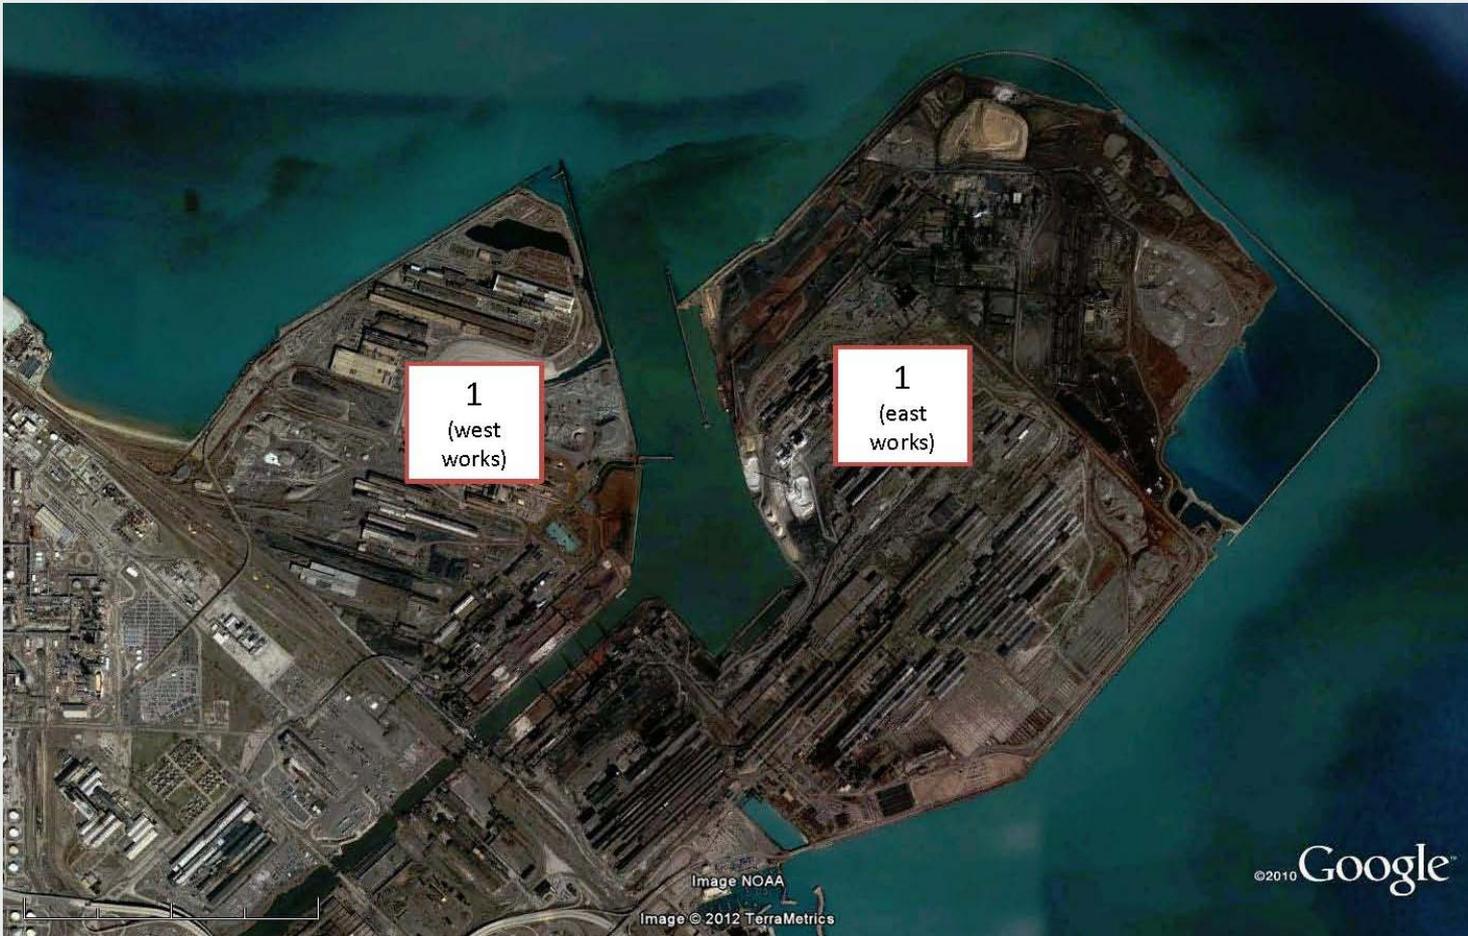
# Indiana Harbor:

Overall rating of 'C'

- 1. ArcelorMittal – Indiana Harbor Works

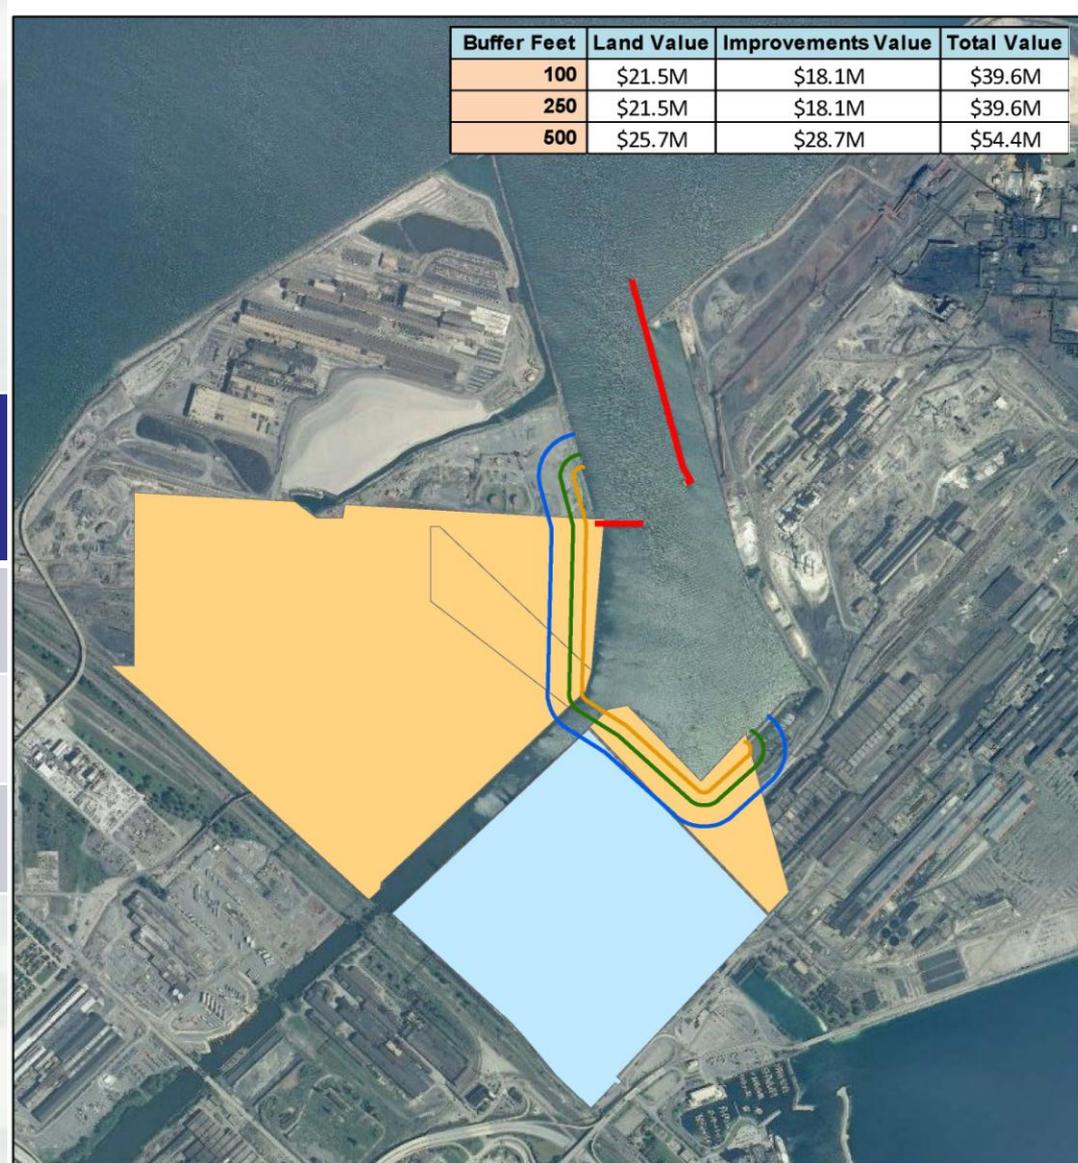
## INDIANA HARBOR East Chicago, IN

# Indiana Harbor: Potential Impact Areas

Buffer Feet	Land Value	Improv. Value	Total Assessed Value
100	\$21.5M	\$18.1M	\$39.6M
250	\$21.5M	\$18.1M	\$39.6M
500	\$25.7M	\$28.7M	\$54.4M

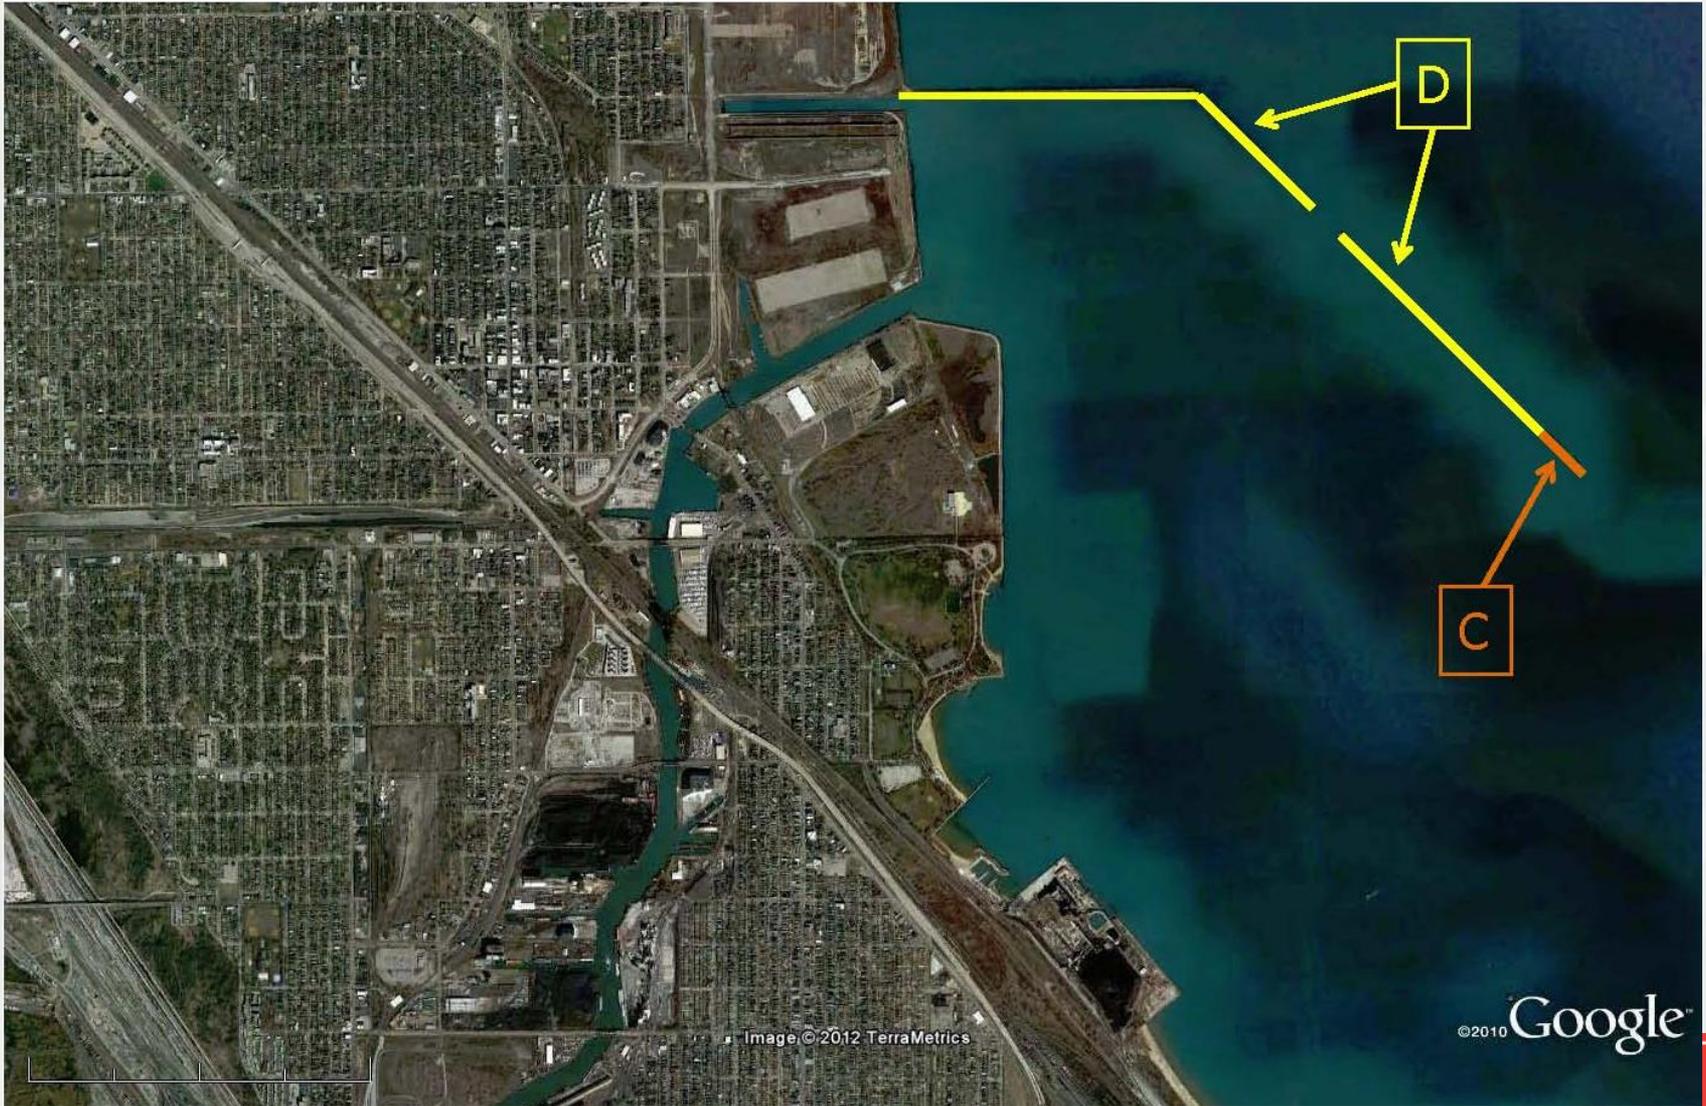
# Calumet Harbor: D – High Risk of Failure

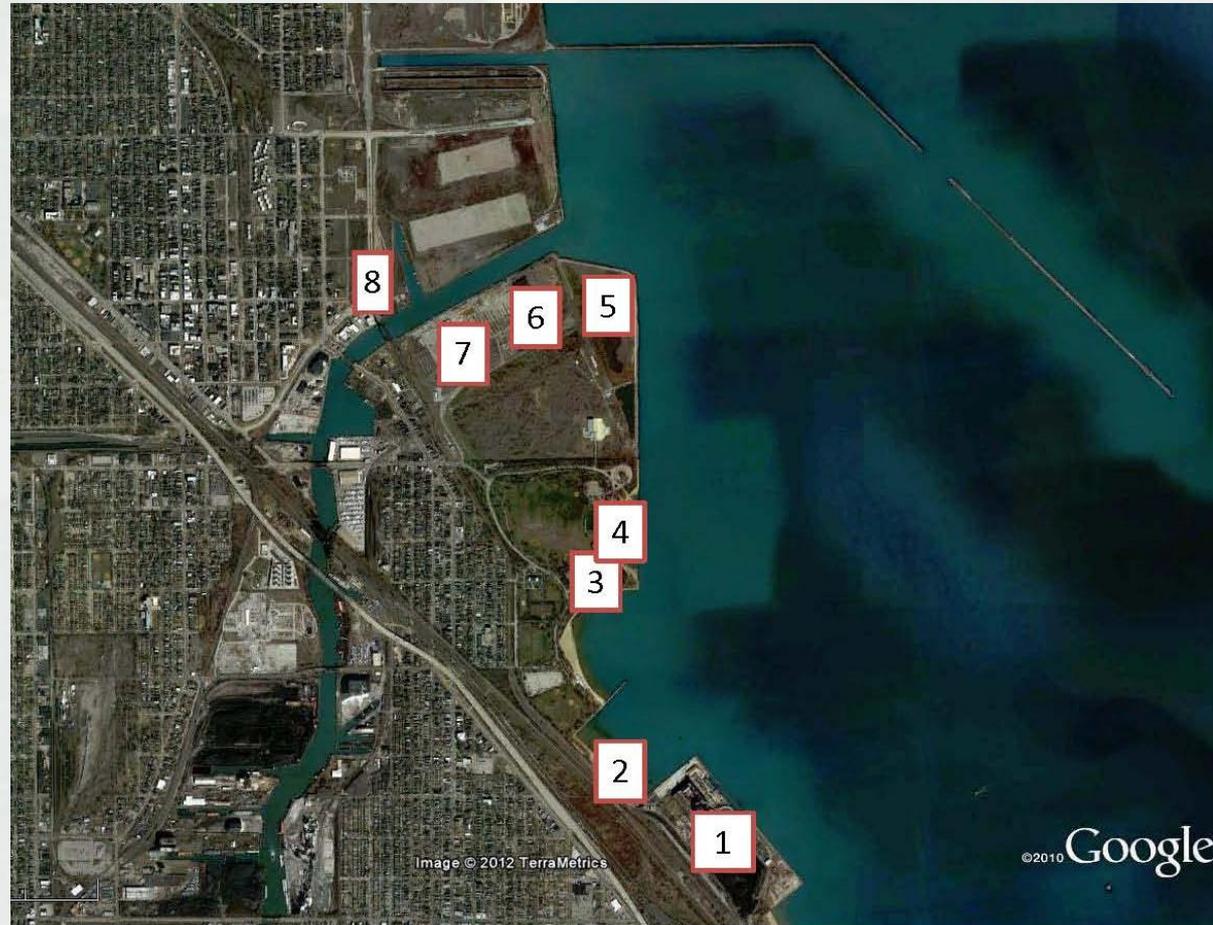
# Calumet Harbor:

Overall rating of 'D'

1. State Line Generation Plant
2. Calumet Yacht Club
3. U.S. Coast Guard – Station Calumet Harbor
4. Calumet Park Pavilion
5. Chicago Area Confined Disposal Facility
6. Chicago Area Stone Storage Dock
7. Illinois International Port District – Iroquois Landing
8. Calumet Harbor Operations Facility

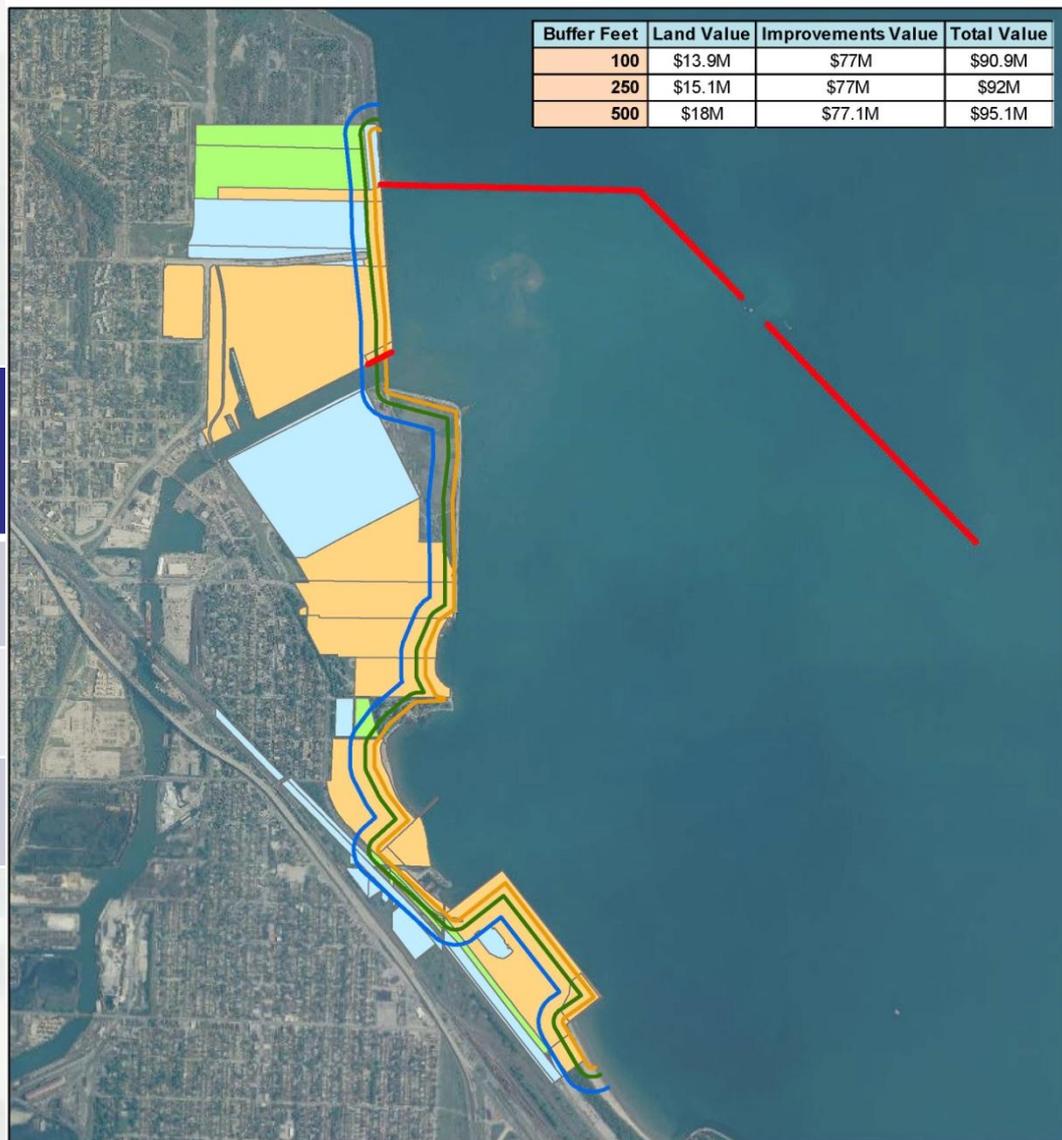
### CALUMET HARBOR

## Potential Impact Areas

Buffer Feet	Land Value	Improv. Value	Total Assessed Value
100	\$13.9M	\$77M	\$90.9M
250	\$15.1M	\$77M	\$92M
500	\$18M	\$77.1M	\$95.1M

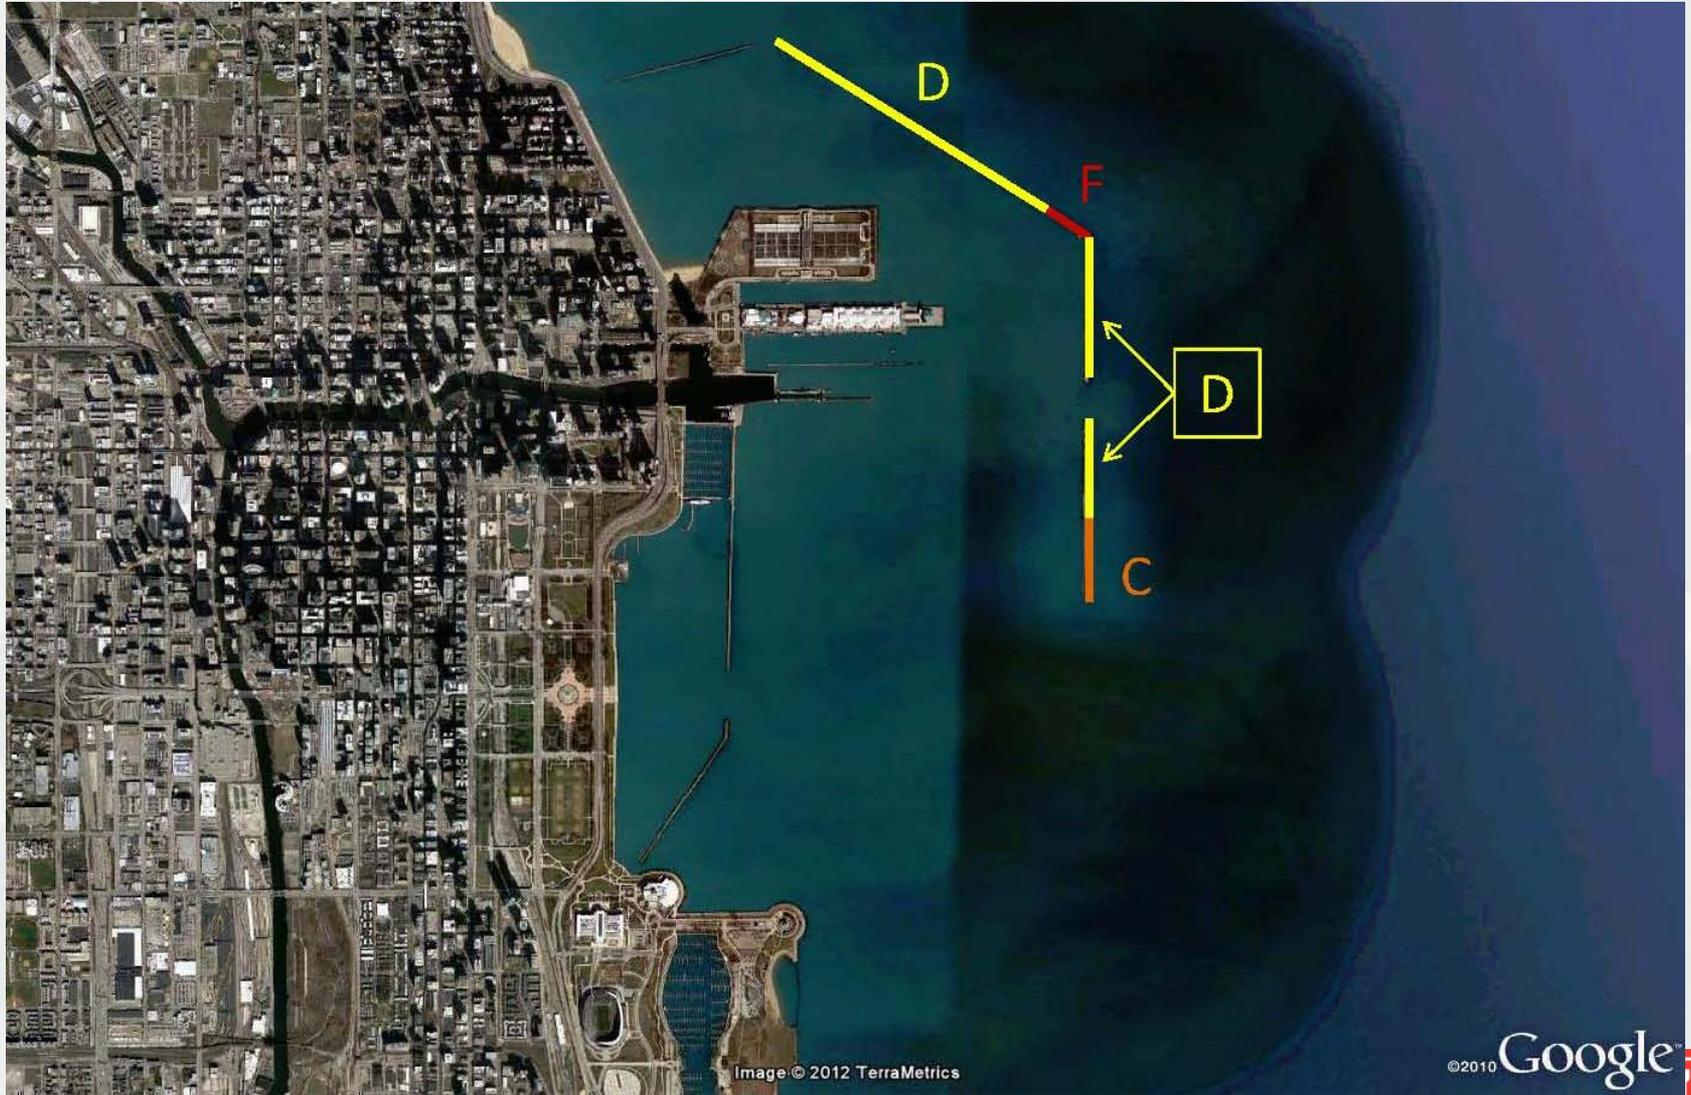
# Chicago Harbor: D – High Risk of Failure

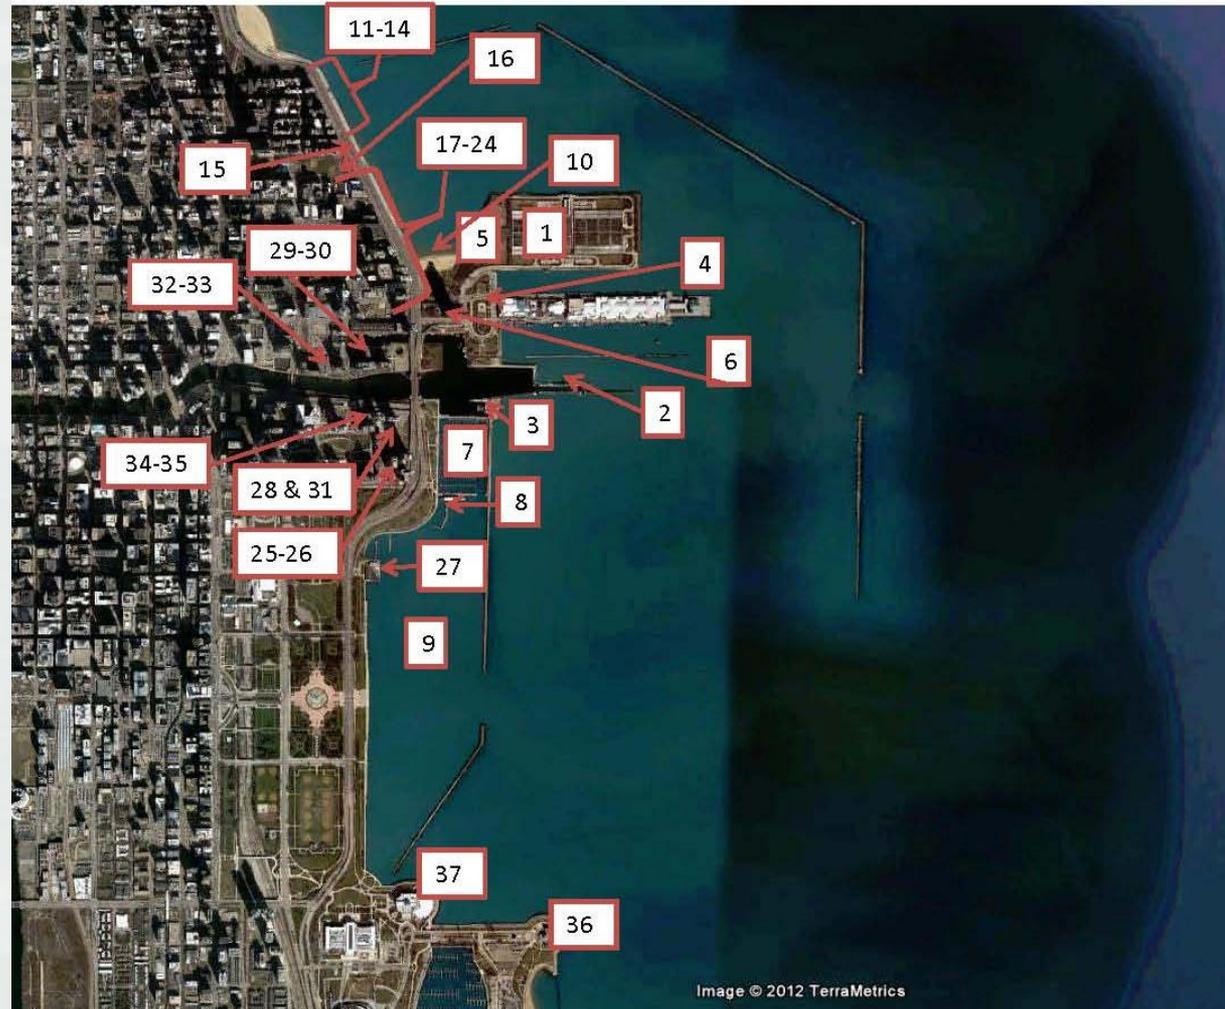
Overall rating of 'D', Portion of Exterior Breakwater rated 'F'  
\$26.3M estimated cost to upgrade D rated structures to an acceptable level of risk (Level B)

1. James W. Jardine Water Purification Plant
2. Chicago Harbor Lock Control House
3. Chicago Marine Safety Station
4. Gateway Park and Fountain
5. Milton Lee Olive Park
6. Lake Point Towers
7. DuSable Harbor
8. Columbia Yacht Club Clubship
9. Monroe Harbor
10. Ohio Street Beach
11. 990 North Lake Shore Drive
12. 900-910 North Lake Shore Drive
13. 860-880 North Lake Shore Drive

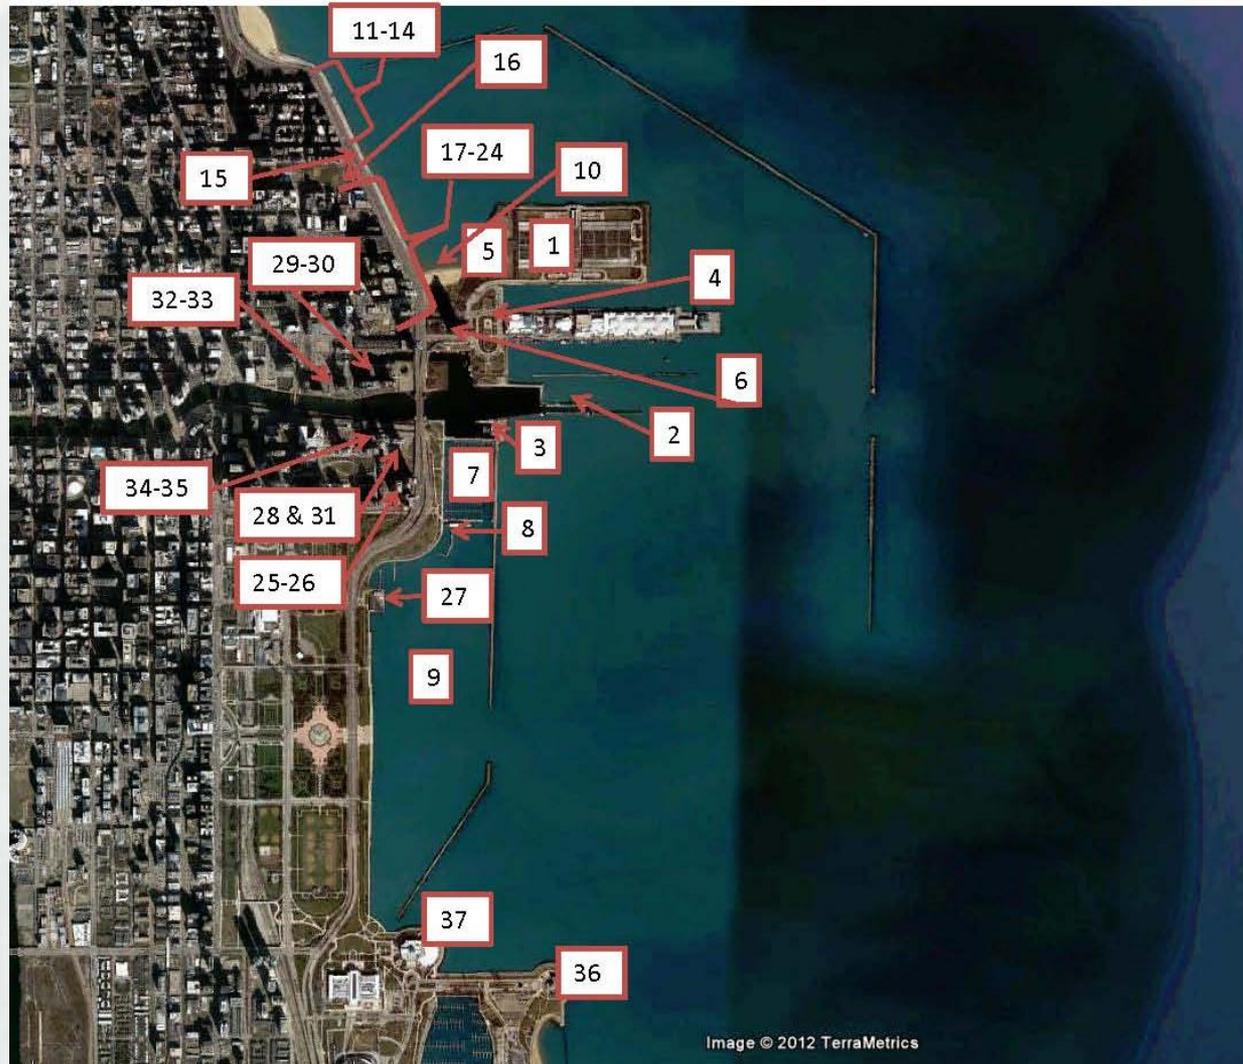
Overall rating of 'D', Portion of Exterior Breakwater rated 'F'

\$26.3M estimated cost to upgrade D rated structures to an acceptable level of risk (Level B)

- 14. 840 North Lake Shore Drive
- 15. North Lake Shore Drive
- 16. Lake Shore Park
- 17. Northwestern University – School of Law
- 18. Northwestern University – Abbott Hall
- 19. 680 North Lake Shore Drive
- 20. The W Hotel Chicago - Lakeshore
- 21. 600 North Lake Shore Drive
- 22. 540 North Lake Shore Drive
- 23. 530 North Lake Shore Drive
- 24. North Pier Apartment Tower
- 25. The Parkshore
- 26. Harbor Point
- 27. Chicago Yacht Club
- 28. The Chandler
- 29. East Water Place Townhomes

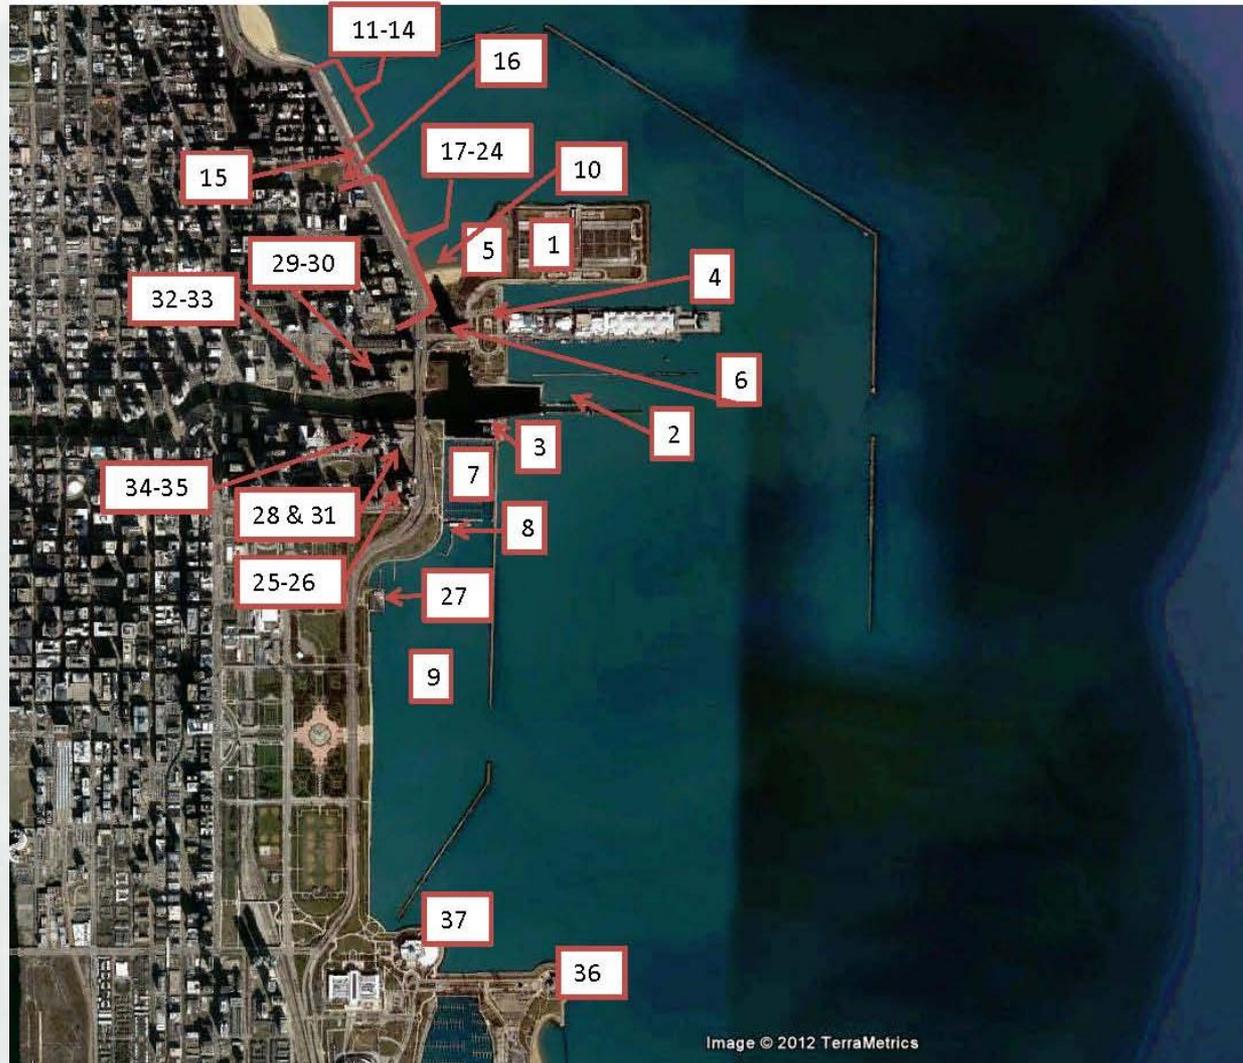
Overall rating of 'D', Portion of Exterior Breakwater rated 'F'

\$26.3M estimated cost to upgrade D rated structures to an acceptable level of risk (Level B)

- 30. River View Condominiums
- 31. The Regatta
- 32. Cityfront Place
- 33. Sheraton Chicago Hotel & Towers
- 34. Swissotel Chicago
- 35. 303 East Wacker
- 36. Adler Planetarium & Astronomy Museum
- 37. John G. Shedd Aquarium

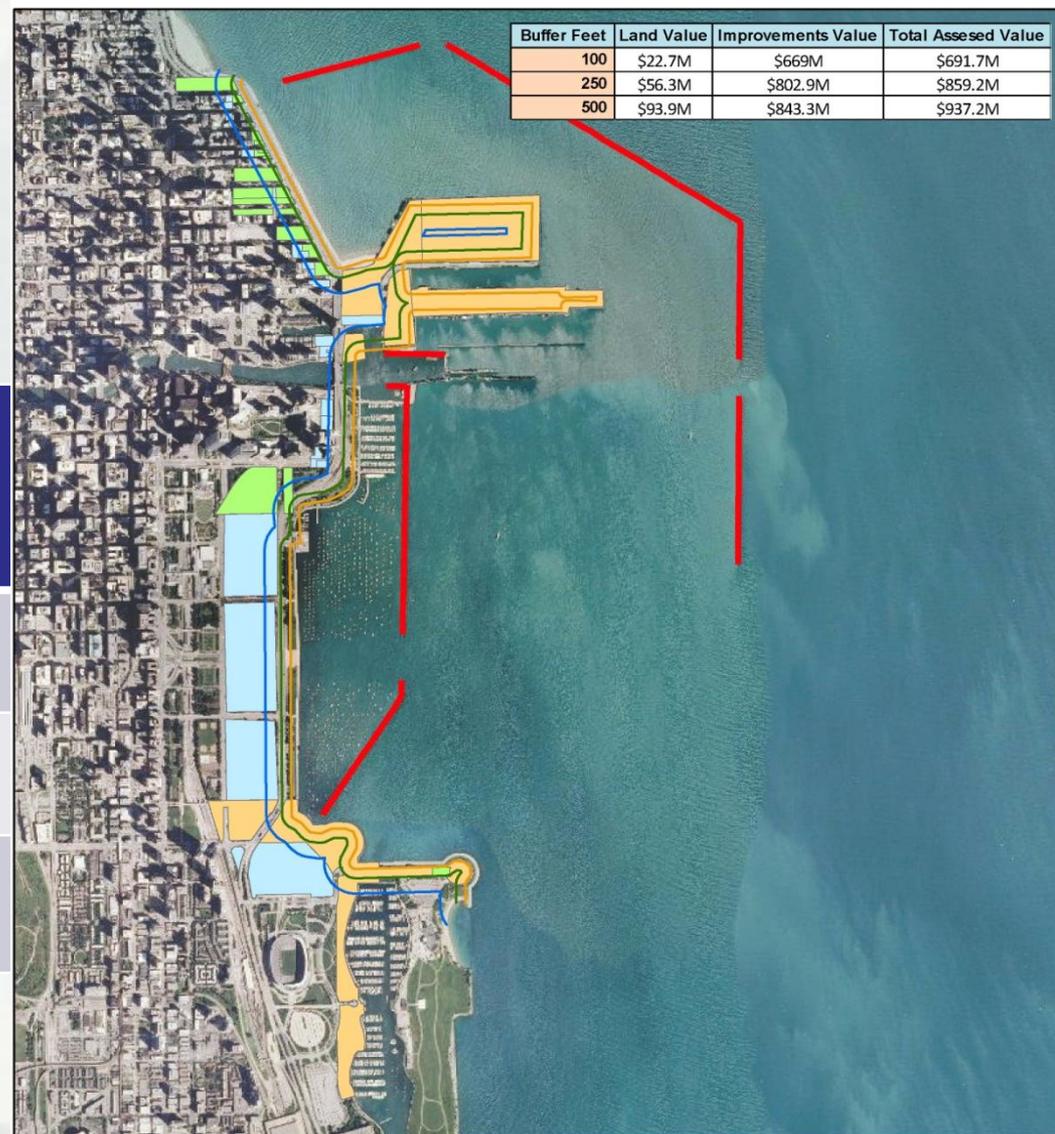
**CHICAGO HARBOR**  
Chicago, IL

## Potential Impact Areas

Buffer Feet	Land Value	Improv. Value	Total Assessed Value
100	\$22.7M	\$669M	\$691.7M
250	\$56.3M	\$802.9M	\$859.2M
500	\$93.9M	\$843.3M	\$937.2M
