1. Introduction

The Soo Locks, which is situated between Lake Superior and Lake Huron and the remaining Great Lakes, forms the border region between the United States and Canada. It has been referred to as one of the great wonders of the world and serves the largest waterway traffic system on earth. The St. Marys River is the only water connection between Lake Superior and the lower Great Lakes. In the upper reach of the river, known as the St. Marys Rapids, the water falls about 21 feet from the level of Lake Superior to the level of the lower lakes. This natural barrier to navigation made necessary the construction of the locks project known as the St. Marys Falls Canal.

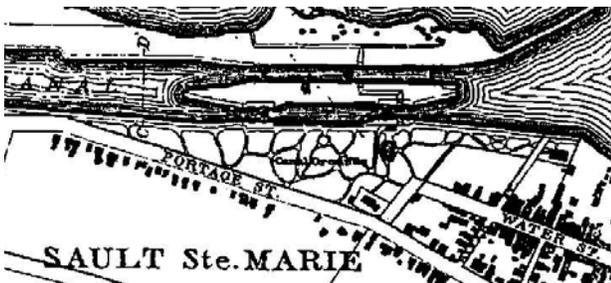
Drawing 1.

The open space which now is defined as the Upper and Lower Canal Park has been associated with the locks since their original construction. The image below in Drawing 1 is a portion of a map from Sauer's *Illustrated Atlas of Sault Ste. Marie, Michigan and Ontario* from 1888 as shown in *Up bound Down bound The Story of the Soo Locks* by Bernie Arbic and Nancy Steinhaus. The Canal Grounds are indicated on the map with many curvilinear paths and a structure at the intersection of Portage Street and Osborn Boulevard. (Water Street extended).

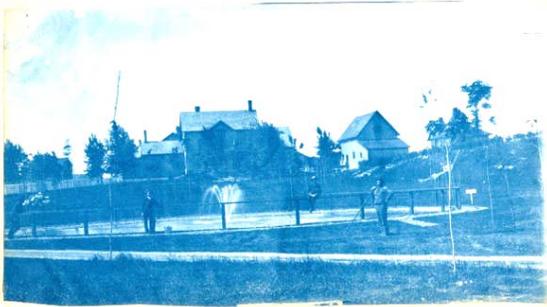
Photograph 1 taken in 1885 of workers constructing the fountain in the Lower Canal Park provided by the Bayless Library.

Photograph 1 depicts workers at the construction of the fountain in the Lower Canal Park just below the grand staircase.

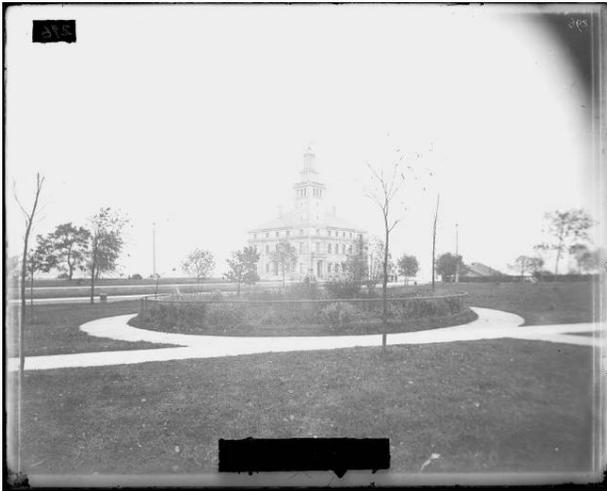
Photograph 4 taken in 1892 looking towards the Weitzel Lock at the circular planting bed. Photograph was taken by and provided by the US Army Corps of Engineers.

throughout the space. There was no physical or visual barrier between the locks and the park. The Park possessed a trail system of both wood and concrete materials, and is one of the first applications of concrete walkways in designated park space in the State of Michigan. The large, straight walkway along the locks, which was lighted, the walkway from the entrance on Portage Street, and the winding paths transcending through the Park were visualized within this design era. The winding paths centralized to a formal, radial design that served as a designation locale within the park. Based on historical photographs, this circular space provided opportunities for reflection and display of horticultural design. See Photograph 3 and 4 depicting this design feature.

This circular movement disappeared some time between the 1920's and 1940's. It had been located between the present Visitor's Center and the Portage Street entrance walkway.

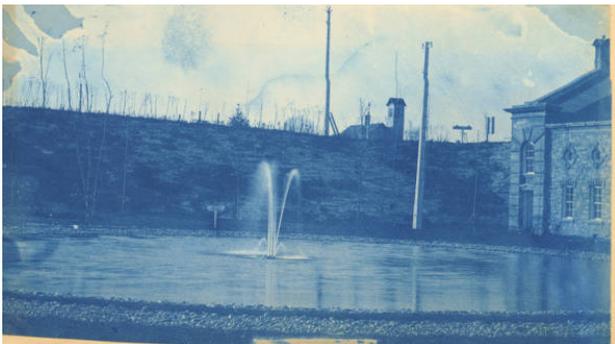
Photograph 5 taken in 1885 in the Lower Canal Park of the fountain and staircase at the transition point between the Upper and Lower Canal Parks as provided by the Bayless Library.

The first structures in the park were built during this period, including the fountain, the grand stone staircase connecting the Upper and Lower Parks, and a cottage. The staircase can be viewed in the foreground of Photograph 2, and on the right hand side of Photograph 5.

This stone structure was present until the 1940's when the stairs and a new retaining wall were designed and constructed. While space was limited within the staircase structure it is possible, based on the

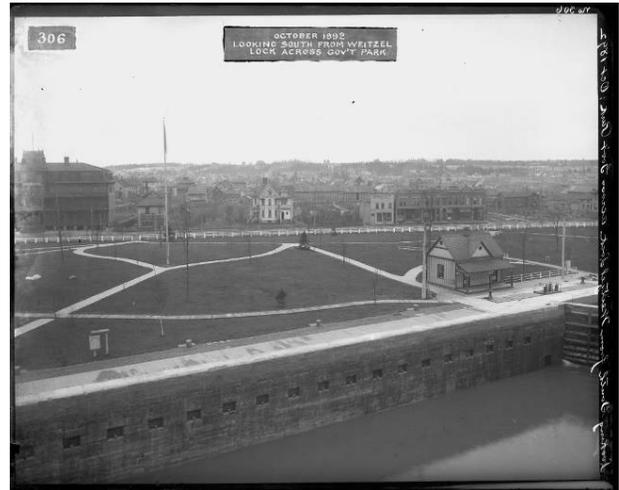
Photograph 6 taken in 1892 of the Weitzel Lock and the Upper Canal Park. Photograph was taken by and provided by the US Army Corps of Engineers.

The cottage like structure depicted in Photograph 6 was located within the Upper Canal Park overlooking the Weitzel Lock. Its gabled roof, upward design, and the use of different colors is suggestive of the Victorian Era (1825-1900), which was very popular in Northern Michigan including the Traverse City, Petoskey, and Old Mission Peninsula areas. Based on photograph 7 showing a Victorian style hotel in the background, it made its way to Sault Ste. Marie as well. The architecture of this period drew deeply from history, nature and geometry. It is surmised this building served as a switching room, weather station, shipping information, and a communication post for the sailors. It also could have provided the public with historical and technical information on the locks. Its demolition date is not known, but two new switching buildings were built in the early 1900's at this location, and the other end of the locks complex. These buildings still remain today, with the addition of small observation decks placed on their roofs. The sailor's communication post it is believed to have been replaced by the Merchant Marine's Library that served in that capacity until the 1970's.

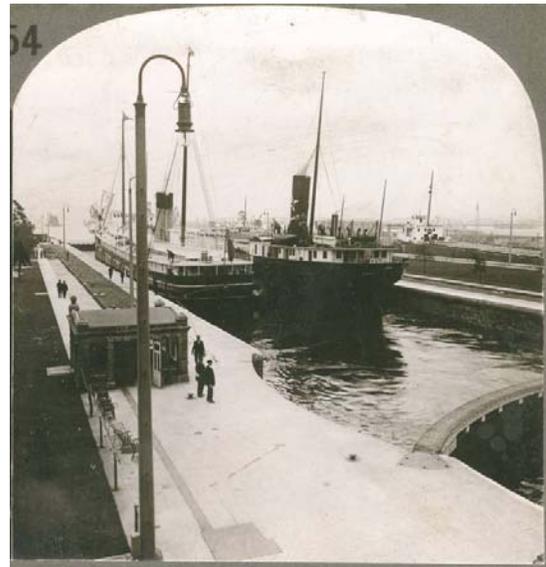
Photograph 9, provided by the Maritime History Museum of the Great Lakes, is titled the "Greatest Canal Traffic in the World". This photograph was taken in 1912. Note the switching room buildings on the sidewalk, one in the foreground, and one in the far background. These buildings still exist today with the small observation decks built on their roofs. The platforms were erected in the late 1940's. This is also the first photograph where benches begin to appear. The middle bench depicted in this photograph is very

reminiscent of the green movable benches the park currently has.

Photograph 9 taken 1912 of the Weitzel Lock and the Upper Canal Park. Photograph provided by the Maritime Museum.

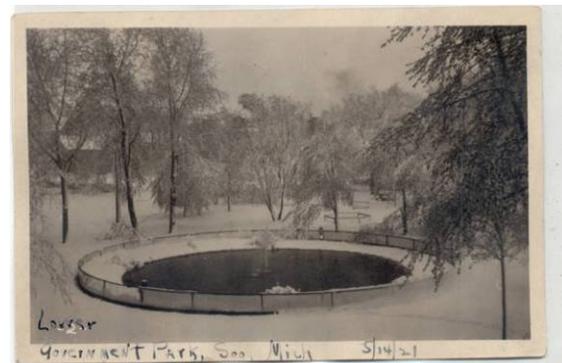
While the Upper Canal Park was beginning to create a sense of place and destination, the Lower Canal Park was still primarily being used as open space. As depicted below in a Photograph 10 from May 1921, the fountain that was built in the late 1880's still exists, but it is formalized a bit more with fencing. The trees are now larger and it is apparent from the stature that the trees are elms, which will play an important design role in the upcoming decades. It is also interesting to see the amount of snow in this May photograph.

Photograph 10 taken in 1921 of the fountain in the Lower Canal Park provided by the Bayless Library.

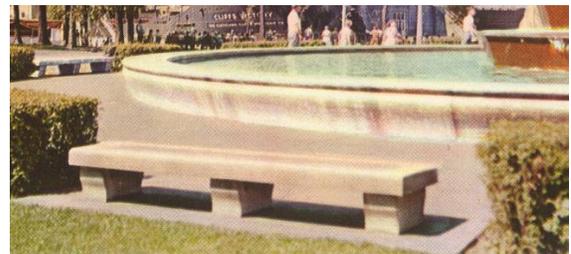
Postcard 4 from the 1950's depicting a typical concrete bench found within both Upper and Lower Canal Park

Important elements included in the detailing of the park were the benches, concrete pillars and fencing, the lock display models, and lamp posts. Photographs 11 and Postcards 4 and 5 show a few of these elements.

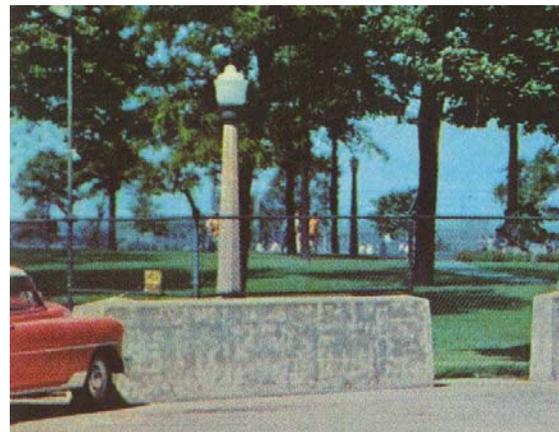
Postcard 5 from the 1950's depicting a lamp post and the concrete wall detail used throughout the park.

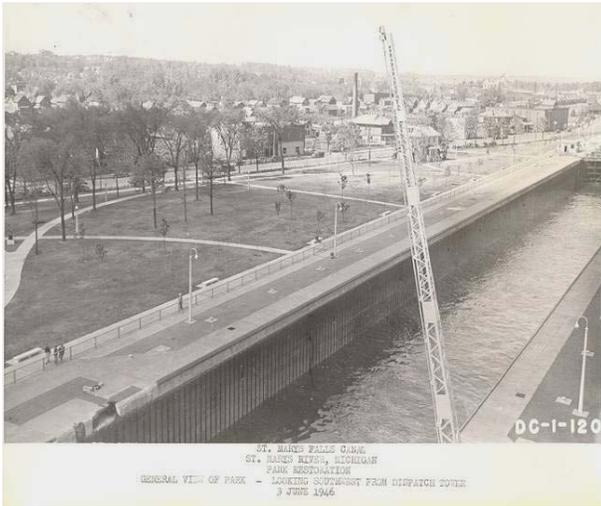
Photograph 12 taken by the Corps in 1946 immediately following the restoration construction of the parks.

2. a wider sidewalk to facilitate large groups along the fence to allow circulation and ship viewing, as depicted in Photograph 12;
3. lighting in the interior park spaces;
4. retaining wall separating the Upper and Lower Parks that included a public washroom facility and a new stairway a shown in Photograph 13;

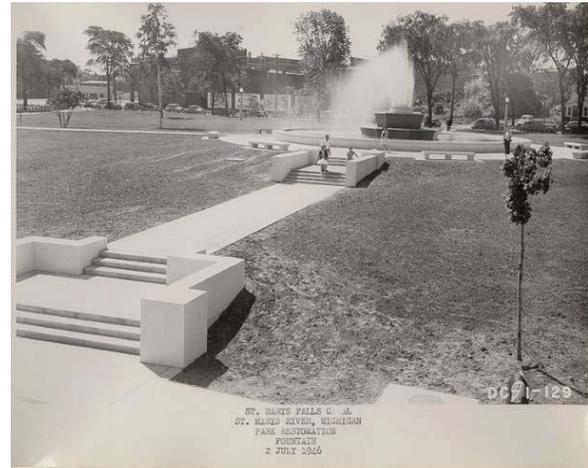
Photograph 14 taken by the Corps in 1946 immediately following the restoration construction of the parks.

1. a fence along the walkway parallel to the locks to create a barrier between the public and the locks;
5. removal of the fountain designed in the 1880's and construction of a new fountain in a new location and circulation pattern in the Lower Park, as depicted in Photograph 14;

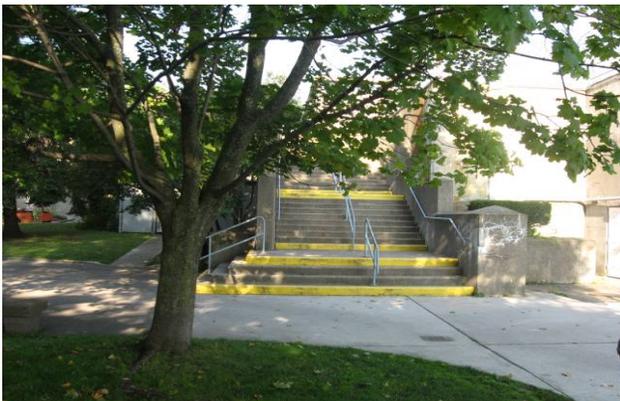
Photograph 13 taken of the staircase in 2009.

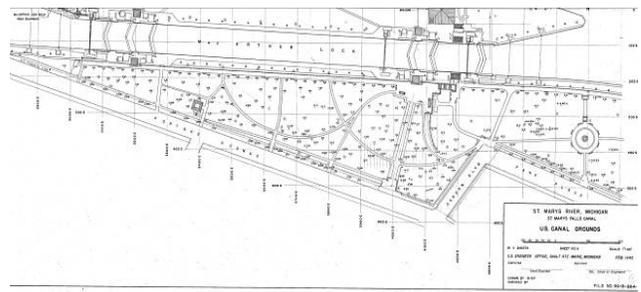
Drawing 2 is a depiction of the planting and circulation plan of the 1940's. The planting plan strives to combine existing trees with new proposed trees to create sight lines, sense of place and comfort.

Drawing 2 showing the 1945 planting plan provided by the Corps.

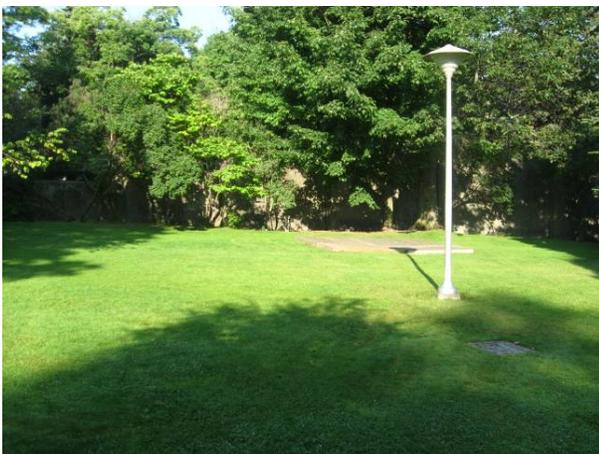
The plans detailing these improvements show a new light pole to replace existing lamp posts. These lights as depicted in Photograph 15 were very futuristic in style for the time, and drastically changed the sense of place the previous lights created.

Photograph 15 taken of a light pole in 2009.

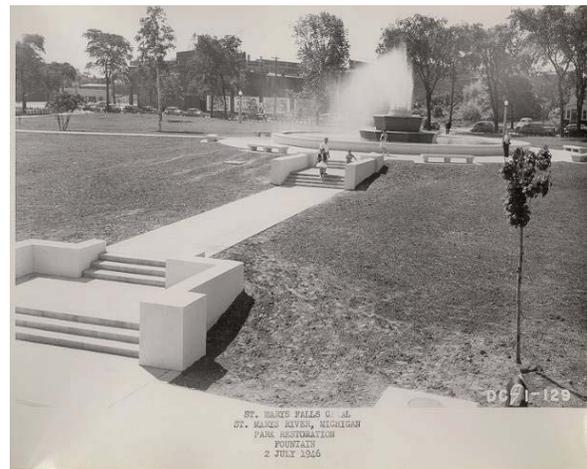
Photograph 16 and 17, one key element to the Park's design (the fountain in this example) was purposefully left open for viewing and now over time and with over planting, it has become closed.

Photograph 16 taken by the Corps in 1946 immediately following the restoration construction of the parks.

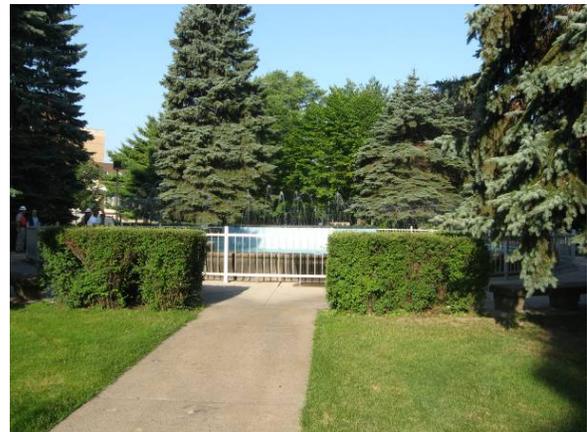
Photograph 17 taken of the fountain in the Lower Canal Park looking west in June of 2009.

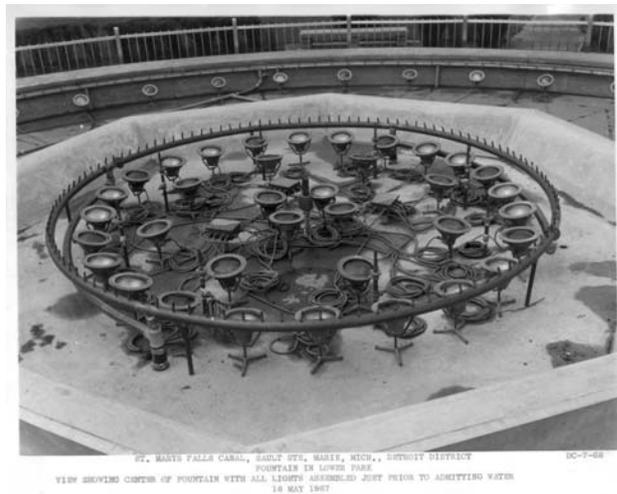
Photograph 26 taken by the COE in 1967 during the fountain's renovation depicting the installation lights.

1. The removal of the top tier of the three tier design.
2. Renovation to install underwater lighting as depicted in Photograph 26.
3. Installation of a fence surrounding the fountain.

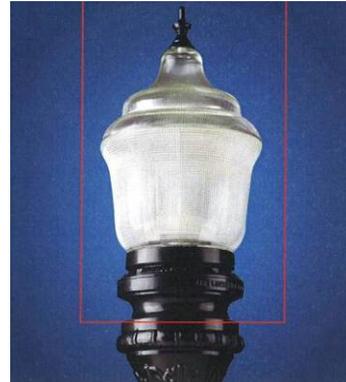
An LED lamp fixture with a clear glass globe and etched external refractor for light distribution has been selected for use in the park. Other lamp options explored were high pressure sodium lamp and metal halide lamp, but based on the LED’s energy conservation, newer technology, lower maintenance and better color rendering LED became the most appealing solution.

To obtain the recommended illumination levels the fixtures/poles will need to be located 70’ apart. This will provide 0.9 footcandle average and 11.3:1 maximum to minimum ratio at grade with the fixture on a 12’-0” high pole.

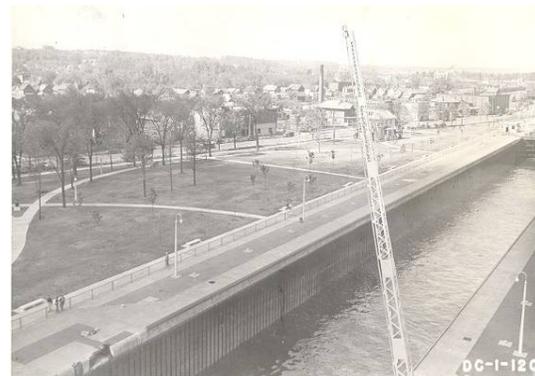
As shown in Photograph 27, the historical lighting appears to be a single fixture, acorn style, pendant hung from a shepherd’s hook mounted to a 25-ft square tapered pole. This was also the fixture historically located in the west and east MSB parking lots.

Photograph 27 taken by the Corps in 1946 immediately following the restoration construction of the parks.

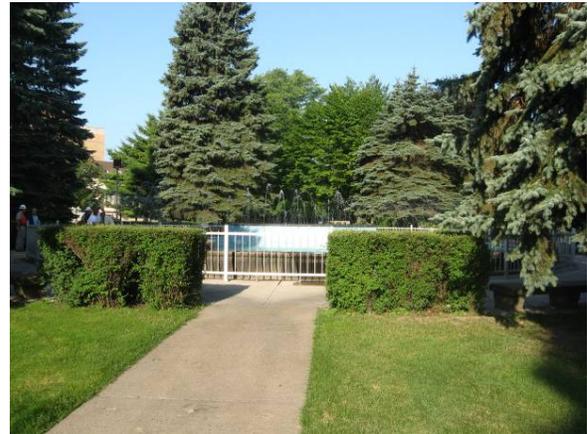
Photograph 28 taken in 2009 of the fountain. The speaker is the existing box like structure on the right hand side of the photo situated between the spruces.

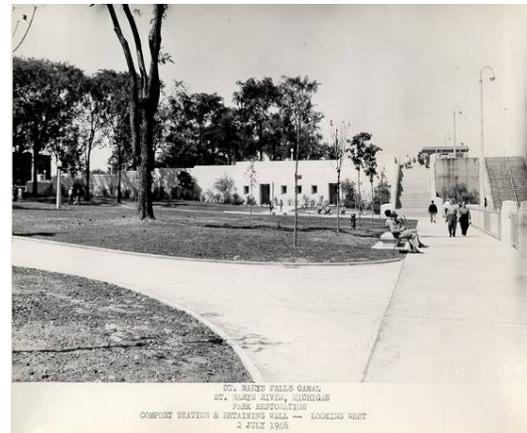
Photograph 29 taken by the Corps in 1946 immediately following the restoration construction of the parks.

Photograph 29 depicts the Lower Canal Park looking west along the main walkway in July of 1946 immediately following the Park's major renovation and the then newly installed concrete benches. These benches were primarily placed along the main walkway adjacent to the lock and at the fountain. They are still widely used today, and are in very good condition. They afford the user the opportunity to look in either direction, and they have become an integral part of the park. However, these benches are cold, low in numbers, and lack comfort because of the absence of a back rest.

With further viewing of this photograph it becomes apparent that the movable, green benches are placed throughout and used in conjunction with the concrete benches, similar to today as depicted below in Photograph 30. These benches are movable, have a back rest, and are more numerous throughout the park (approximately 20). This Plan proposes to keep the benches, but to move some of the green benches to the interior of the park to promote seating within that portion of the park. While moving these benches will take effort during mowing, the movement can be random, and require little effort for a wonderful amenity that completes the entire site. Should the benches need replacing similar models are readily available through many bench manufacturers with the ability to provide custom made benches if required.

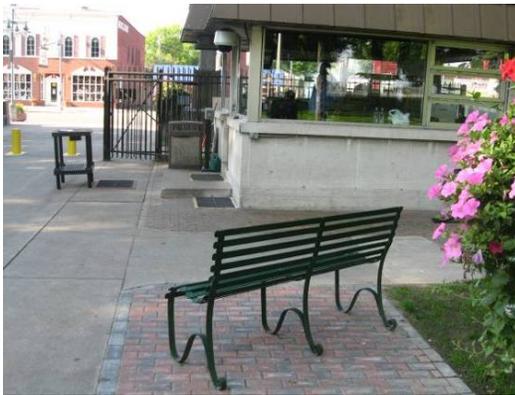
Photograph 30 taken of the movable green benches found throughout the parks in June of 2009.

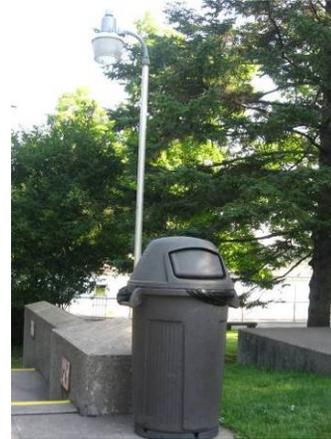
The waste receptacles on site are very industrial as seen in Photograph 31. They are a brown Rubbermaid Product that is moveable and does little to enhance the experience. This Plan proposes four alternative trash receptacles that fit into the character of the park and its history.

Photograph 31 taken of the fountain in the Lower Canal Park looking north in June of 2009.

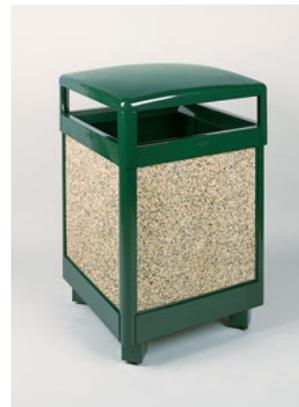
This Plan recommends the waste receptacle depicted in Photograph 32. This model is easy to maintain, durable and economically feasibility, and captures both the stone and green element found throughout the park with its benches and lighting.

Photograph 32 of the proposed waste receptacle..

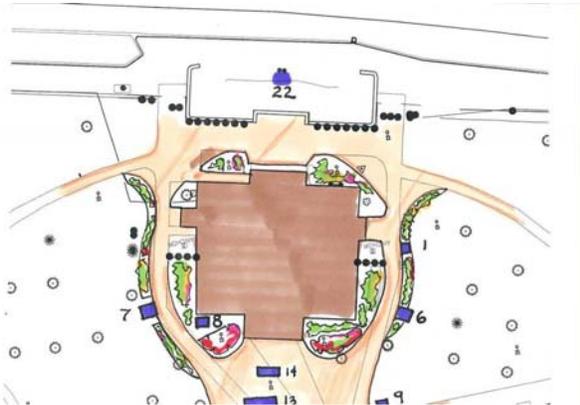
Drawing 3 proposes a new circulation pattern around the Visitors Center including monument placement. As discussed within the proposed circulation portion of this document, there is more open space for visitors to move about and better flow of foot traffic around the Visitors Center to the observation decks while creating space for viewing of the monuments. When placed together, the monuments have a greater impact and begin to tell a story as the user walks from the entrance to the locks. The beds will be redesigned to incorporate more suitable shrubs and perennials.
