INVENTORY AND MAPPING OF SHORELINE PROTECTION AND BOATING STRUCTURES IN DROWNED RIVERMOUTH AREAS OF LAKE MICHIGAN

**GRAND RIVER, GRAND HAVEN, MI
LAKE MACATAWA, HOLLAND, MI
KALAMAZOO LAKE AND RIVER, SAUGATUCK/DOUGLAS, MI
SHEBOYGAN RIVER, SHEBOYGAN, WI**

LAKE MICHIGAN POTENTIAL DAMAGES STUDY

Contract DACW35-00-P-0075

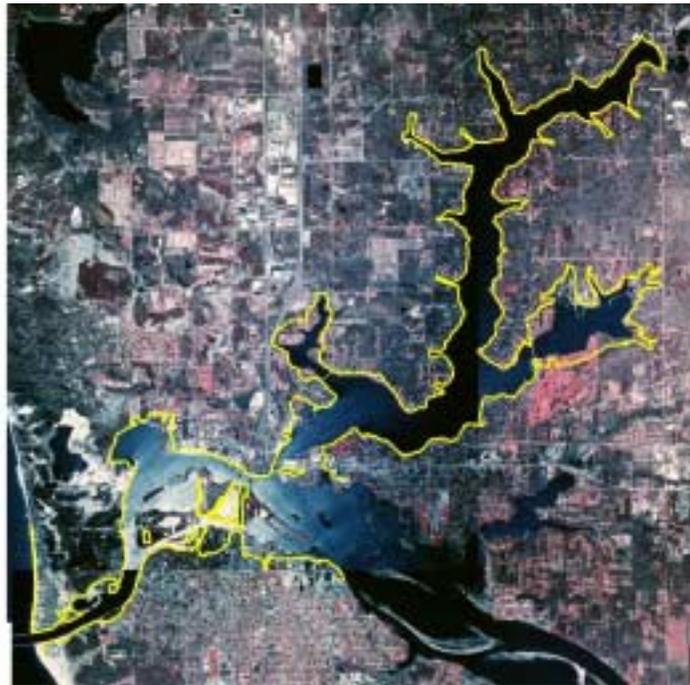
Figure 2 – Example of High Water Mapping, Grand River, Grand Haven, Michigan

In 1999, Wade Trim conducted a series of backwater and storm water rise determinations for these four rivermouth areas. A product of this analysis was a series of "high water maps" that showed the upstream limit of high water events on Lake Michigan in these rivermouth areas. An example is presented in Figure 2. For mapping purposes in this task, shore protection and boating structures were only required to be identified within these backwater limits.

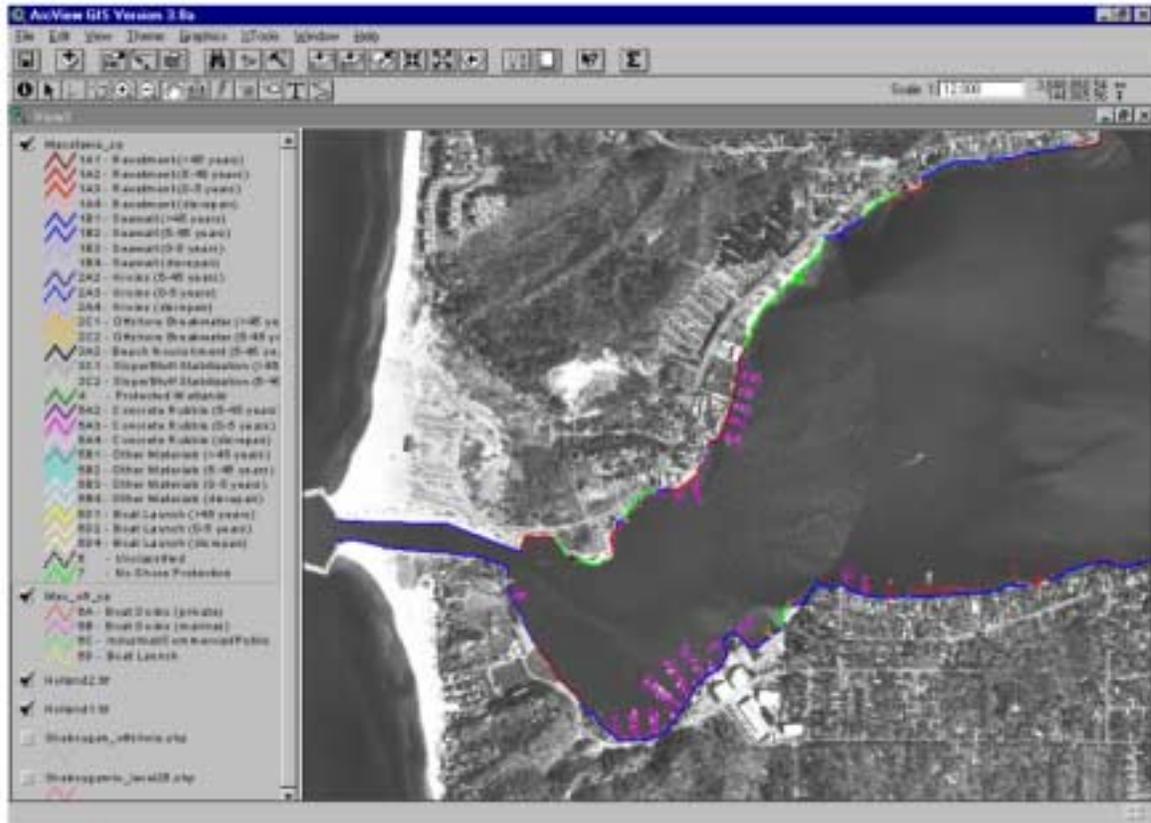
Figure 4 - Example of Shoreline Protection and Boating Related Structures GIS Mapping, Portion of Lake Macatawa, Holland, Michigan

The shore protection, dock structure, and reach classification data were all mapped in ArcView GIS and provided as separate data coverages (Arc shape files) which were delivered electronically to USACE Detroit. Examples of the mapping for each rivermouth area can be found in Figures 3-6. Hardcopy map printouts showing the entire area of each rivermouth are presented in Appendix 1.

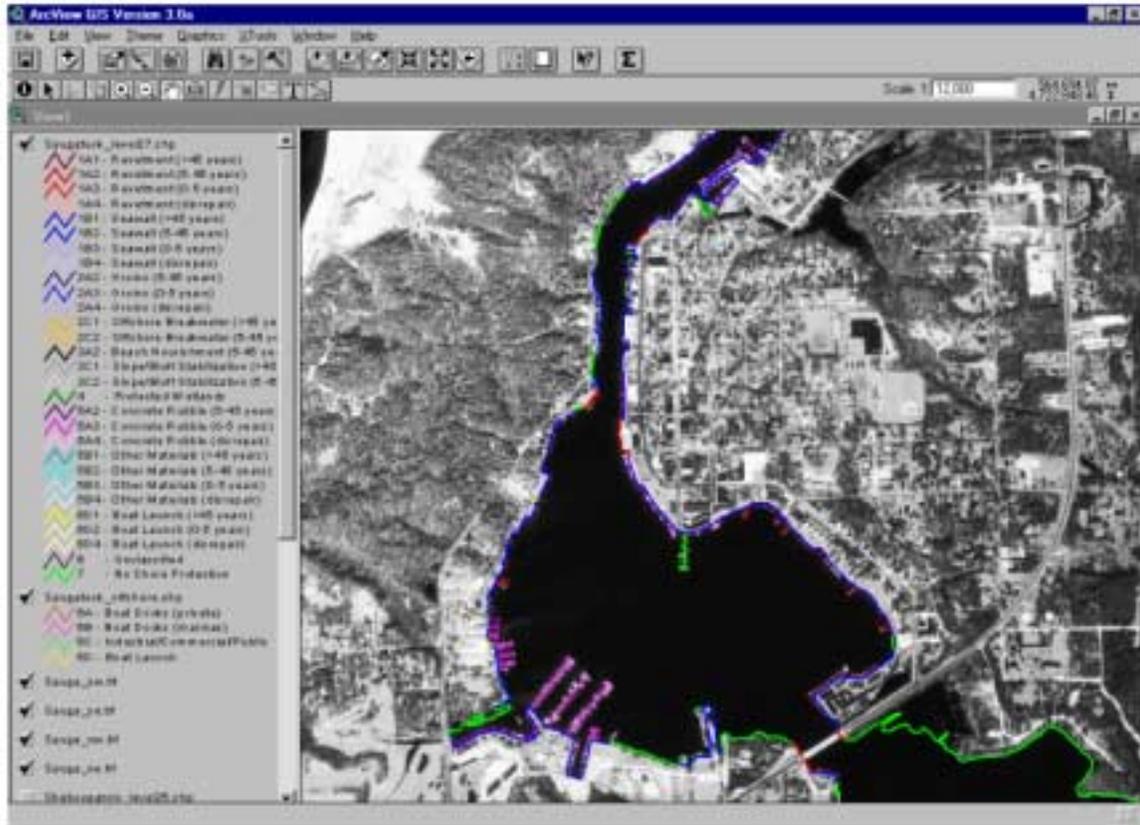
Figure 5 - Example of Shoreline Protection and Boating Related Structures GIS Mapping, Portion of Kalamazoo Lake and River, Saugatuck, Michigan

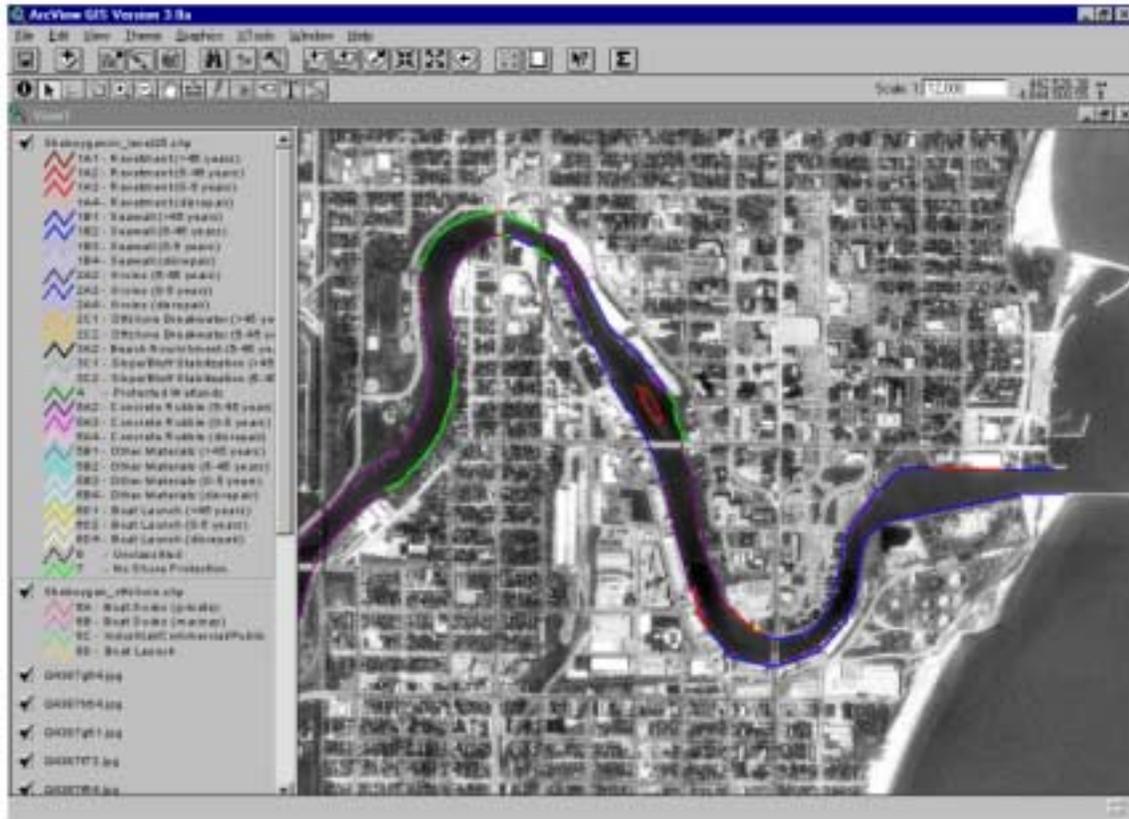
Figure 6 - Example of Shoreline Protection and Boating Related Structures GIS Mapping, Portion of Sheboygan River, Sheboygan, Wisconsin.
