HARBOR INFRASTRUCTURE INVENTORIES Oswego Harbor, New York

Project Description: Oswego Harbor is a deep draft commercial harbor. Protective structures consist of east and west arrowhead laid up stone breakwaters, and outer west timber crib with concrete cap breakwater and a detached laid up stone breakwater with a total length of 10,265'.

Current Condition Assessment: F

Date of Site Visit: 4 June 2010

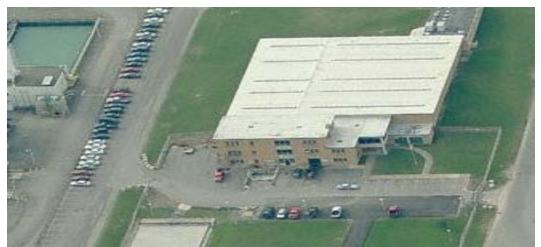
1. City of Oswego Westside Wastewater Treatment Plant: 12 million gallon per day water treatment facility built in 1974 at a cost of \$5 million. Serves the City of Oswego and the Town of Scriba, an estimated population of 23,000. 6,250' long 10' diameter intake running northwest into the lake. Plant is just west of the west breakwater, and therefore would not be impacted by breakwater failure or inundation.

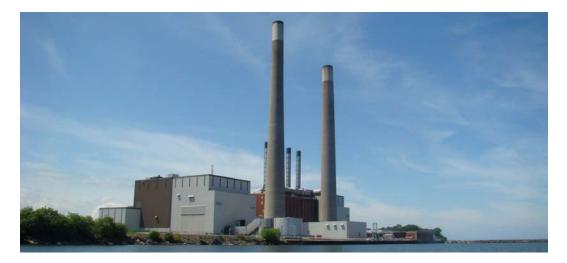
2x850 MW in service since 1975. Two power units were installed at a cost of \$90 million each. Plant originally built in 1939, however original units no longer in service. All fuel is brought in by lake from Montreal. Plant is reliant on lake and safe harbor for fuel delivery. Oil is stored in 4 tanks onsite with a total storage of 1.5 million barrels and at a remote site with a capacity of 3.5 million barrels. The remote site is connected via pipeline to the plant. Plant dockage facility consists of an 720' wharf with an 18' draft. The plant runs as demand increases, running a total of about 3% of the time. When generating, the plant has 50 workers; the workforce is cut to 5 while on standby. Plant concerns are with continued degradation of breakwater which would cause damage to the wharf, limits to fuel delivery and would likely curtail generation.

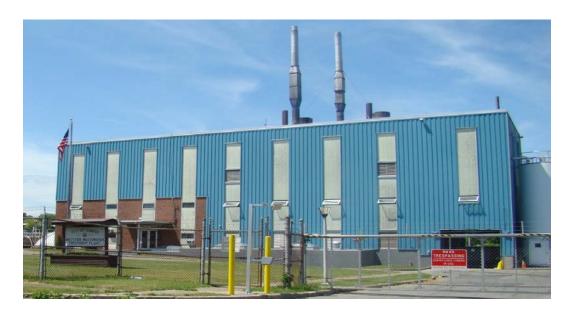
3. City of Oswego Westside Wastewater Treatment Plant: 4 million gallon per day activated sludge wastewater treatment facility build in 1979 at a cost of \$6 million. Serves the west side of the City of Oswego, the State University of New York College at Oswego, and the Town of Oswego. Plant serves a population of about 16,000 people. Plant discharges into the inner harbor, however the plant itself is set back from shore.

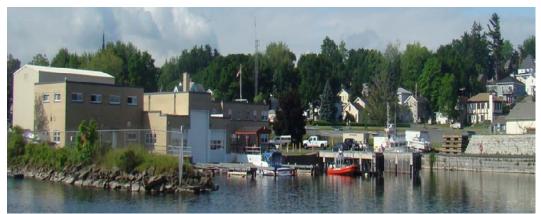
10. U.S. Coast Guard Station Oswego: Coast Guard Station with area of responsibility extending from Cape Vincent to Sodus, NY. 3 vessels and an occasional research vessel based at site. 2 story station. Major concern with breakwaters is armor stone that is occasionally falling into harbor and creating hazards to navigation.

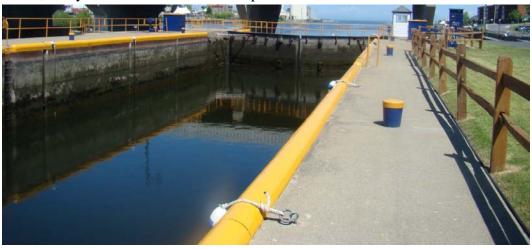
14. New York State Canal Corporation Oswego Canal Lock 8: State owned 300'x40' lock connecting the 524 mile long New York State Canal system with the Port of Oswego and Lake Ontario. Built in 1918 to serve freight traffic, today recreational users make up about 80-90% of traffic.

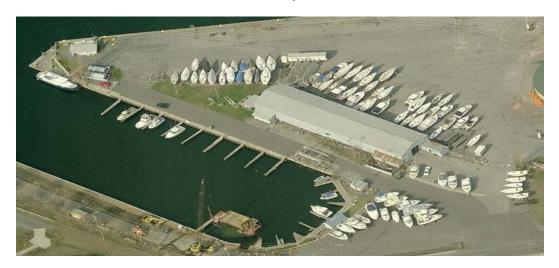
16. Oswego Port Authority: Port authority with ownership of the East and West terminals of the Port of Oswego. West Terminal run by Essroc, Lafarge and Sprague corporations. East Terminal handles less that 1 million tons of freight per year, with an estimated value of about \$5 million. Structures and facilities include a 100,000 square foot warehouse, 3 domes capable of storing 35,000 tons each, a 100,000 ton capacity barrel building, 1,200' slips, dockside rail with mainline service by CSX, 400,000 square feet of open storage space, 25 ton to 600 ton cranes and mobile conveyors with a total capacity in excess of 30,000 bushels per hour. The port authority employs 11 full time employees and between 2 and 30 longshoreman, as needed. Primary commodities received are agricultural, including corn and soy beans, pot ash, aluminum, salt and specialty cargo such as transformers, windmills and rebar. Incoming shipments predominantly arrive by boat from Ontario, other parts of Canada and worldwide. Outgoing shipments are handled by rail, truck and boat primarily destined for local markets. The port has seen a dramatic increase in agricultural products, while pot ash shipments have remained steady and salt shipments have increased slightly. The breakwaters are key to port operations, and breakwater failure and inundation would be detrimental to port shipments and activity. Additionally, the CSX rail spur serving the port runs north out of the port and then east along the lakeshore. Breakwater failure would cause increased wave action acting upon the railway, resulting in limits to use and damage.

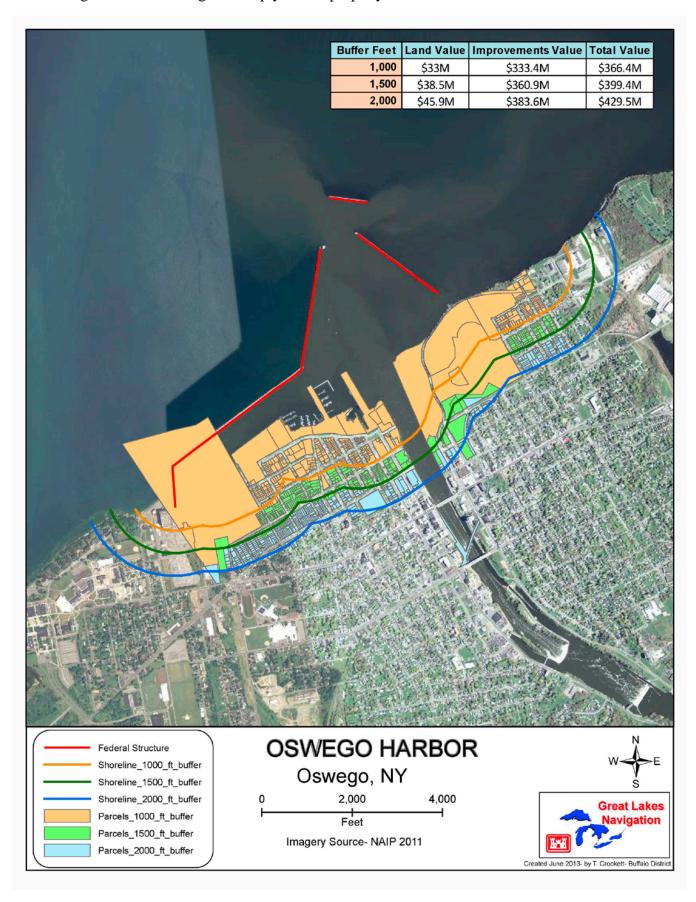
Potential Impact Area: The following graphic displays property parcels that could be impacted within various zones defined by different setbacks from the shoreline behind existing Federal coastal structures. Values are based on real property tax assessments from these parcels, and don't reflect any detailed coastal zone damage assessments. Figures simply reflect property values at various setbacks.
