Coastal Structures Risk Communication Middle UP, Northern Wisconsin Harbors

Dave Wright
Chief of Operations
Detroit District

Oct 29, 2013

US Army Corps of Engineers
BUILDING STRONG

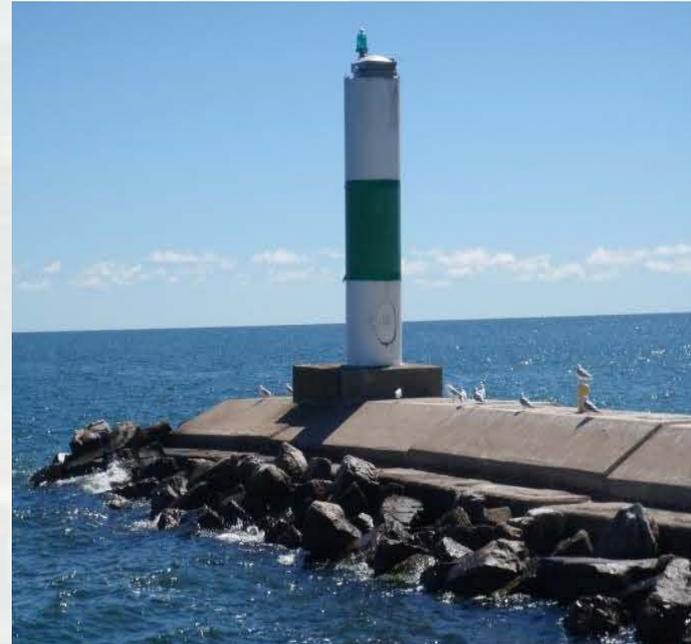
South Breakwater, end pier is inclined away from navigation light.

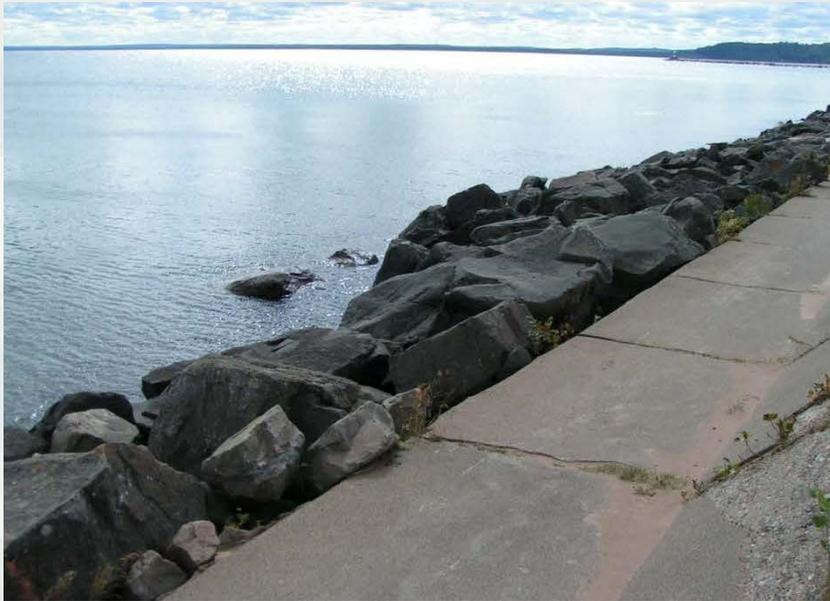
Stone protection lakeside of Breakwater.

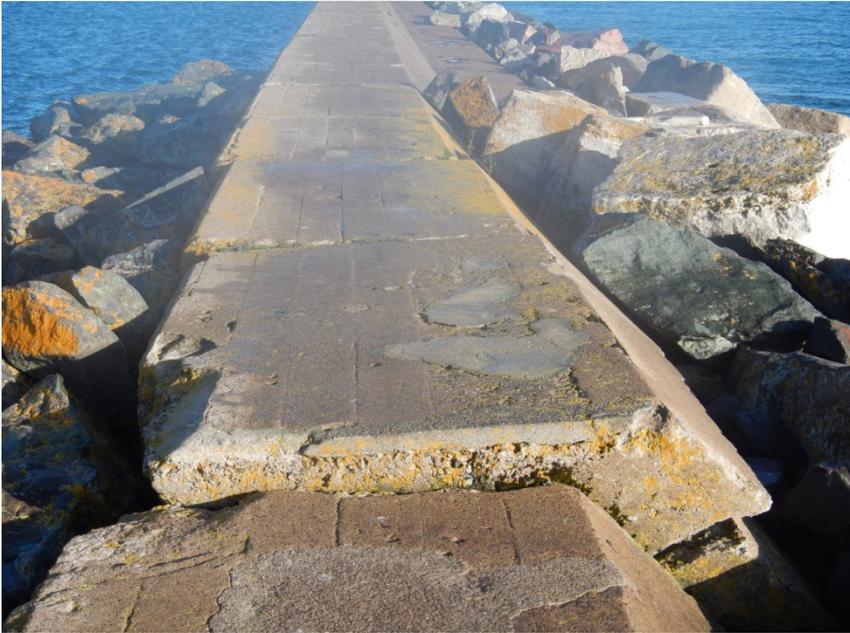
Breakwater concrete miss alignment.

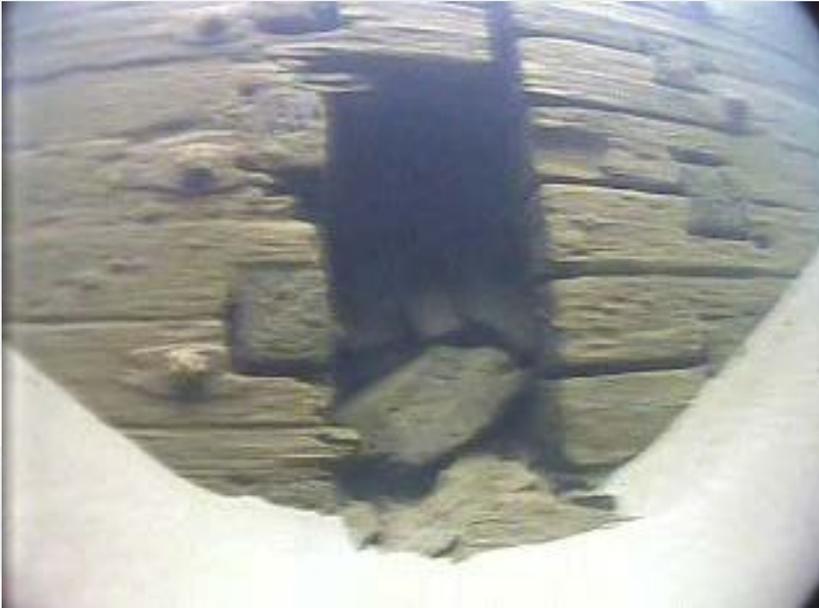
Under water video showing a 24" void between the timber cribs near cross section 22+40 facing west.

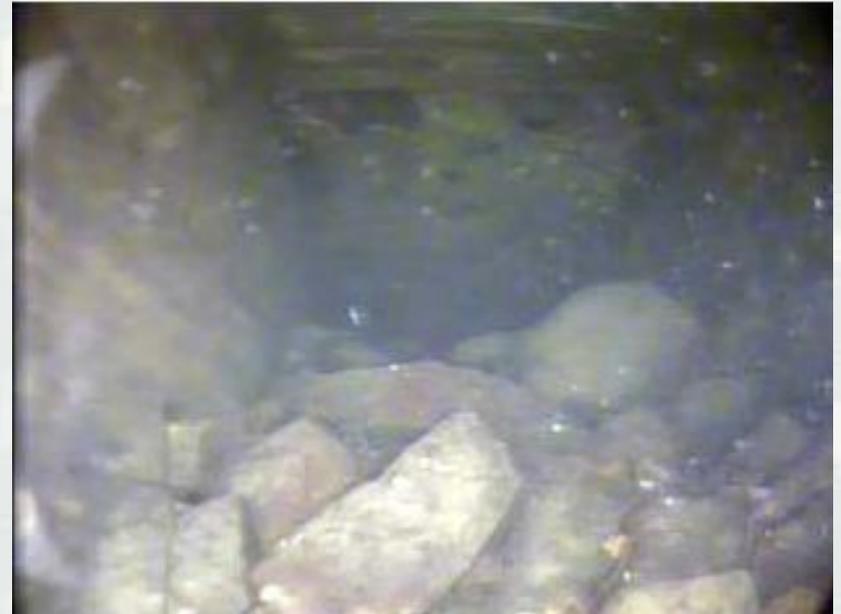
Remote Operated Vehicle is inside timber crib structure near cross section 22+40.

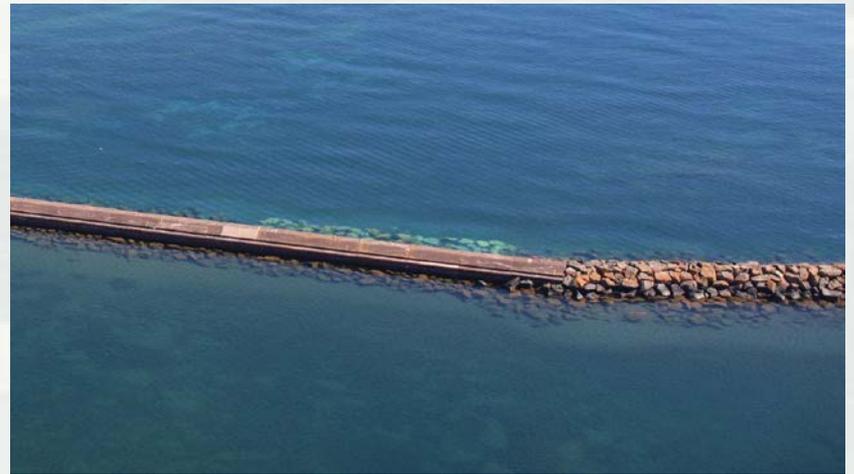
Transition from concrete to rubble mound.

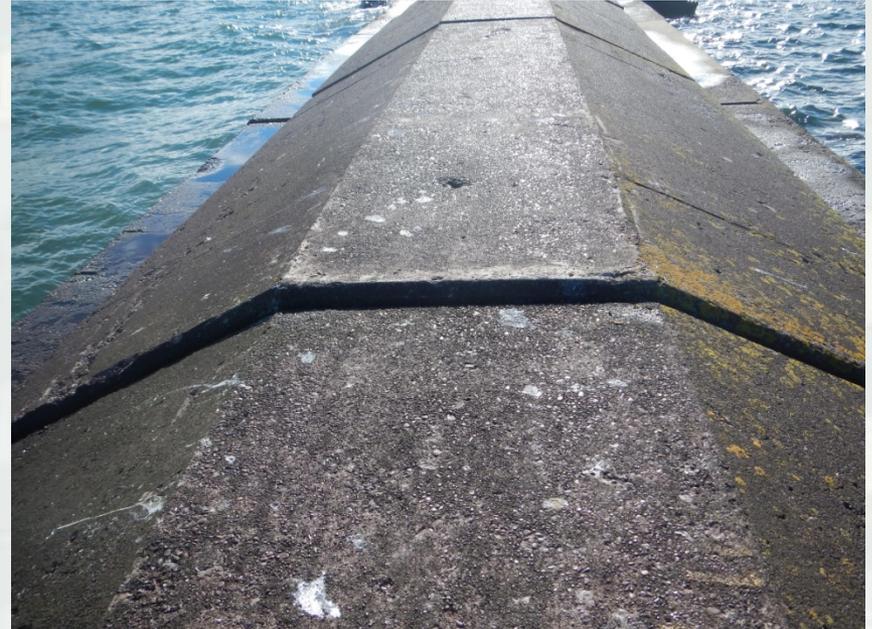
Settlement between breakwater sections.

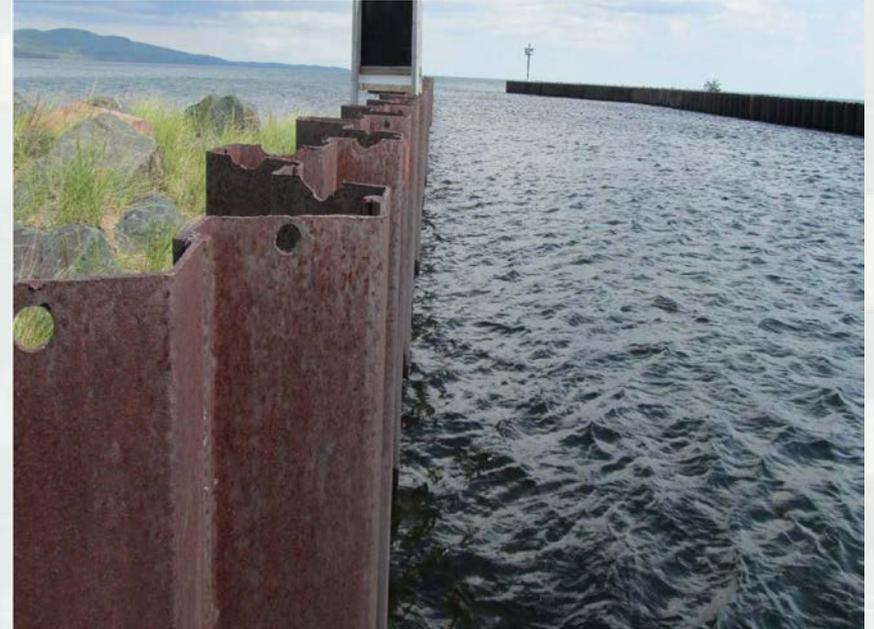
North Entry.

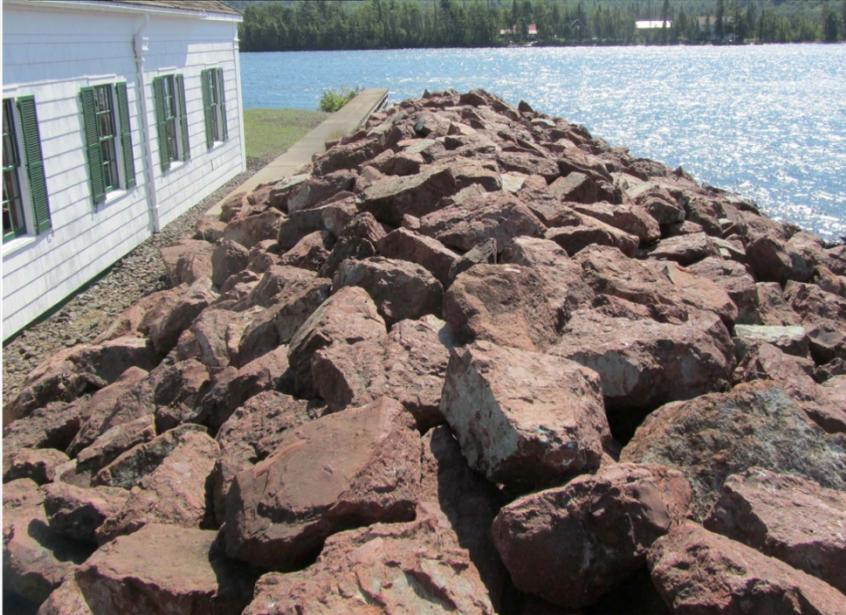
Rubble Mound Breakwater – Looking South.

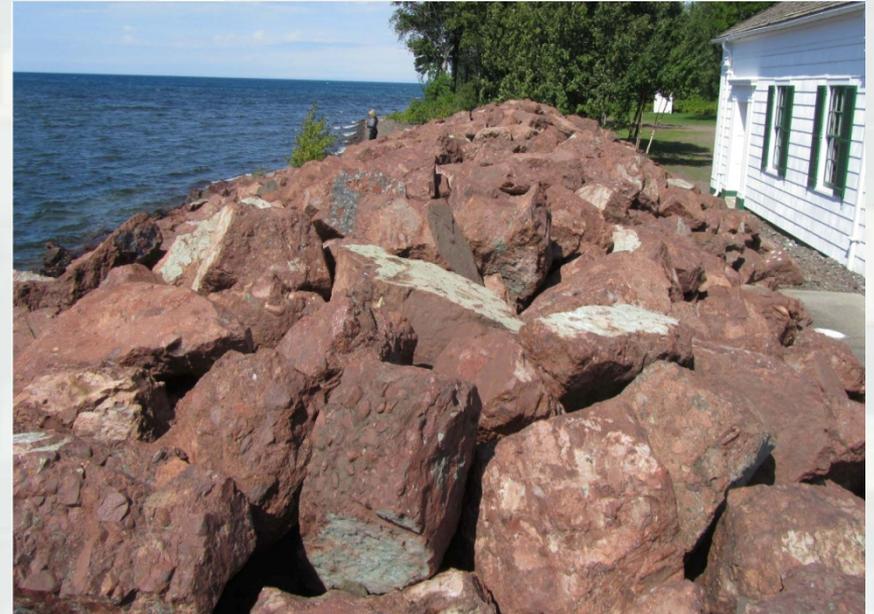
Rubble Mound Breakwater – Looking North.

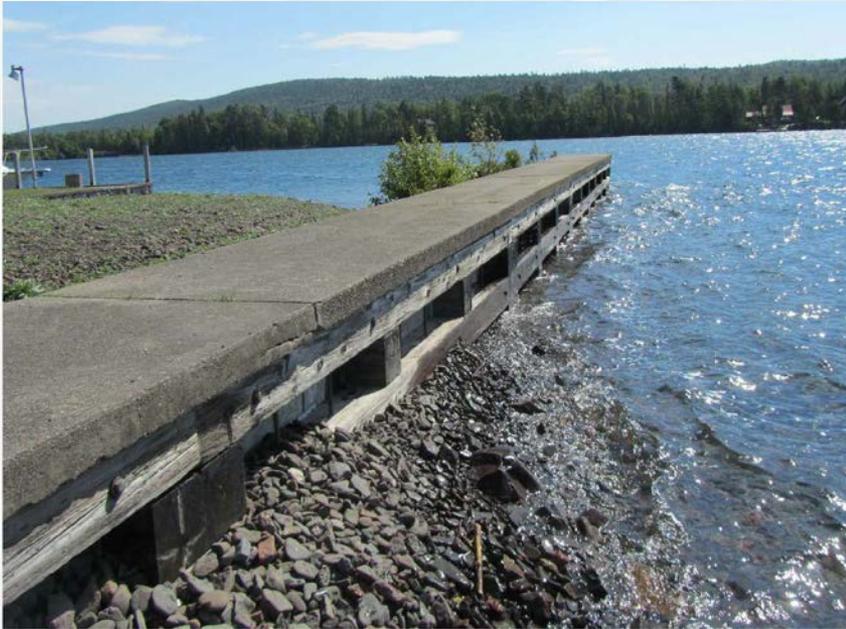
Steel Revetment, Looking South.

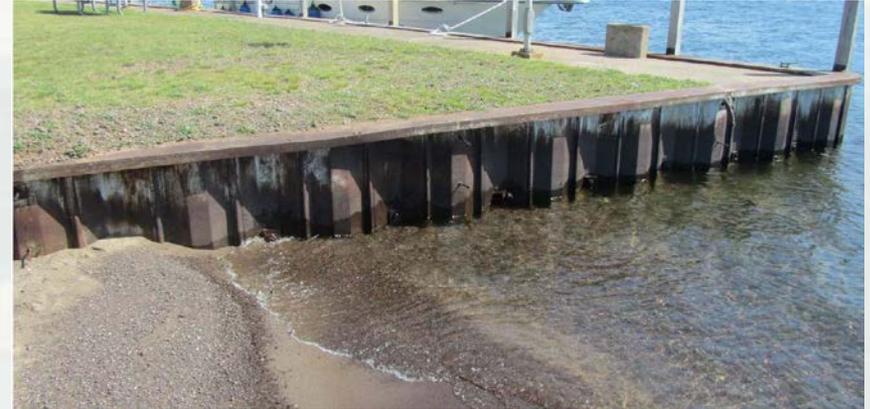
Steel Revetment, Looking Southwest

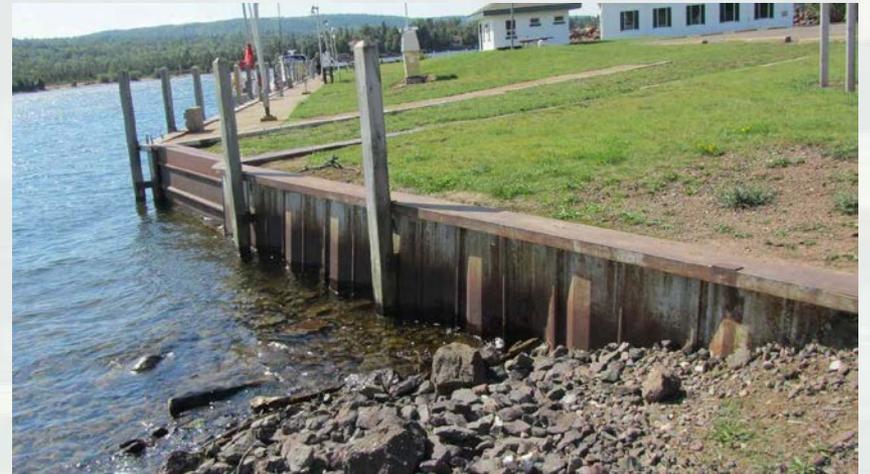
Steel Revetment, Looking West.

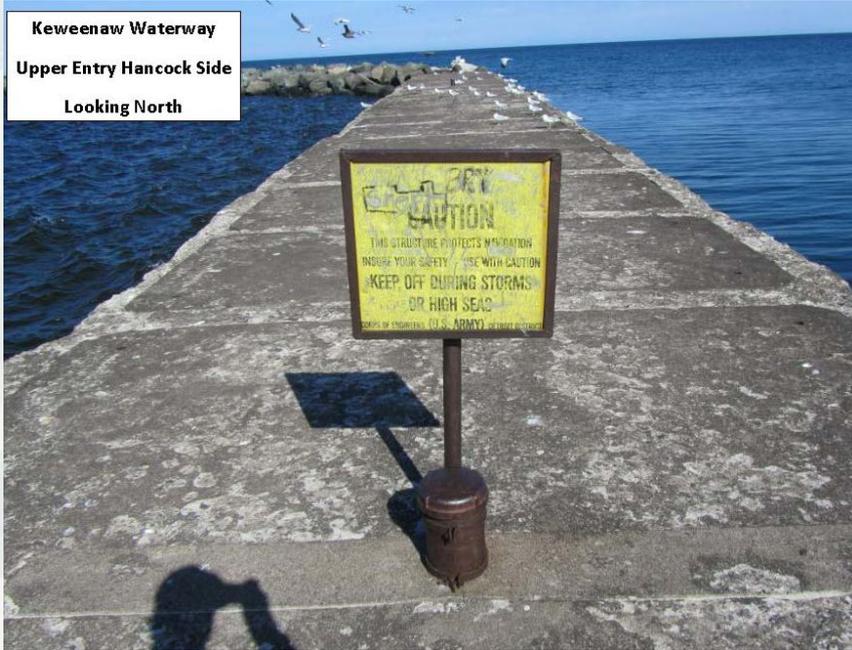
Keweenaw Waterway
Upper Entry Hancock Side
Looking North

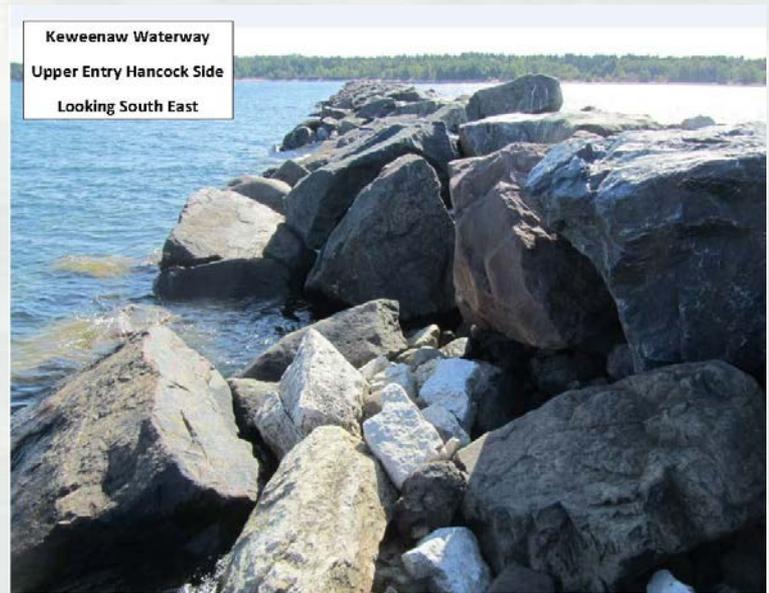
Keweenaw Waterway
Upper Entry Hancock Side
Looking South East

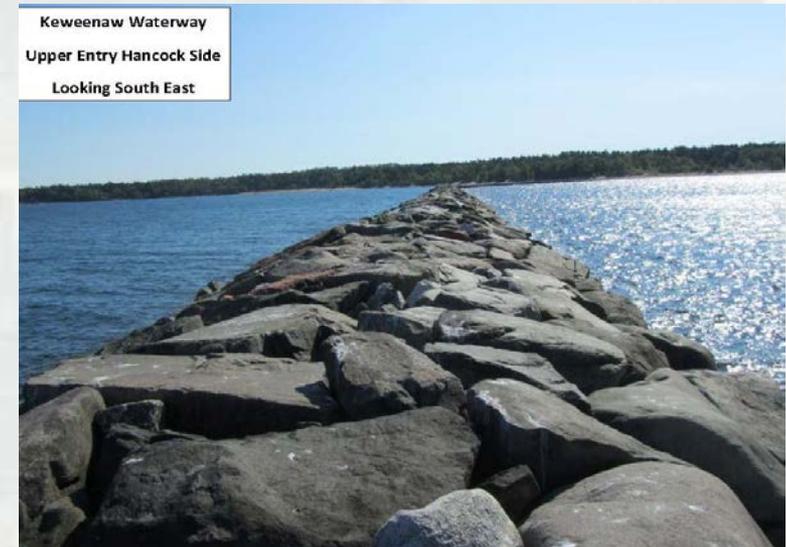
Keweenaw Waterway
Upper Entry Hancock Side
Looking South East
